## Profile/Photo Observation Report

Street:	<b>OFF E 37TH AVE</b>	Flow Control:	<b>Not Controlled</b>
City:	<b>Hobart, IN</b>	Year Renewed:	
Location:	<b>Other</b>	Tape/Media #:	
Purpose:	<b>Not Known</b>	Dia/Height:	<b>10"</b>
Use:	<b>Sanitary</b>	Material:	<b>PVC</b>
Drain Area:	<b>NA</b>	Lining:	
Category:	<b>NA</b>		
Comment:	<b>null m-802-002 surcharged highwater</b>

Location Details:		Direction of Survey:	<b>Downstream</b>
US MH:	<b>M-903-059</b>	DS MH:	<b>M-903-039</b>
		Total Length Surveyed (ft):	<b>288.9</b>

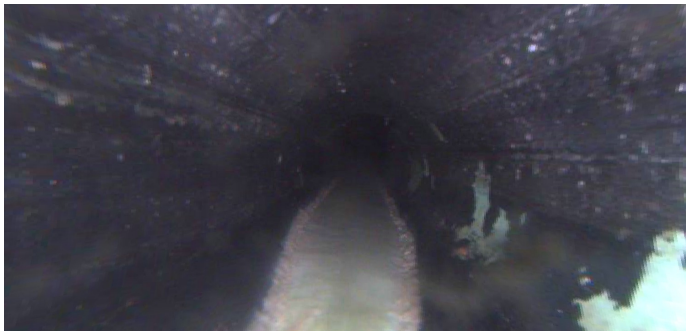
Code: **AMH**  
Description: **Manhole**

Distance (ft): **.0**  
Structural Grade: **0**  
O&M Grade: **0**  
Clock Start/From:  
Clock To:  
1st Value:  
2nd Value:  
Value Percent:  
Continuous Index:  
Within 8" of Joint: **NO**  
Remarks: **M-903-059**

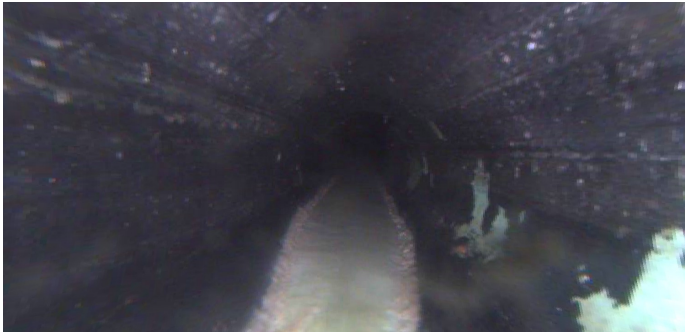
Code:	<b>MWL</b>
Description:	<b>Water Level</b>

Distance (ft):	<b>.0</b>
Structural Grade:	<b>0</b>
O&M Grade:	<b>0</b>
Clock Start/From:	
Clock To:	
1st Value:	
2nd Value:	
Value Percent:	<b>5.000</b>
Continuous Index:	
Within 8" of Joint:	<b>NO</b>
Remarks:

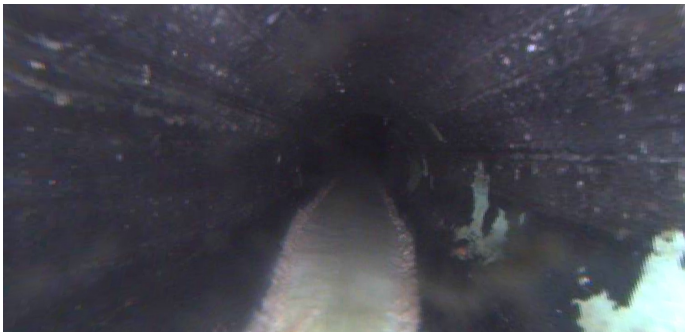
Code:	<b>DAZ</b>
Description:	<b>Deposits Attached Other</b>

Distance (ft):	<b>.0</b>
Structural Grade:	<b>0</b>
O&M Grade:	<b>2</b>
Clock Start/From:	<b>7</b>
Clock To:	<b>5</b>
1st Value:	
2nd Value:	
Value Percent:	<b>5.000</b>
Continuous Index:	<b>S01</b>
Within 8" of Joint:	<b>YES</b>
Remarks:	<b>WANDER</b>

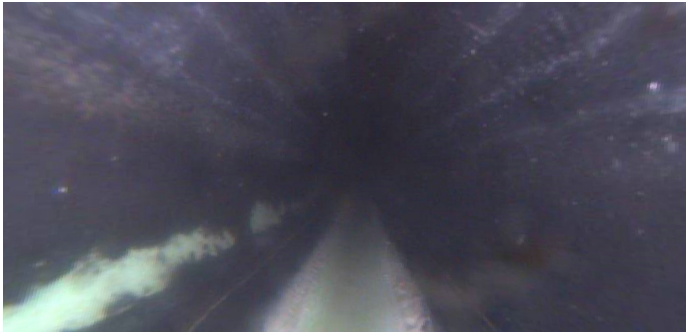
Code: **DAGS**  
Description: **Deposits Attached Grease**

Distance (ft): **15.6**  
Structural Grade: **0**  
O&M Grade: **2**  
Clock Start/From: **7**  
Clock To: **5**  
1st Value:  
2nd Value:  
Value Percent: **5.000**  
Continuous Index: **S02**  
Within 8" of Joint: **YES**  
Remarks: **WANDER**

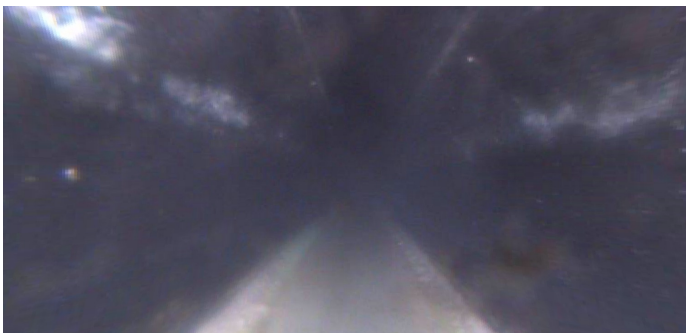
Code: **MGO**  
Description: **General Observation**

Distance (ft): **27.5**  
Structural Grade: **0**  
O&M Grade: **0**  
Clock Start/From:  
Clock To:  
1st Value:  
2nd Value:  
Value Percent:  
Continuous Index:  
Within 8" of Joint: **NO**  
Remarks: **FOG**

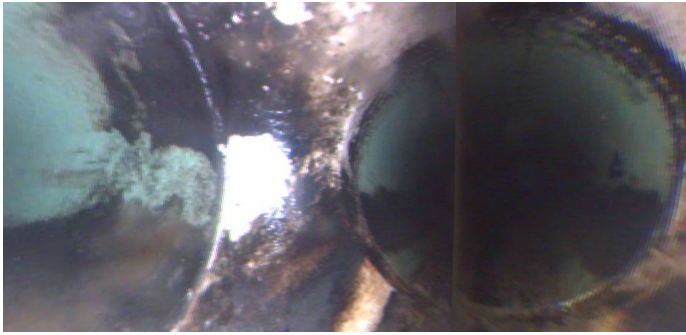
Code: **TF**  
Description: **Tap Factory**

Distance (ft): **166.8**  
Structural Grade: **0**  
O&M Grade: **0**  
Clock Start/From: **3**  
Clock To:  
1st Value: **4.000**  
2nd Value:  
Value Percent:  
Continuous Index:  
Within 8" of Joint:  
Remarks:

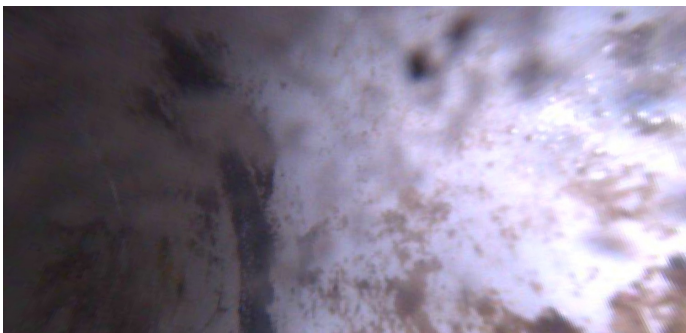
Code: **AMH**  
Description: **Manhole**

Distance (ft): **288.9**  
Structural Grade: **0**  
O&M Grade: **0**  
Clock Start/From:  
Clock To:  
1st Value:  
2nd Value:  
Value Percent:  
Continuous Index:  
Within 8" of Joint: **NO**  
Remarks: **M-903-039**

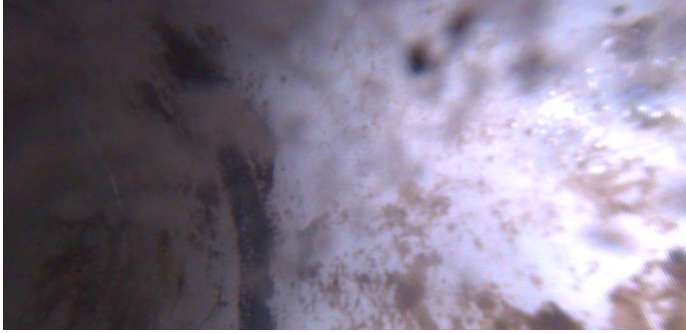
Code: **DAGS**  
Description: **Deposits Attached Grease**

Distance (ft): **288.9**  
Structural Grade: **0**  
O&M Grade: **2**  
Clock Start/From: **7**  
Clock To: **5**  
1st Value:  
2nd Value:  
Value Percent: **5.000**  
Continuous Index: **F02**  
Within 8" of Joint: **YES**  
Remarks: **WANDER**

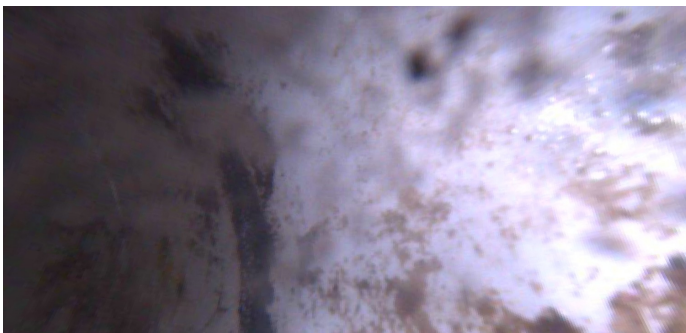
Code: **DAZ**  
Description: **Deposits Attached Other**

Distance (ft): **288.9**  
Structural Grade: **0**  
O&M Grade: **2**  
Clock Start/From: **7**  
Clock To: **5**  
1st Value:  
2nd Value:  
Value Percent: **5.000**  
Continuous Index: **F01**  
Within 8" of Joint: **YES**  
Remarks: **WANDER**
