Profile/Photo Observation Report

Date:	08/03/2023	Weather:		Coding:	PACP 7.0
Pipe Length (ft):	82.3	Owner:	City of Hobart	Pre Clean:	Heavy Cleaning
P.O.#:	YES502259	Surveyor:	S. Bucklin	PSR:	M-903-061-M-903-061
Customer:	City of Hobart	Clean Date:	06/12/2023	Shape:	C

Street:	East Ridge Road	Flow Control:	Not Controlled
City:	Hobart, IN	Year Renewed:	
Location:	Easement/Right of Way	Tape/Media #:	
Purpose:	Routine Assessment	Dia/Height:	8"
Use:	Sanitary Sewage Pipe	Material:	PVC
Drain Area:		Lining:	None
Category:	NA

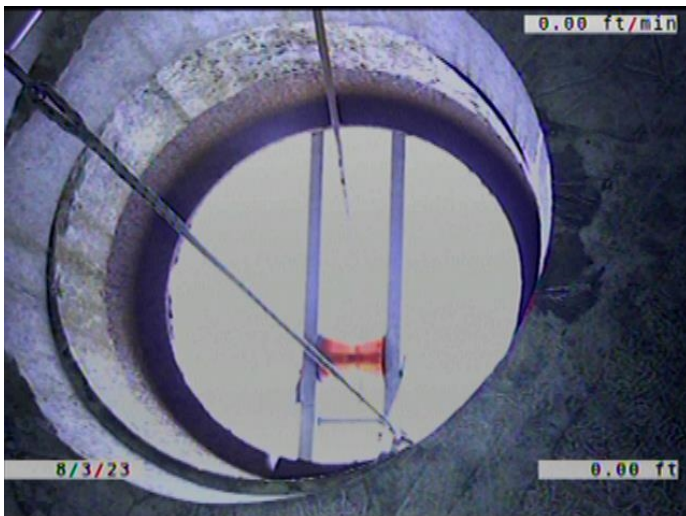
Code:	AMH
Description:	Manhole
Distance (ft):	.0
Structural Grade:	0
O&M Grade:	0
Clock Start/From:	
Clock To:	
1st Value:	
2nd Value:	
Value Percent:	
Continuous Index:	
Within 8" of Joint:	NO
Remarks:	M-903-061

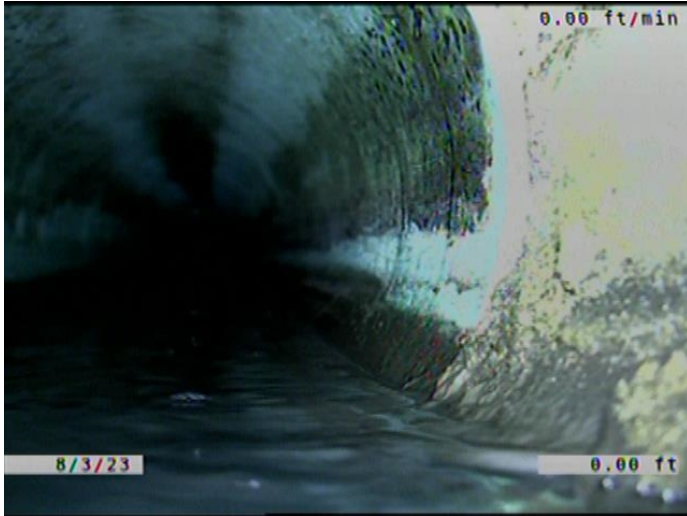
Code: **MWL**
Description: **Miscellaneous Water Level**

Distance (ft): **.0**
Structural Grade: **0**
O&M Grade: **0**
Clock Start/From:
Clock To:
1st Value:
2nd Value:
Value Percent: **15.000**
Continuous Index:
Within 8" of Joint: **NO**
Remarks:

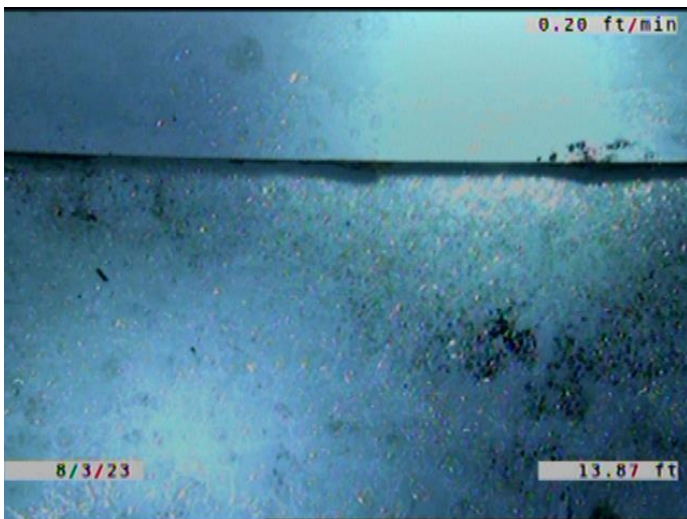
Code: **MGO**
Description: **Miscellaneous General Observation**

Distance (ft): **13.9**
Structural Grade: **0**
O&M Grade: **0**
Clock Start/From:
Clock To:
1st Value:
2nd Value:
Value Percent:
Continuous Index:
Within 8" of Joint: **NO**
Remarks: **JOINT/ PIPES NOT PUSHED ALL THE WAY TOGETHER WHEN INSTALLED**

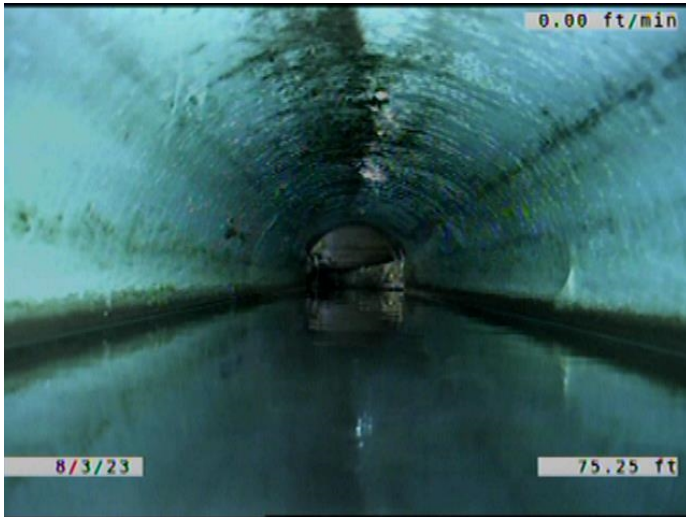
Code: **MWL**
Description: **Miscellaneous Water Level**

Distance (ft): **75.2**
Structural Grade: **0**
O&M Grade: **0**
Clock Start/From:
Clock To:
1st Value:
2nd Value:
Value Percent: **25.000**
Continuous Index:
Within 8" of Joint: **NO**
Remarks:

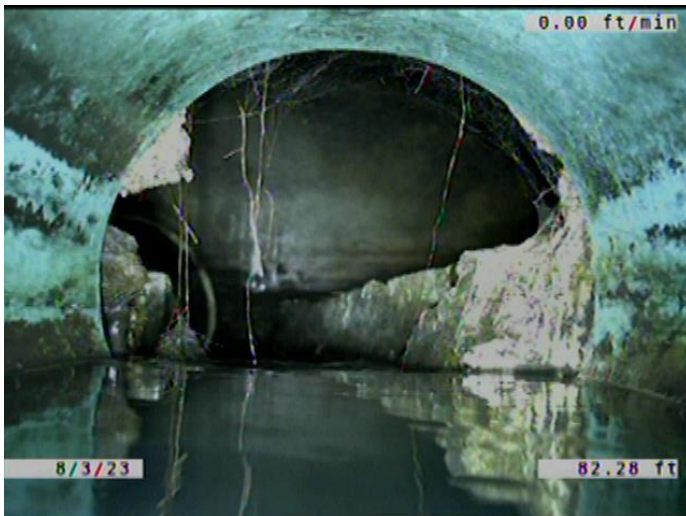
Code: **MGO**
Description: **Miscellaneous General Observation**

Distance (ft): **82.3**
Structural Grade: **0**
O&M Grade: **0**
Clock Start/From:
Clock To:
1st Value:
2nd Value:
Value Percent:
Continuous Index:
Within 8" of Joint: **NO**
Remarks: **CHANNEL IN THE MANHOLE NOT SHAPED WELL. DOES NOT ALLOW PR**

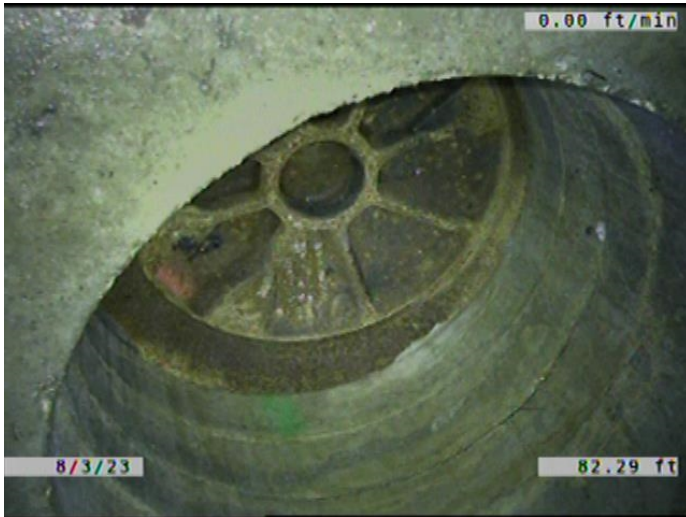
Code:	AMH
Description:	Manhole
Distance (ft):	82.3
Structural Grade:	0
O&M Grade:	0
Clock Start/From:	
Clock To:	
1st Value:	
2nd Value:	
Value Percent:	
Continuous Index:	
Within 8" of Joint:	NO
Remarks:	M-903-063
