## Profile/Photo Observation Report

Street:	<b>E RAND ST &amp; SPENCER PL</b>	Flow Control:	<b>Not Controlled</b>
City:	<b>Hobart, IN</b>	Year Renewed:	
Location:	<b>Other</b>	Tape/Media #:	
Purpose:	<b>Not Known</b>	Dia/Height:	<b>8"</b>
Use:	<b>Sanitary</b>	Material:	<b>PVC</b>
Drain Area:	<b>NA</b>	Lining:	
Category:	<b>NA</b>		
Comment:

Location Details:		Direction of Survey:	<b>Downstream</b>
US MH:	<b>M-903-064</b>	DS MH:	<b>M-903-012</b>
		Total Length Surveyed (ft):	<b>215.2</b>

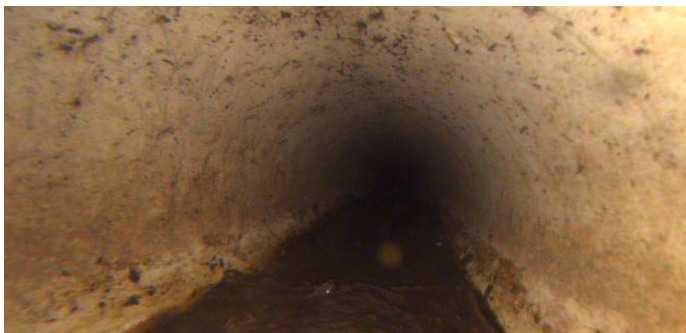
Code: **AMH**  
Description: **Manhole**

Distance (ft): **.0**  
Structural Grade: **0**  
O&M Grade: **0**  
Clock Start/From:  
Clock To:  
1st Value:  
2nd Value:  
Value Percent:  
Continuous Index:  
Within 8" of Joint: **NO**  
Remarks: **M-903-064**

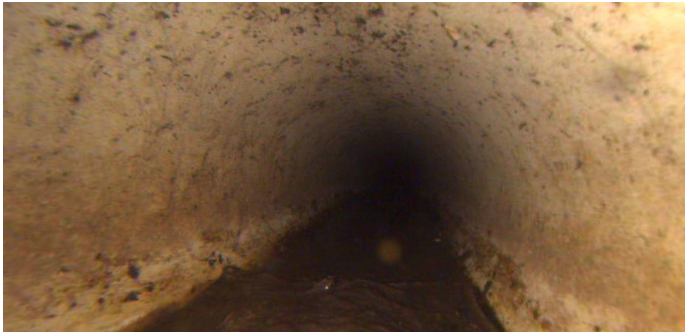
Code:	<b>MWL</b>
Description:	<b>Water Level</b>

Distance (ft):	<b>.0</b>
Structural Grade:	<b>0</b>
O&M Grade:	<b>0</b>
Clock Start/From:	
Clock To:	
1st Value:	
2nd Value:	
Value Percent:	<b>10.000</b>
Continuous Index:	
Within 8" of Joint:	<b>NO</b>
Remarks:

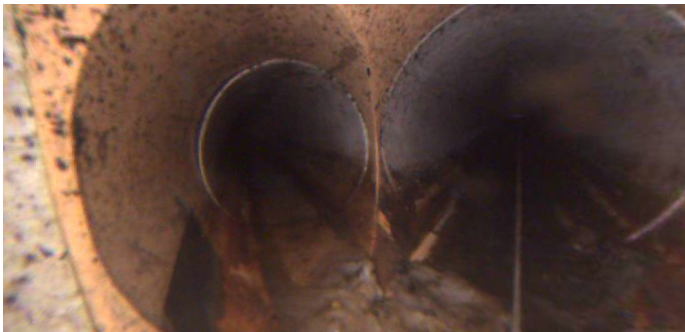
Code:	<b>TFA</b>
Description:	<b>Tap Factory Active</b>

Distance (ft):	<b>14.5</b>
Structural Grade:	<b>0</b>
O&M Grade:	<b>0</b>
Clock Start/From:	<b>3</b>
Clock To:	
1st Value:	<b>4.000</b>
2nd Value:	
Value Percent:	
Continuous Index:	
Within 8" of Joint:	
Remarks:

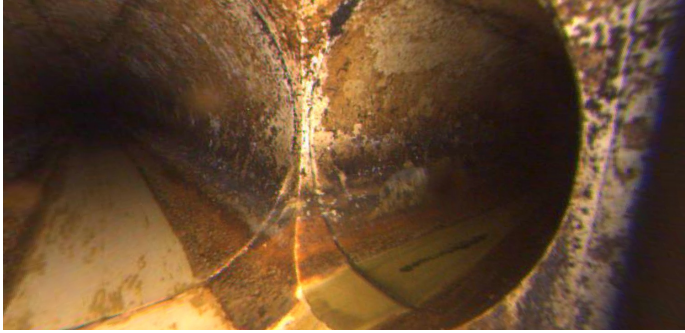
Code: **TFA**  
Description: **Tap Factory Active**

Distance (ft): **52.0**  
Structural Grade: **0**  
O&M Grade: **0**  
Clock Start/From: **3**  
Clock To:  
1st Value: **4.000**  
2nd Value:  
Value Percent:  
Continuous Index:  
Within 8" of Joint:  
Remarks:

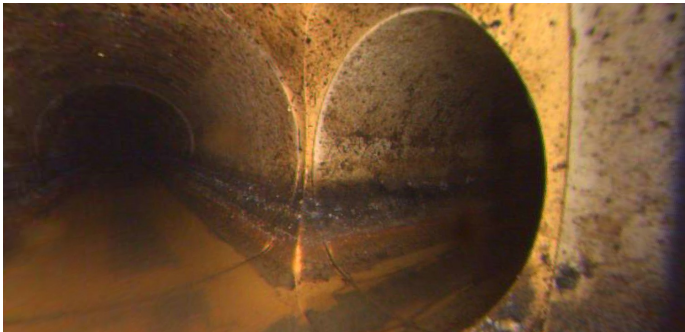
Code: **TFA**  
Description: **Tap Factory Active**

Distance (ft): **111.6**  
Structural Grade: **0**  
O&M Grade: **0**  
Clock Start/From: **3**  
Clock To:  
1st Value: **4.000**  
2nd Value:  
Value Percent:  
Continuous Index:  
Within 8" of Joint:  
Remarks:

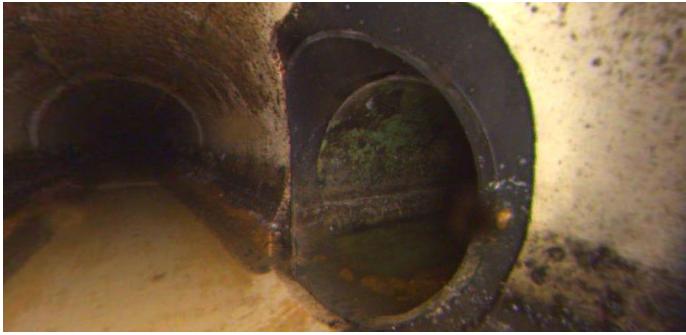
Code: **TBA**  
Description: **Tap Break-in Active**

Distance (ft): **187.5**  
Structural Grade: **0**  
O&M Grade: **0**  
Clock Start/From: **3**  
Clock To:  
1st Value: **4.000**  
2nd Value:  
Value Percent:  
Continuous Index:  
Within 8" of Joint:  
Remarks:

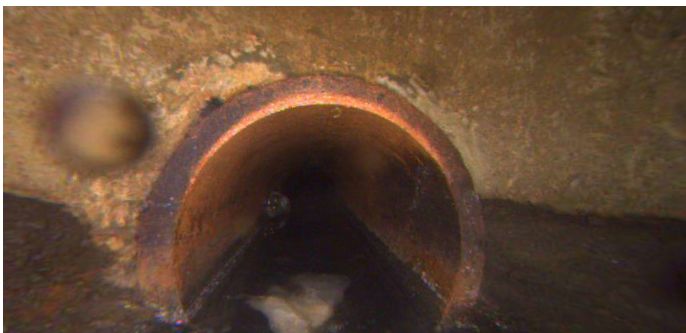
Code: **AMH**  
Description: **Manhole**

Distance (ft): **215.2**  
Structural Grade: **0**  
O&M Grade: **0**  
Clock Start/From:  
Clock To:  
1st Value:  
2nd Value:  
Value Percent:  
Continuous Index:  
Within 8" of Joint: **NO**  
Remarks: **M-903-012**
