Profile/Photo Observation Report

Street:	Rand St.	Flow Control:	Not Controlled
City:	Hobart, IN	Year Renewed:	
Location:	Other	Tape/Media #:	
Purpose:	Not Known	Dia/Height:	8"
Use:	Sanitary	Material:	PVC
Drain Area:	NA	Lining:	
Category:	NA		
Comment:

Location Details:		Direction of Survey:	Downstream
US MH:	M-903-064	DS MH:	M-903-012
		Total Length Surveyed (ft):	215.2

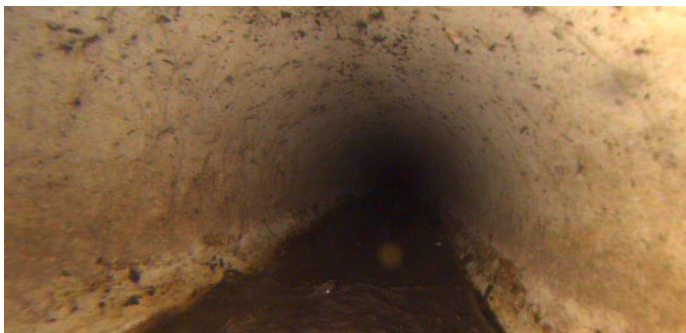
Code: **AMH**
Description: **Manhole**

Distance (ft): **.0**
Structural Grade: **0**
O&M Grade: **0**
Clock Start/From:
Clock To:
1st Value:
2nd Value:
Value Percent:
Continuous Index:
Within 8" of Joint: **NO**
Remarks: **M-903-064**

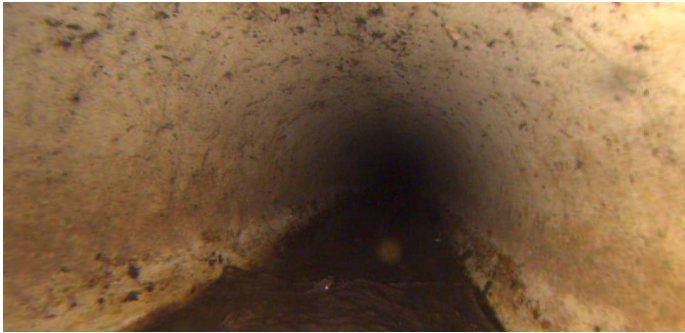
Code:	MWL
Description:	Water Level

Distance (ft):	.0
Structural Grade:	0
O&M Grade:	0
Clock Start/From:	
Clock To:	
1st Value:	
2nd Value:	
Value Percent:	10.000
Continuous Index:	
Within 8" of Joint:	NO
Remarks:

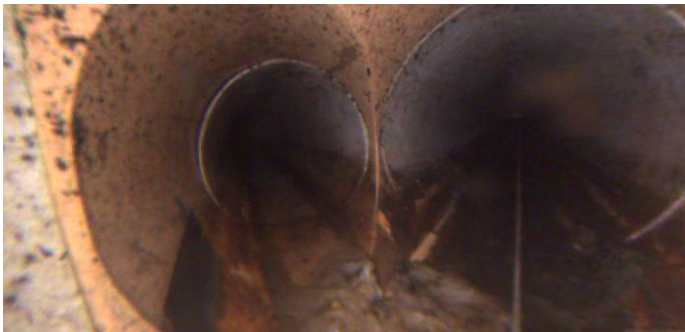
Code:	TFA
Description:	Tap Factory Active

Distance (ft):	14.5
Structural Grade:	0
O&M Grade:	0
Clock Start/From:	3
Clock To:	
1st Value:	4.000
2nd Value:	
Value Percent:	
Continuous Index:	
Within 8" of Joint:	
Remarks:

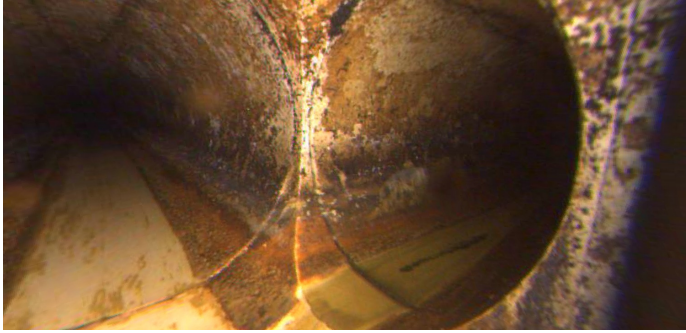
Code: **TFA**
Description: **Tap Factory Active**

Distance (ft): **52.0**
Structural Grade: **0**
O&M Grade: **0**
Clock Start/From: **3**
Clock To:
1st Value: **4.000**
2nd Value:
Value Percent:
Continuous Index:
Within 8" of Joint:
Remarks:

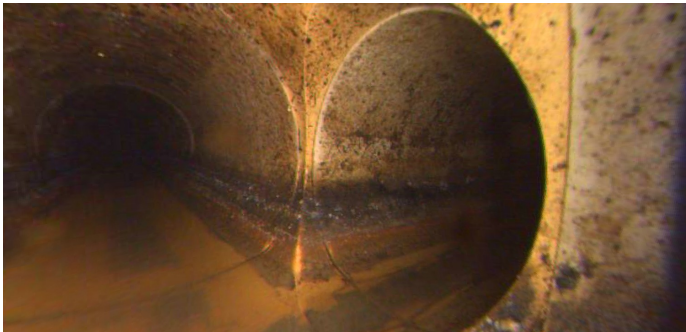
Code: **TFA**
Description: **Tap Factory Active**

Distance (ft): **111.6**
Structural Grade: **0**
O&M Grade: **0**
Clock Start/From: **3**
Clock To:
1st Value: **4.000**
2nd Value:
Value Percent:
Continuous Index:
Within 8" of Joint:
Remarks:

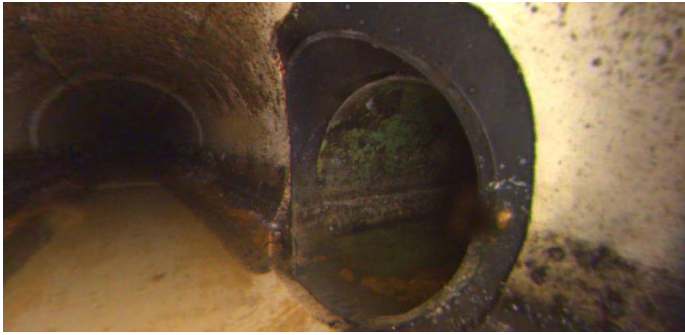
Code: **TBA**
Description: **Tap Break-in Active**

Distance (ft): **187.5**
Structural Grade: **0**
O&M Grade: **0**
Clock Start/From: **3**
Clock To:
1st Value: **4.000**
2nd Value:
Value Percent:
Continuous Index:
Within 8" of Joint:
Remarks:

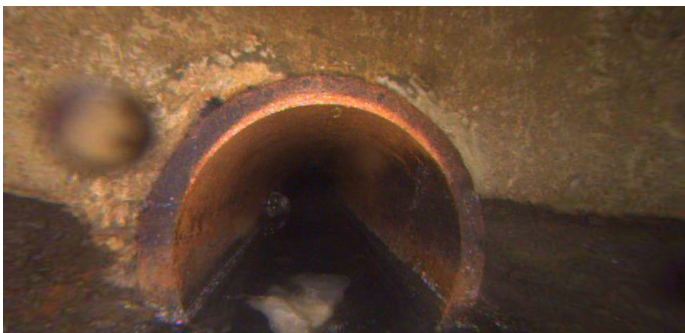
Code: **AMH**
Description: **Manhole**

Distance (ft): **215.2**
Structural Grade: **0**
O&M Grade: **0**
Clock Start/From:
Clock To:
1st Value:
2nd Value:
Value Percent:
Continuous Index:
Within 8" of Joint: **NO**
Remarks: **M-903-012**
