## Profile/Photo Observation Report

Street:	<b>E RAND ST &amp; BRANDT ST</b>	Flow Control:	<b>Not Controlled</b>
City:	<b>Hobart, IN</b>	Year Renewed:	
Location:	<b>Other</b>	Tape/Media #:	
Purpose:	<b>Not Known</b>	Dia/Height:	<b>12"</b>
Use:	<b>Sanitary</b>	Material:	<b>VCP</b>
Drain Area:	<b>NA</b>	Lining:	
Category:	<b>NA</b>		
Comment:

Location Details:		Direction of Survey:	<b>Upstream</b>
US MH:	<b>M-903-202</b>	DS MH:	<b>M-903-021</b>
		Total Length Surveyed (ft):	<b>17.4</b>

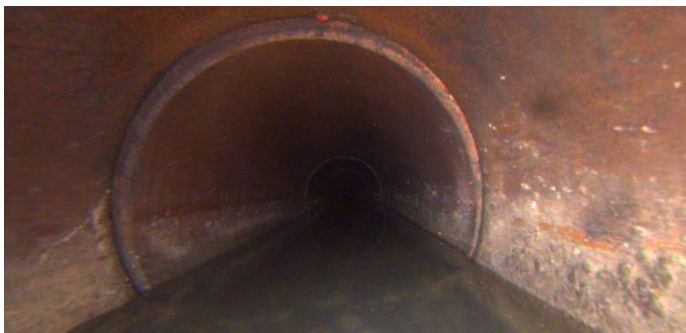
Code: **AMH**  
Description: **Manhole**

Distance (ft): **.0**  
Structural Grade: **0**  
O&M Grade: **0**  
Clock Start/From:  
Clock To:  
1st Value:  
2nd Value:  
Value Percent:  
Continuous Index:  
Within 8" of Joint: **NO**  
Remarks: **M-903-021**

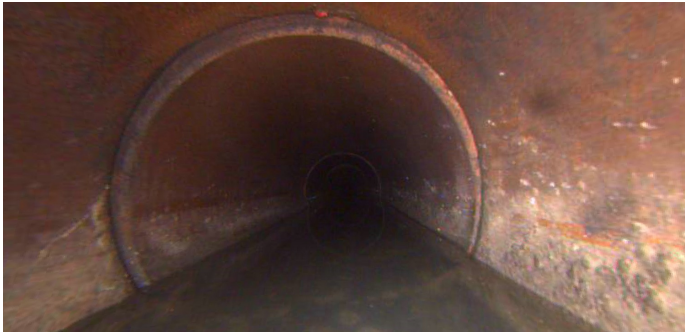
Code:	<b>MWL</b>
Description:	<b>Water Level</b>

Distance (ft):	<b>.0</b>
Structural Grade:	<b>0</b>
O&M Grade:	<b>0</b>
Clock Start/From:	
Clock To:	
1st Value:	
2nd Value:	
Value Percent:	<b>30.000</b>
Continuous Index:	
Within 8" of Joint:	<b>NO</b>
Remarks:

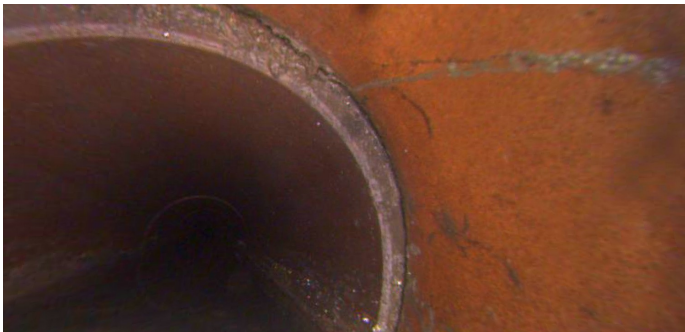
Code:	<b>FL</b>
Description:	<b>Fracture Longitudinal</b>

Distance (ft):	<b>6.6</b>
Structural Grade:	<b>3</b>
O&M Grade:	<b>0</b>
Clock Start/From:	<b>2</b>
Clock To:	
1st Value:	
2nd Value:	
Value Percent:	
Continuous Index:	
Within 8" of Joint:	<b>YES</b>
Remarks:

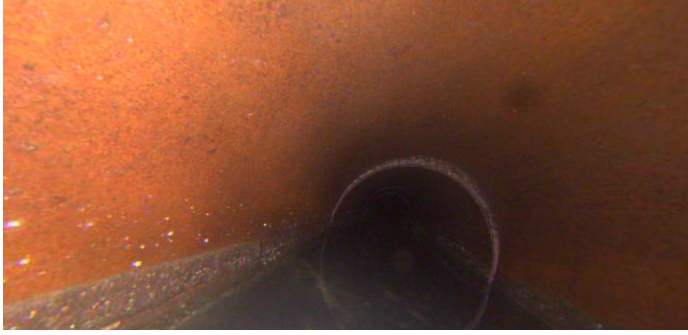
Code:	<b>MSA</b>
Description:	<b>Abandoned Survey</b>
Distance (ft):	<b>17.4</b>
Structural Grade:	<b>0</b>
O&M Grade:	<b>0</b>
Clock Start/From:	
Clock To:	
1st Value:	
2nd Value:	
Value Percent:	
Continuous Index:	
Within 8" of Joint:	<b>NO</b>
Remarks:	<b>OVERTURNED</b>
