Profile/Photo Observation Report

Date:	04/14/2018	Weather:		Coding:	PACP 6.0
Pipe Length (ft):	237.5	Owner:	NA	Pre Clean:	Not Known
P.O.#:		Surveyor:	Jen Costello	PSR:	P-904-001-002
Customer:		Clean Date:	01/01/1900	Shape:	C

Street:	N Union St.	Flow Control:	Not Controlled
City:	Hobart, IN	Year Renewed:	
Location:	Other	Tape/Media #:	
Purpose:	Not Known	Dia/Height:	8"
Use:	Sanitary	Material:	PVC
Drain Area:	NA	Lining:	
Category:	NA		
Comment:

Location Details:		Direction of Survey:	Downstream
US MH:	M-904-002	DS MH:	M-904-001
		Total Length Surveyed (ft):	233.8

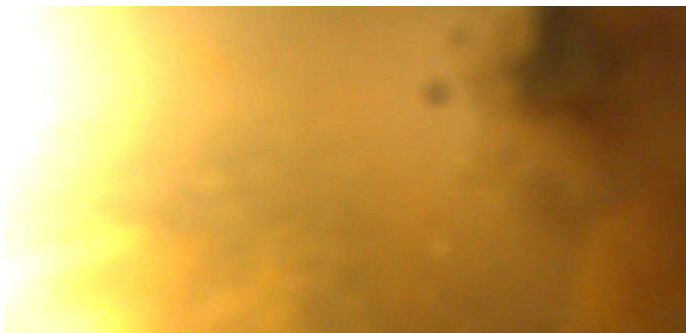
Code: **AMH**
Description: **Manhole**

Distance (ft): **.0**
Structural Grade: **0**
O&M Grade: **0**
Clock Start/From:
Clock To:
1st Value:
2nd Value:
Value Percent:
Continuous Index:
Within 8" of Joint: **NO**
Remarks: **M-904-002**

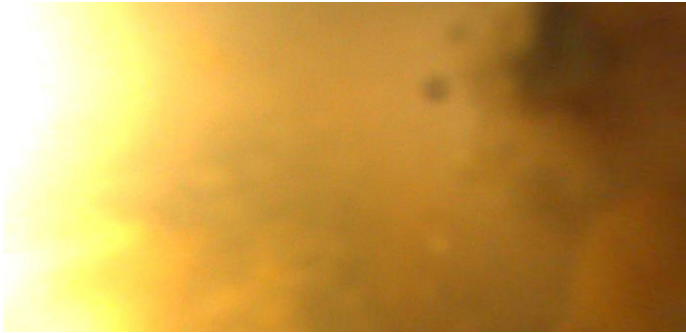
Code:	MWL
Description:	Water Level

Distance (ft):	.0
Structural Grade:	0
O&M Grade:	0
Clock Start/From:	
Clock To:	
1st Value:	
2nd Value:	
Value Percent:	100.000
Continuous Index:	
Within 8" of Joint:	NO
Remarks:

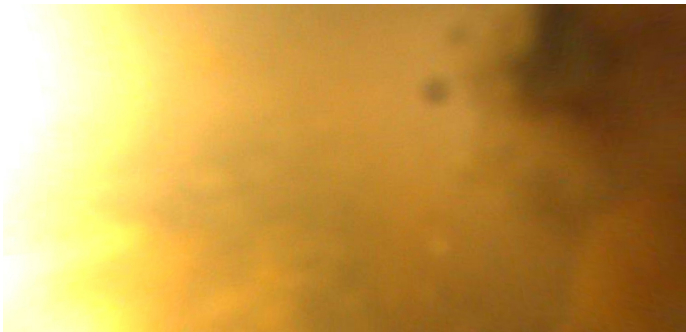
Code:	MGO
Description:	General Observation

Distance (ft):	.0
Structural Grade:	0
O&M Grade:	0
Clock Start/From:	
Clock To:	
1st Value:	
2nd Value:	
Value Percent:	
Continuous Index:	
Within 8" of Joint:	NO
Remarks:	rear camera

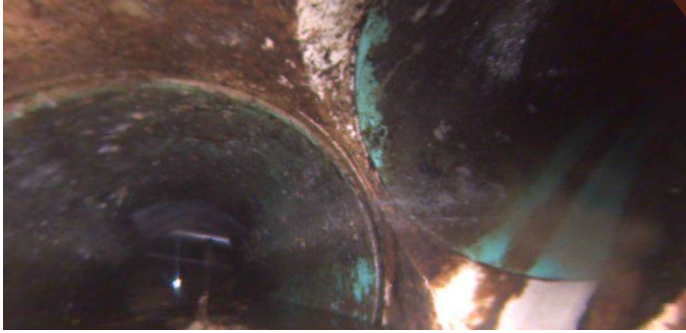
Code: **TF**
Description: **Tap Factory**

Distance (ft): **2.3**
Structural Grade: **0**
O&M Grade: **0**
Clock Start/From: **10**
Clock To:
1st Value: **4.000**
2nd Value:
Value Percent:
Continuous Index:
Within 8" of Joint:
Remarks:

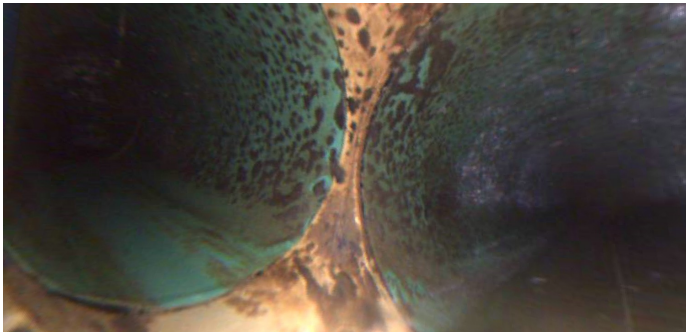
Code: **TFA**
Description: **Tap Factory Active**

Distance (ft): **72.6**
Structural Grade: **0**
O&M Grade: **0**
Clock Start/From: **3**
Clock To:
1st Value: **4.000**
2nd Value:
Value Percent:
Continuous Index:
Within 8" of Joint:
Remarks:

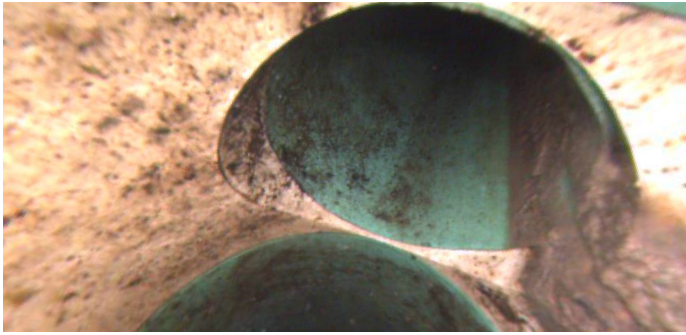
Code: **TF**
Description: **Tap Factory**

Distance (ft): **79.9**
Structural Grade: **0**
O&M Grade: **0**
Clock Start/From: **11**
Clock To:
1st Value: **4.000**
2nd Value:
Value Percent:
Continuous Index:
Within 8" of Joint:
Remarks:

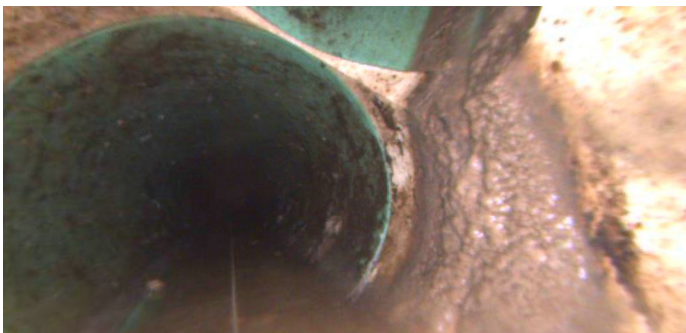
Code: **DAGS**
Description: **Deposits Attached Grease**

Distance (ft): **79.9**
Structural Grade: **0**
O&M Grade: **2**
Clock Start/From: **8**
Clock To: **10**
1st Value:
2nd Value:
Value Percent: **5.000**
Continuous Index:
Within 8" of Joint: **NO**
Remarks:

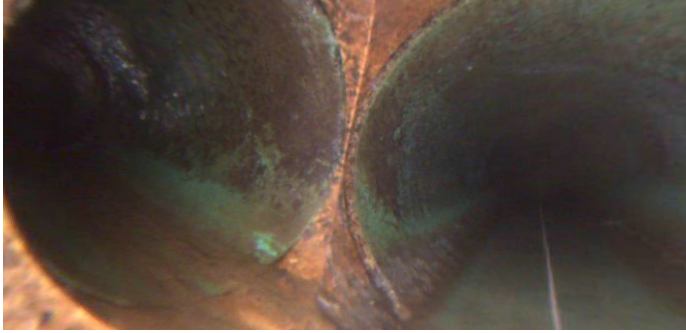
Code: **TFA**
Description: **Tap Factory Active**

Distance (ft): **144.6**
Structural Grade: **0**
O&M Grade: **0**
Clock Start/From: **3**
Clock To:
1st Value: **4.000**
2nd Value:
Value Percent:
Continuous Index:
Within 8" of Joint:
Remarks:

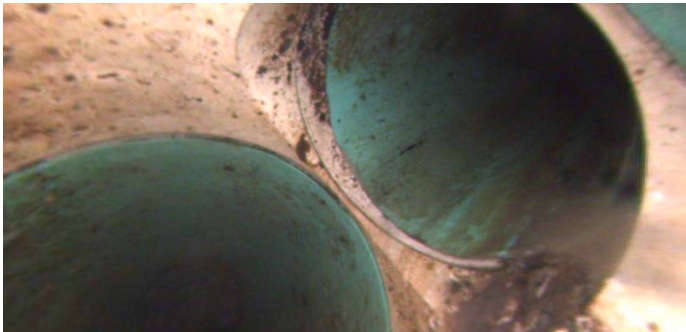
Code: **TF**
Description: **Tap Factory**

Distance (ft): **154.9**
Structural Grade: **0**
O&M Grade: **0**
Clock Start/From: **10**
Clock To:
1st Value: **4.000**
2nd Value:
Value Percent:
Continuous Index:
Within 8" of Joint:
Remarks:

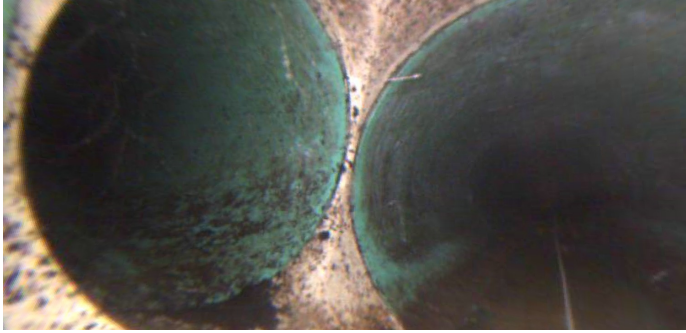
Code: **TF**
Description: **Tap Factory**

Distance (ft): **199.9**
Structural Grade: **0**
O&M Grade: **0**
Clock Start/From: **3**
Clock To:
1st Value: **4.000**
2nd Value:
Value Percent:
Continuous Index:
Within 8" of Joint:
Remarks:

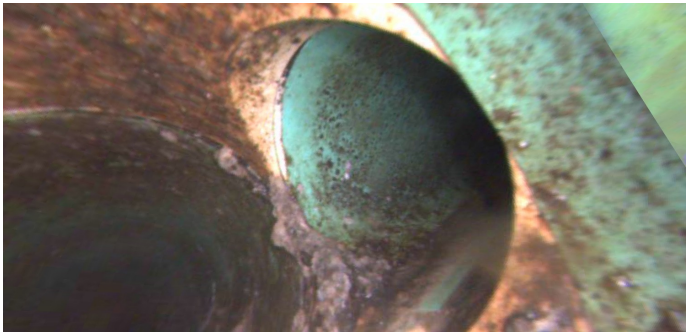
Code: **TFA**
Description: **Tap Factory Active**

Distance (ft): **230.4**
Structural Grade: **0**
O&M Grade: **0**
Clock Start/From: **10**
Clock To:
1st Value: **4.000**
2nd Value:
Value Percent:
Continuous Index:
Within 8" of Joint:
Remarks:

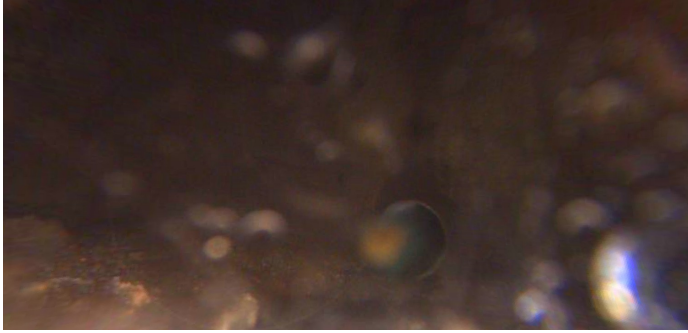
Code:	AMH
Description:	Manhole
Distance (ft):	233.8
Structural Grade:	0
O&M Grade:	0
Clock Start/From:	
Clock To:	
1st Value:	
2nd Value:	
Value Percent:	
Continuous Index:	
Within 8" of Joint:	NO
Remarks:	M-904-001
