Profile/Photo Observation Report

Street:	N Union St.	Flow Control:	Not Controlled
City:	Hobart, IN	Year Renewed:	
Location:	Other	Tape/Media #:	
Purpose:	Not Known	Dia/Height:	8"
Use:	Sanitary	Material:	PVC
Drain Area:	NA	Lining:	
Category:	NA		
Comment:

Location Details:		Direction of Survey:	Upstream
US MH:	M-904-003	DS MH:	M-904-002
		Total Length Surveyed (ft):	294.3

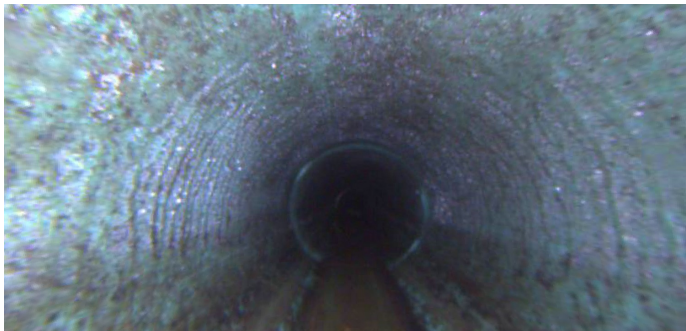
Code: **AMH**
Description: **Manhole**

Distance (ft): **.0**
Structural Grade: **0**
O&M Grade: **0**
Clock Start/From:
Clock To:
1st Value:
2nd Value:
Value Percent:
Continuous Index:
Within 8" of Joint: **NO**
Remarks: **M-904-002**

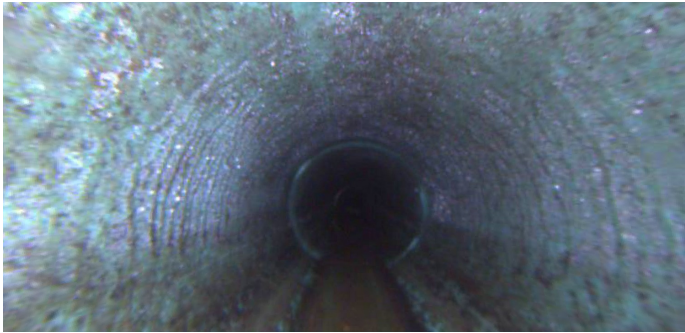
Code:	MWL
Description:	Water Level

Distance (ft):	.0
Structural Grade:	0
O&M Grade:	0
Clock Start/From:	
Clock To:	
1st Value:	
2nd Value:	
Value Percent:	5.000
Continuous Index:	
Within 8" of Joint:	NO
Remarks:

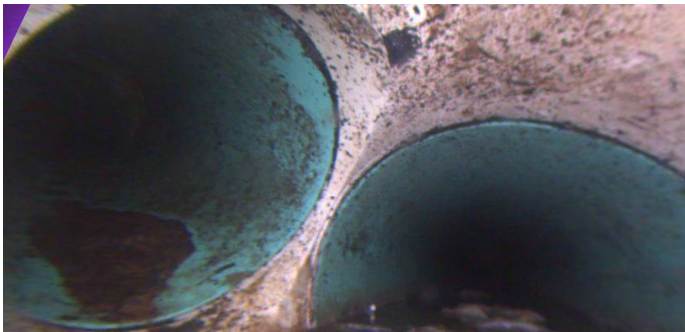
Code:	TF
Description:	Tap Factory

Distance (ft):	5.2
Structural Grade:	0
O&M Grade:	0
Clock Start/From:	10
Clock To:	
1st Value:	4.000
2nd Value:	
Value Percent:	
Continuous Index:	
Within 8" of Joint:	
Remarks:

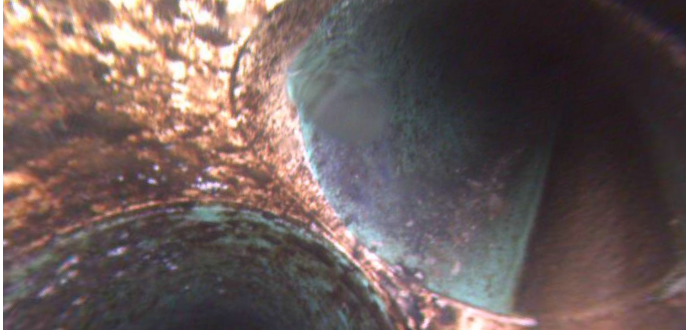
Code: **TFA**
Description: **Tap Factory Active**

Distance (ft): **67.0**
Structural Grade: **0**
O&M Grade: **0**
Clock Start/From: **1**
Clock To:
1st Value: **4.000**
2nd Value:
Value Percent:
Continuous Index:
Within 8" of Joint:
Remarks:

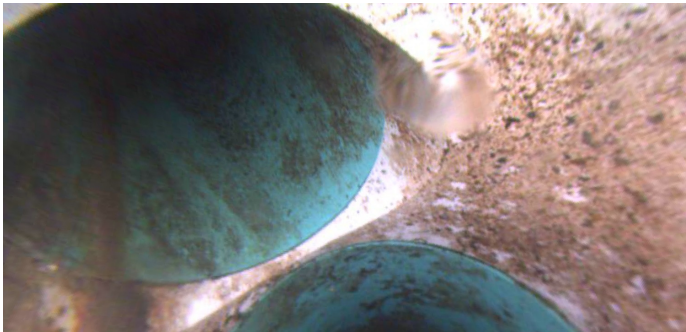
Code: **TF**
Description: **Tap Factory**

Distance (ft): **74.4**
Structural Grade: **0**
O&M Grade: **0**
Clock Start/From: **11**
Clock To:
1st Value: **4.000**
2nd Value:
Value Percent:
Continuous Index:
Within 8" of Joint:
Remarks:

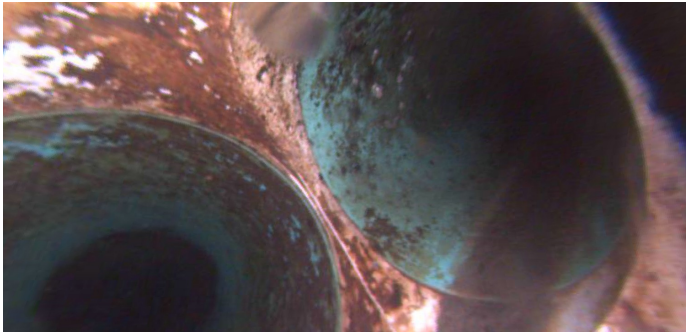
Code: **TF**
Description: **Tap Factory**

Distance (ft): **144.0**
Structural Grade: **0**
O&M Grade: **0**
Clock Start/From: **2**
Clock To:
1st Value: **4.000**
2nd Value:
Value Percent:
Continuous Index:
Within 8" of Joint:
Remarks:

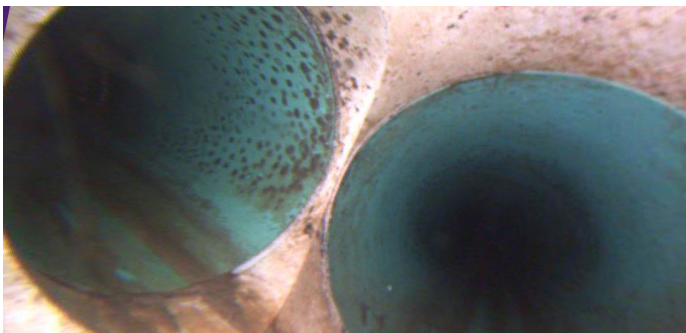
Code: **TF**
Description: **Tap Factory**

Distance (ft): **151.5**
Structural Grade: **0**
O&M Grade: **0**
Clock Start/From: **10**
Clock To:
1st Value: **4.000**
2nd Value:
Value Percent:
Continuous Index:
Within 8" of Joint:
Remarks:

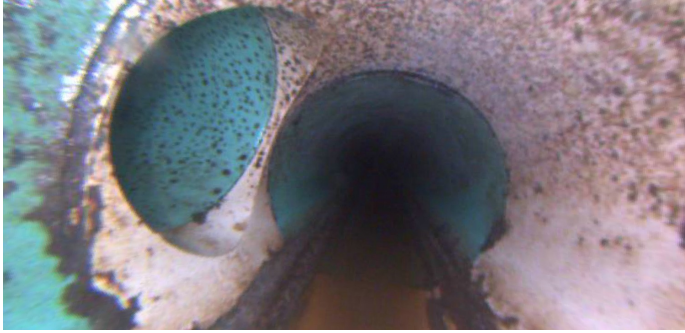
Code: **TF**
Description: **Tap Factory**

Distance (ft): **215.2**
Structural Grade: **0**
O&M Grade: **0**
Clock Start/From: **9**
Clock To:
1st Value: **4.000**
2nd Value:
Value Percent:
Continuous Index:
Within 8" of Joint:
Remarks:

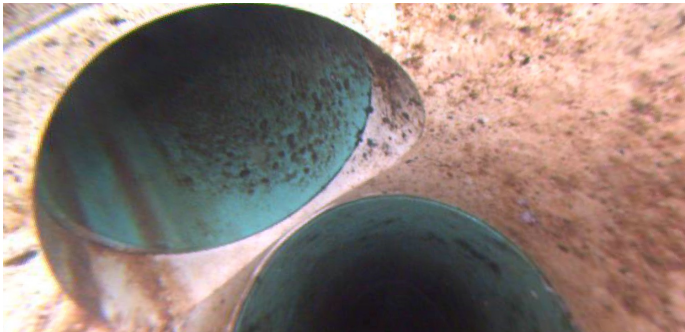
Code: **TF**
Description: **Tap Factory**

Distance (ft): **288.8**
Structural Grade: **0**
O&M Grade: **0**
Clock Start/From: **11**
Clock To:
1st Value: **4.000**
2nd Value:
Value Percent:
Continuous Index:
Within 8" of Joint:
Remarks:

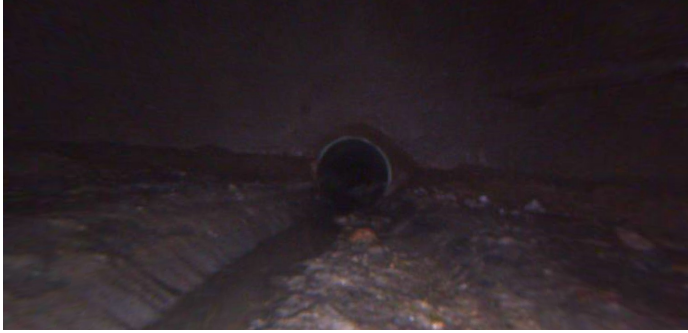
Code:	AMH
Description:	Manhole
Distance (ft):	294.3
Structural Grade:	0
O&M Grade:	0
Clock Start/From:	
Clock To:	
1st Value:	
2nd Value:	
Value Percent:	
Continuous Index:	
Within 8" of Joint:	NO
Remarks:	M-904-003
