Profile/Photo Observation Report

Street:	N UNION ST	Flow Control:	Not Controlled
City:	Hobart, IN	Year Renewed:	
Location:	Other	Tape/Media #:	
Purpose:	Not Known	Dia/Height:	8"
Use:	Sanitary	Material:	PVC
Drain Area:	NA	Lining:	
Category:	NA		
Comment:

Location Details:		Direction of Survey:	Downstream
US MH:	M-904-004	DS MH:	M-904-003
		Total Length Surveyed (ft):	295.6

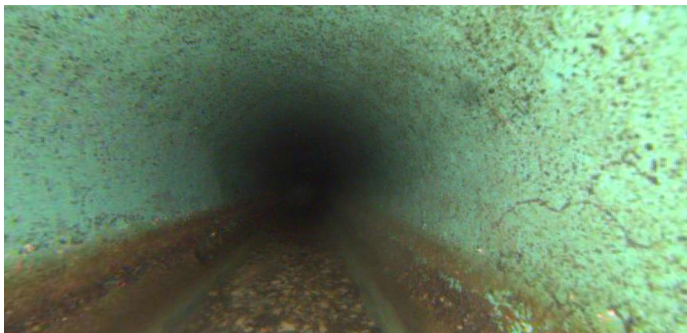
Code:	MWL
Description:	Water Level

Distance (ft):	.0
Structural Grade:	0
O&M Grade:	0
Clock Start/From:	
Clock To:	
1st Value:	
2nd Value:	
Value Percent:	10.000
Continuous Index:	
Within 8" of Joint:	NO
Remarks:

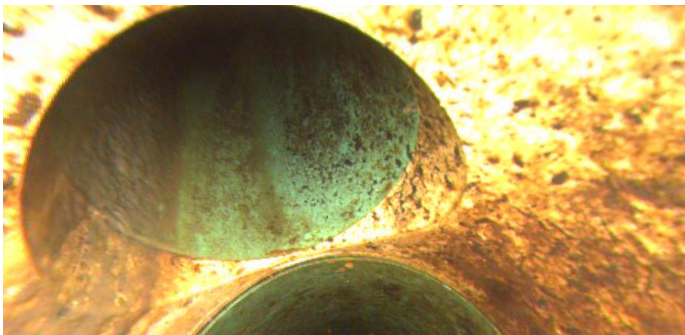
Code:	TF
Description:	Tap Factory

Distance (ft):	11.6
Structural Grade:	0
O&M Grade:	0
Clock Start/From:	11
Clock To:	
1st Value:	4.000
2nd Value:	
Value Percent:	
Continuous Index:	
Within 8" of Joint:	
Remarks:

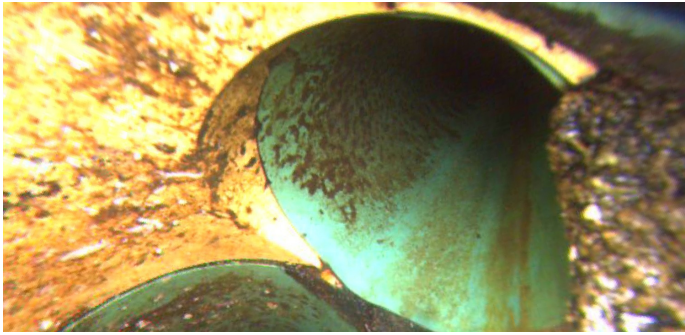
Code: **TFD**
Description: **Tap Factory Defective**

Distance (ft): **74.0**
Structural Grade: **0**
O&M Grade: **2**
Clock Start/From: **1**
Clock To:
1st Value: **4.000**
2nd Value:
Value Percent:
Continuous Index:
Within 8" of Joint:
Remarks: **dae**

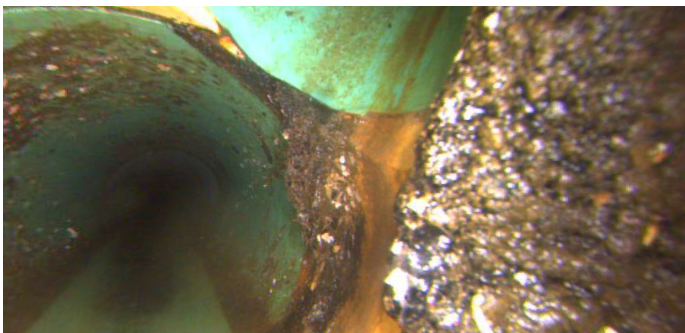
Code: **DAE**
Description: **Deposits Attached Encrustation**

Distance (ft): **74.0**
Structural Grade: **0**
O&M Grade: **2**
Clock Start/From: **1**
Clock To: **4**
1st Value:
2nd Value:
Value Percent: **10.000**
Continuous Index:
Within 8" of Joint: **NO**
Remarks:

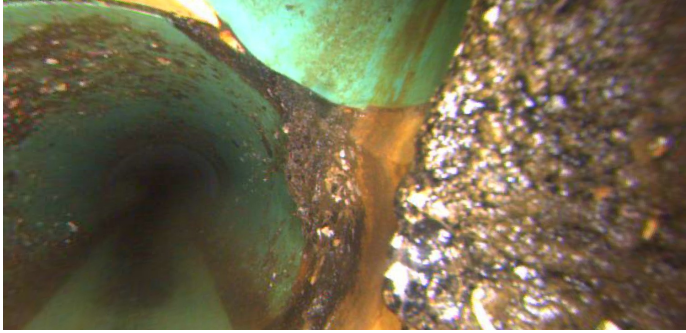
Code: **RMC**
Description: **Roots Medium Connection**

Distance (ft): **74.0**
Structural Grade: **0**
O&M Grade: **3**
Clock Start/From: **12**
Clock To: **2**
1st Value:
2nd Value:
Value Percent: **5.000**
Continuous Index:
Within 8" of Joint: **NO**
Remarks:

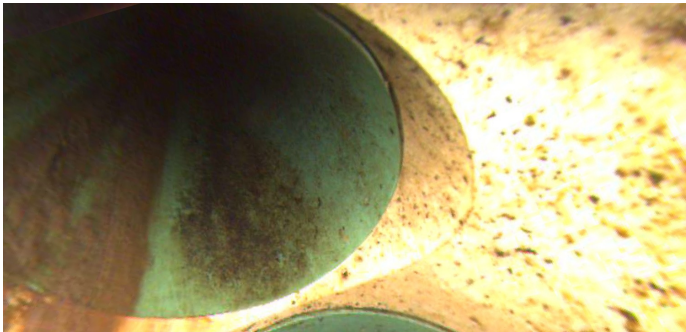
Code: **TF**
Description: **Tap Factory**

Distance (ft): **98.6**
Structural Grade: **0**
O&M Grade: **0**
Clock Start/From: **11**
Clock To:
1st Value: **4.000**
2nd Value:
Value Percent:
Continuous Index:
Within 8" of Joint:
Remarks:

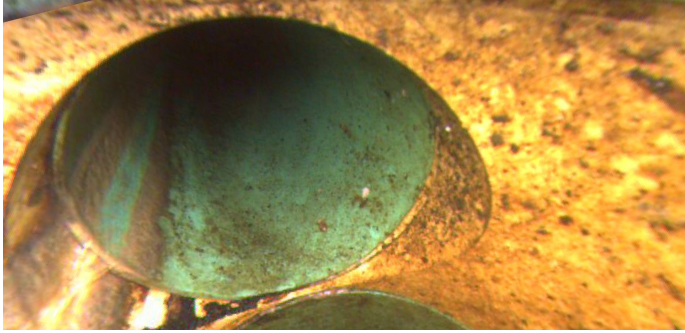
Code: **TF**
Description: **Tap Factory**

Distance (ft): **105.8**
Structural Grade: **0**
O&M Grade: **0**
Clock Start/From: **11**
Clock To:
1st Value: **4.000**
2nd Value:
Value Percent:
Continuous Index:
Within 8" of Joint:
Remarks:

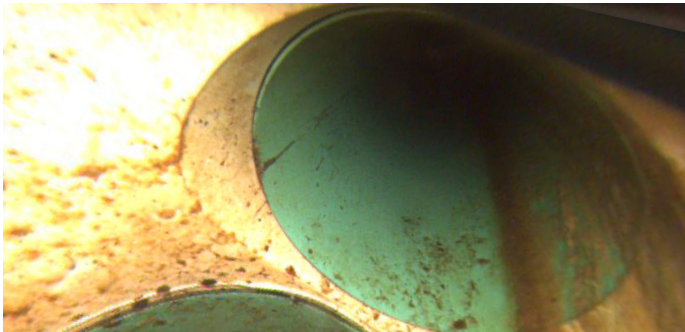
Code: **TF**
Description: **Tap Factory**

Distance (ft): **148.9**
Structural Grade: **0**
O&M Grade: **0**
Clock Start/From: **1**
Clock To:
1st Value: **4.000**
2nd Value:
Value Percent:
Continuous Index:
Within 8" of Joint:
Remarks:

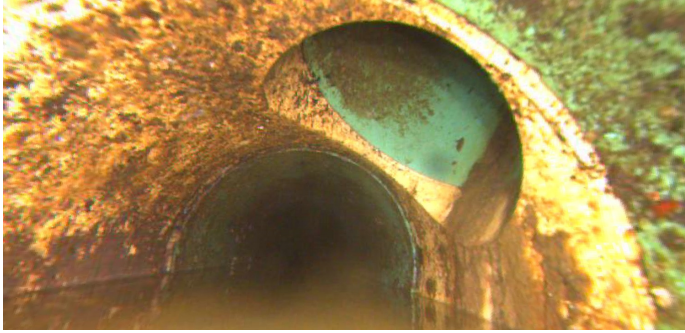
Code: **TF**
Description: **Tap Factory**

Distance (ft): **223.4**
Structural Grade: **0**
O&M Grade: **0**
Clock Start/From: **1**
Clock To:
1st Value: **4.000**
2nd Value:
Value Percent:
Continuous Index:
Within 8" of Joint:
Remarks:

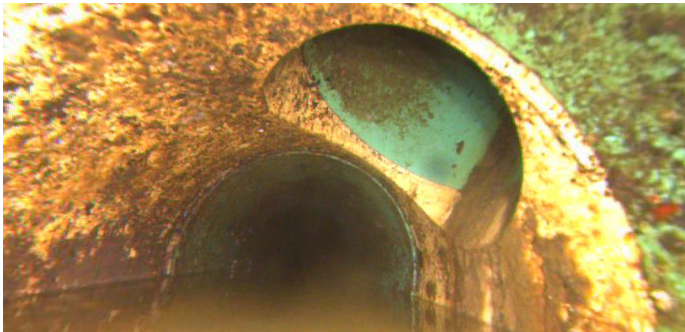
Code: **MWL**
Description: **Water Level**

Distance (ft): **223.4**
Structural Grade: **0**
O&M Grade: **0**
Clock Start/From:
Clock To:
1st Value:
2nd Value:
Value Percent: **40.000**
Continuous Index:
Within 8" of Joint: **NO**
Remarks:

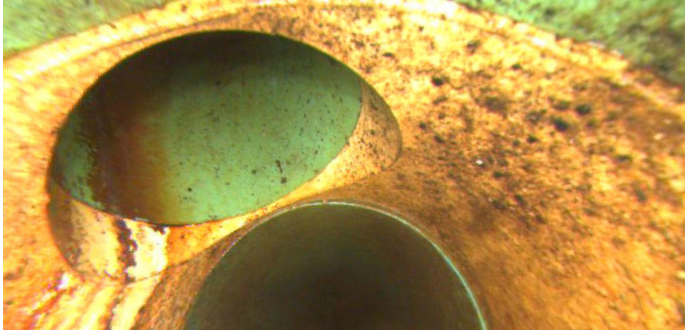
Code: **TF**
Description: **Tap Factory**

Distance (ft): **246.4**
Structural Grade: **0**
O&M Grade: **0**
Clock Start/From: **11**
Clock To:
1st Value: **4.000**
2nd Value:
Value Percent:
Continuous Index:
Within 8" of Joint:
Remarks:

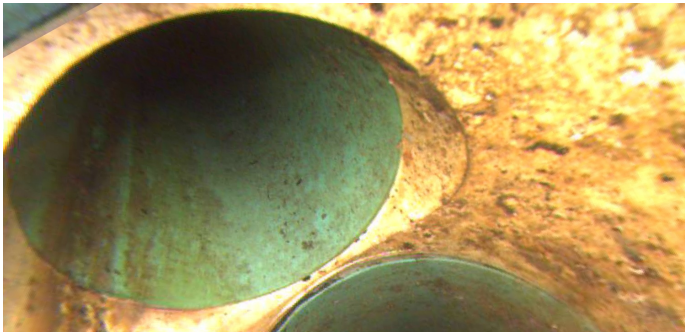
Code: **TF**
Description: **Tap Factory**

Distance (ft): **255.6**
Structural Grade: **0**
O&M Grade: **0**
Clock Start/From: **11**
Clock To:
1st Value: **4.000**
2nd Value:
Value Percent:
Continuous Index:
Within 8" of Joint:
Remarks:

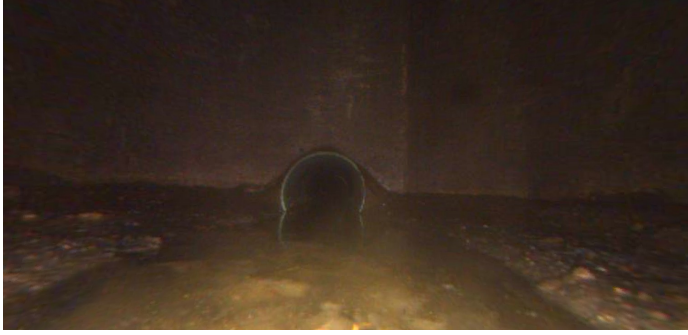
Code:	AMH
Description:	Manhole
Distance (ft):	295.6
Structural Grade:	0
O&M Grade:	0
Clock Start/From:	
Clock To:	
1st Value:	
2nd Value:	
Value Percent:	
Continuous Index:	
Within 8" of Joint:	NO
Remarks:	M-904-003
