Profile/Photo Observation Report

Date:	04/14/2018	Weather:		Coding:	PACP 6.0
Pipe Length (ft):	294.8	Owner:	NA	Pre Clean:	Not Known
P.O.#:		Surveyor:	Jen Costello	PSR:	P-904-003-004
Customer:		Clean Date:	01/01/1900	Shape:	C

Street:	N Union St.	Flow Control:	Not Controlled
City:	Hobart, IN	Year Renewed:	
Location:	Other	Tape/Media #:	
Purpose:	Not Known	Dia/Height:	8"
Use:	Sanitary	Material:	PVC
Drain Area:	NA	Lining:	
Category:	NA		
Comment:

Location Details:		Direction of Survey:	Downstream
US MH:	M-904-004	DS MH:	M-904-003
		Total Length Surveyed (ft):	295.6

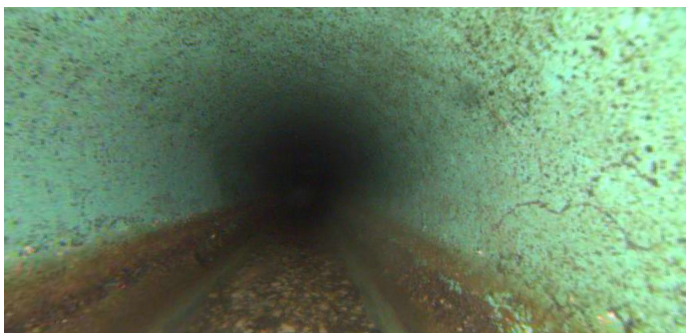
Code: **AMH**
Description: **Manhole**

Distance (ft): **.0**
Structural Grade: **0**
O&M Grade: **0**
Clock Start/From:
Clock To:
1st Value:
2nd Value:
Value Percent:
Continuous Index:
Within 8" of Joint: **NO**
Remarks: **M-904-004**

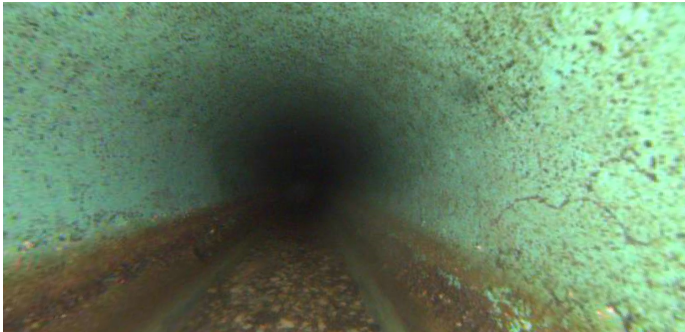
Code:	MWL
Description:	Water Level

Distance (ft):	.0
Structural Grade:	0
O&M Grade:	0
Clock Start/From:	
Clock To:	
1st Value:	
2nd Value:	
Value Percent:	10.000
Continuous Index:	
Within 8" of Joint:	NO
Remarks:

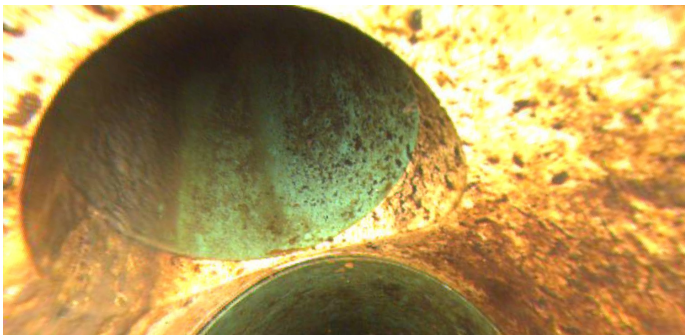
Code:	TF
Description:	Tap Factory

Distance (ft):	11.6
Structural Grade:	0
O&M Grade:	0
Clock Start/From:	11
Clock To:	
1st Value:	4.000
2nd Value:	
Value Percent:	
Continuous Index:	
Within 8" of Joint:	
Remarks:

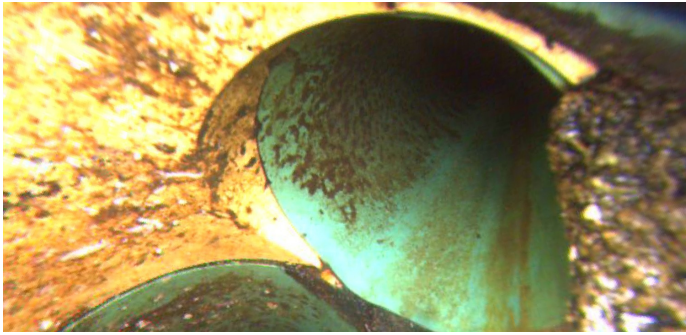
Code: **TFD**
Description: **Tap Factory Defective**

Distance (ft): **74.0**
Structural Grade: **0**
O&M Grade: **2**
Clock Start/From: **1**
Clock To:
1st Value: **4.000**
2nd Value:
Value Percent:
Continuous Index:
Within 8" of Joint:
Remarks: **dae**

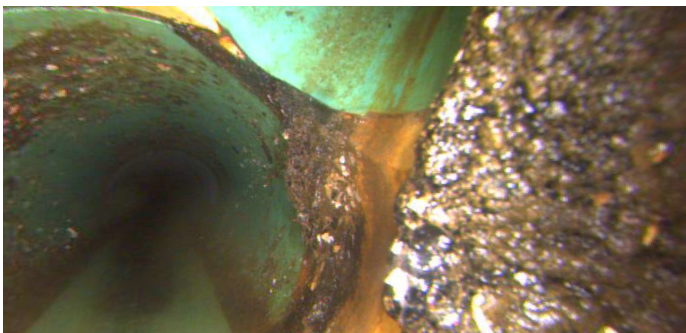
Code: **DAE**
Description: **Deposits Attached Encrustation**

Distance (ft): **74.0**
Structural Grade: **0**
O&M Grade: **2**
Clock Start/From: **1**
Clock To: **4**
1st Value:
2nd Value:
Value Percent: **10.000**
Continuous Index:
Within 8" of Joint: **NO**
Remarks:

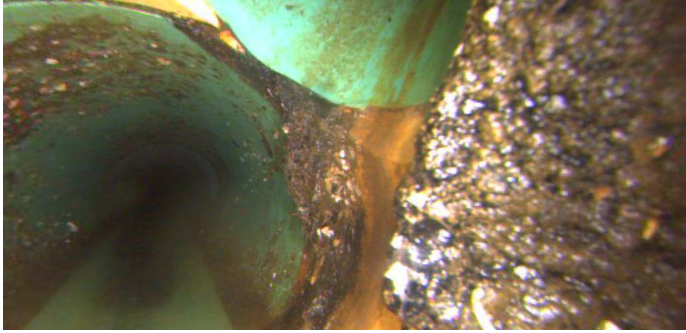
Code: **RMC**
Description: **Roots Medium Connection**

Distance (ft): **74.0**
Structural Grade: **0**
O&M Grade: **3**
Clock Start/From: **12**
Clock To: **2**
1st Value:
2nd Value:
Value Percent: **5.000**
Continuous Index:
Within 8" of Joint: **NO**
Remarks:

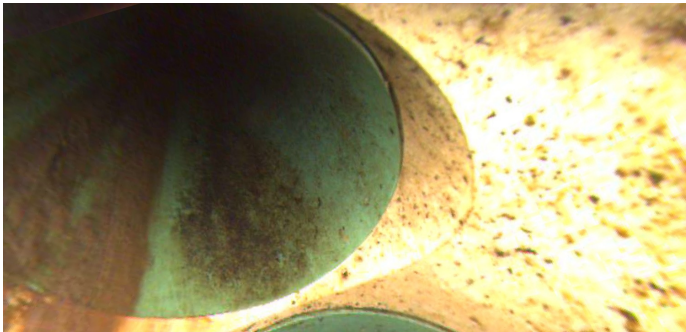
Code: **TF**
Description: **Tap Factory**

Distance (ft): **98.6**
Structural Grade: **0**
O&M Grade: **0**
Clock Start/From: **11**
Clock To:
1st Value: **4.000**
2nd Value:
Value Percent:
Continuous Index:
Within 8" of Joint:
Remarks:

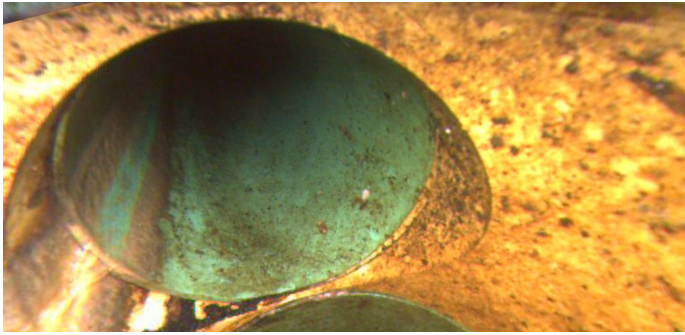
Code: **TF**
Description: **Tap Factory**

Distance (ft): **105.8**
Structural Grade: **0**
O&M Grade: **0**
Clock Start/From: **11**
Clock To:
1st Value: **4.000**
2nd Value:
Value Percent:
Continuous Index:
Within 8" of Joint:
Remarks:

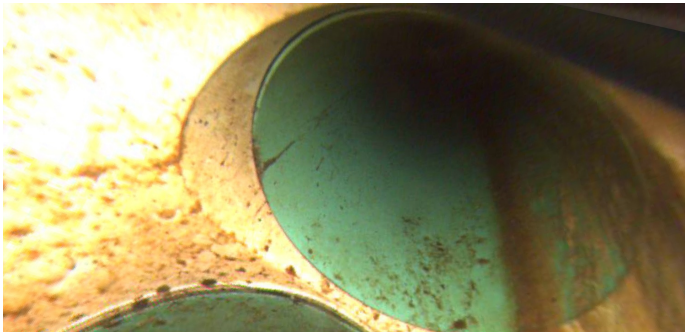
Code: **TF**
Description: **Tap Factory**

Distance (ft): **148.9**
Structural Grade: **0**
O&M Grade: **0**
Clock Start/From: **1**
Clock To:
1st Value: **4.000**
2nd Value:
Value Percent:
Continuous Index:
Within 8" of Joint:
Remarks:

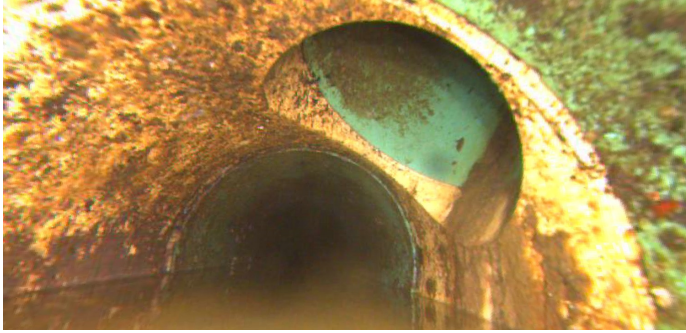
Code: **TF**
Description: **Tap Factory**

Distance (ft): **223.4**
Structural Grade: **0**
O&M Grade: **0**
Clock Start/From: **1**
Clock To:
1st Value: **4.000**
2nd Value:
Value Percent:
Continuous Index:
Within 8" of Joint:
Remarks:

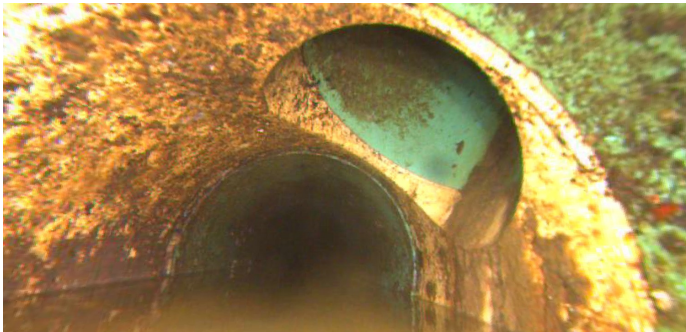
Code: **MWL**
Description: **Water Level**

Distance (ft): **223.4**
Structural Grade: **0**
O&M Grade: **0**
Clock Start/From:
Clock To:
1st Value:
2nd Value:
Value Percent: **40.000**
Continuous Index:
Within 8" of Joint: **NO**
Remarks:

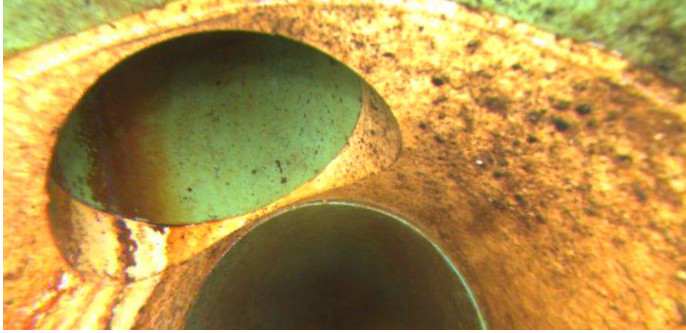
Code: **TF**
Description: **Tap Factory**

Distance (ft): **246.4**
Structural Grade: **0**
O&M Grade: **0**
Clock Start/From: **11**
Clock To:
1st Value: **4.000**
2nd Value:
Value Percent:
Continuous Index:
Within 8" of Joint:
Remarks:

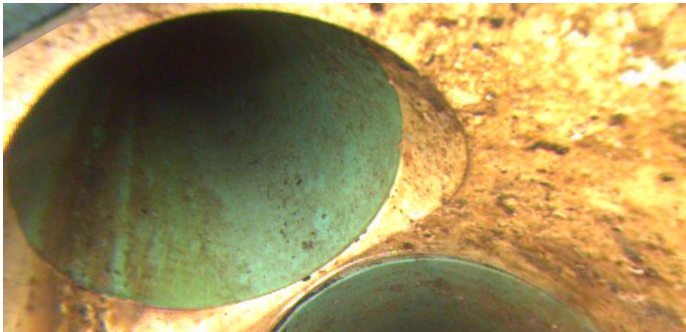
Code: **TF**
Description: **Tap Factory**

Distance (ft): **255.6**
Structural Grade: **0**
O&M Grade: **0**
Clock Start/From: **11**
Clock To:
1st Value: **4.000**
2nd Value:
Value Percent:
Continuous Index:
Within 8" of Joint:
Remarks:

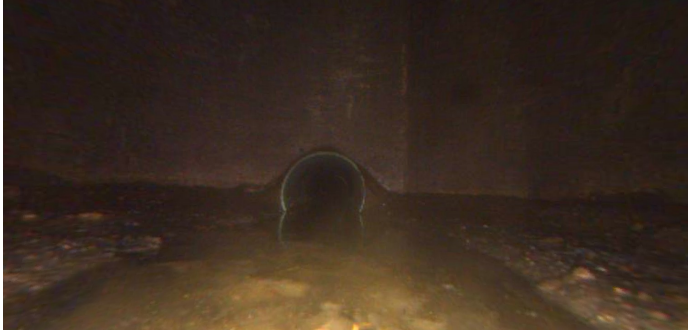
Code:	AMH
Description:	Manhole
Distance (ft):	295.6
Structural Grade:	0
O&M Grade:	0
Clock Start/From:	
Clock To:	
1st Value:	
2nd Value:	
Value Percent:	
Continuous Index:	
Within 8" of Joint:	NO
Remarks:	M-904-003
