Profile/Photo Observation Report

Date:	04/14/2018	Weather:		Coding:	PACP 6.0
Pipe Length (ft):	298.6	Owner:	NA	Pre Clean:	Not Known
P.O.#:		Surveyor:	Jen Costello	PSR:	P-904-004-005
Customer:		Clean Date:	01/01/1900	Shape:	C

Street:	N UNION ST	Flow Control:	Not Controlled
City:	Hobart, IN	Year Renewed:	
Location:	Other	Tape/Media #:	
Purpose:	Not Known	Dia/Height:	8"
Use:	Sanitary	Material:	PVC
Drain Area:	NA	Lining:	
Category:	NA		
Comment:

Location Details:		Direction of Survey:	Upstream
US MH:	M-904-005	DS MH:	M-904-004
		Total Length Surveyed (ft):	292.2

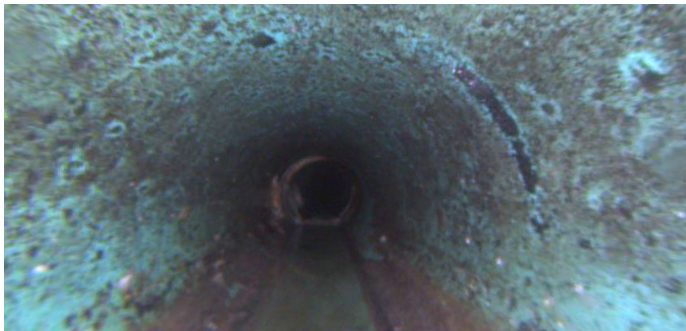
Code: **AMH**
Description: **Manhole**

Distance (ft): **.0**
Structural Grade: **0**
O&M Grade: **0**
Clock Start/From:
Clock To:
1st Value:
2nd Value:
Value Percent:
Continuous Index:
Within 8" of Joint: **NO**
Remarks: **M-904-004**

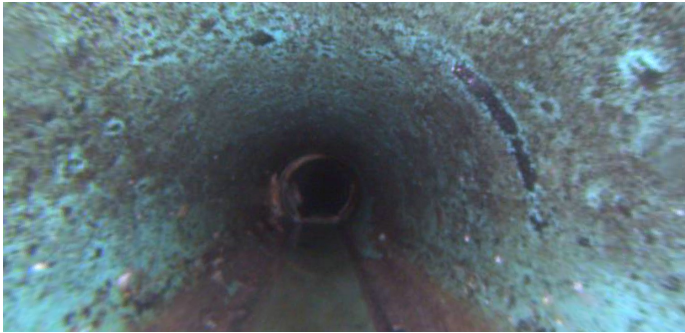
Code:	MWL
Description:	Water Level

Distance (ft):	.0
Structural Grade:	0
O&M Grade:	0
Clock Start/From:	
Clock To:	
1st Value:	
2nd Value:	
Value Percent:	5.000
Continuous Index:	
Within 8" of Joint:	NO
Remarks:

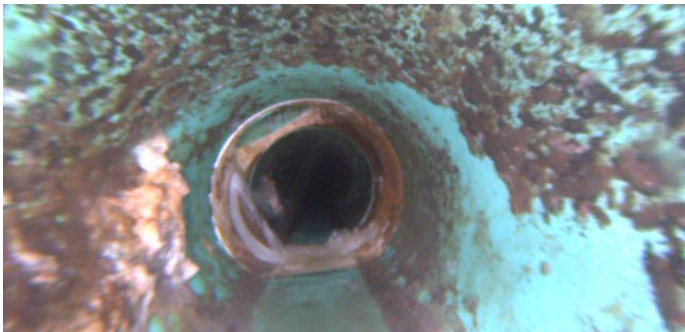
Code:	DAGS
Description:	Deposits Attached Grease

Distance (ft):	2.8
Structural Grade:	0
O&M Grade:	2
Clock Start/From:	8
Clock To:	10
1st Value:	
2nd Value:	
Value Percent:	5.000
Continuous Index:	
Within 8" of Joint:	NO
Remarks:

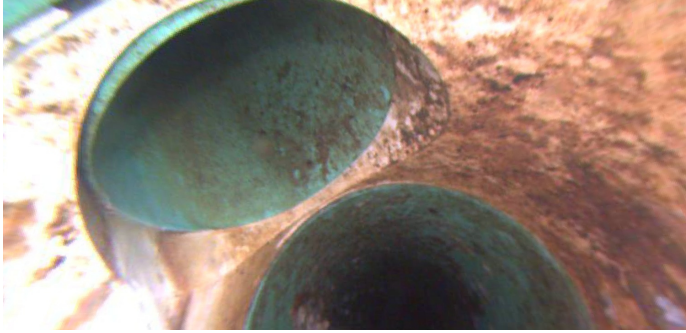
Code: **TF**
Description: **Tap Factory**

Distance (ft): **3.7**
Structural Grade: **0**
O&M Grade: **0**
Clock Start/From: **11**
Clock To:
1st Value: **4.000**
2nd Value:
Value Percent:
Continuous Index:
Within 8" of Joint:
Remarks:

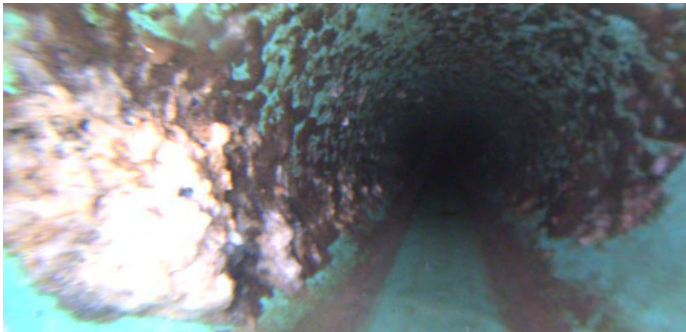
Code: **DAGS**
Description: **Deposits Attached Grease**

Distance (ft): **4.5**
Structural Grade: **0**
O&M Grade: **2**
Clock Start/From: **8**
Clock To: **10**
1st Value:
2nd Value:
Value Percent: **5.000**
Continuous Index:
Within 8" of Joint: **NO**
Remarks:

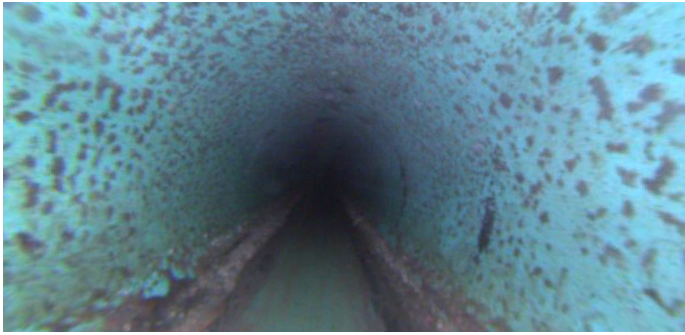
Code: **DAGS**
Description: **Deposits Attached Grease**

Distance (ft): **32.4**
Structural Grade: **0**
O&M Grade: **2**
Clock Start/From: **7**
Clock To: **5**
1st Value:
2nd Value:
Value Percent: **5.000**
Continuous Index: **S01**
Within 8" of Joint: **NO**
Remarks:

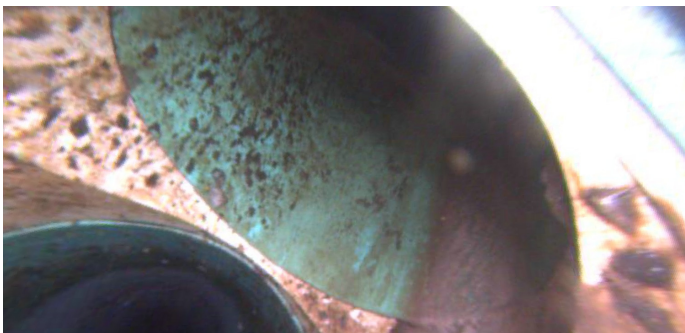
Code: **TF**
Description: **Tap Factory**

Distance (ft): **47.4**
Structural Grade: **0**
O&M Grade: **0**
Clock Start/From: **2**
Clock To:
1st Value: **4.000**
2nd Value:
Value Percent:
Continuous Index:
Within 8" of Joint:
Remarks:

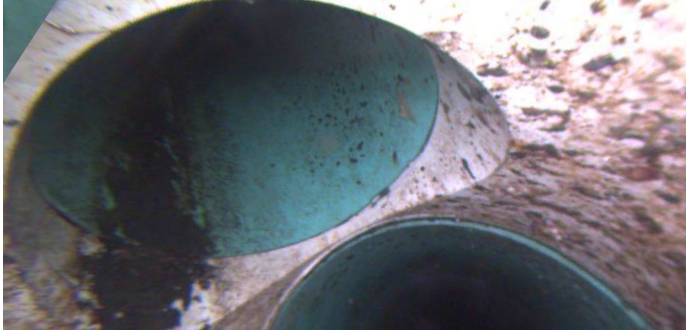
Code: **TF**
Description: **Tap Factory**

Distance (ft): **69.2**
Structural Grade: **0**
O&M Grade: **0**
Clock Start/From: **11**
Clock To:
1st Value: **4.000**
2nd Value:
Value Percent:
Continuous Index:
Within 8" of Joint:
Remarks:

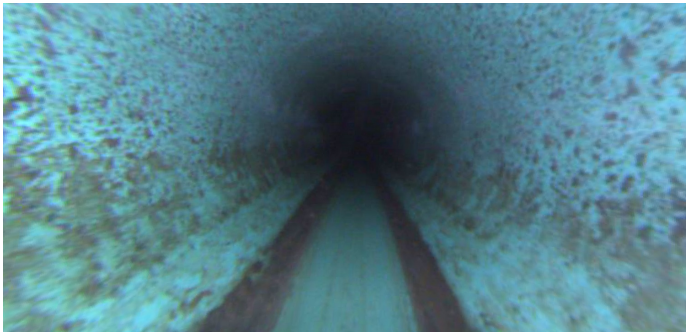
Code: **DAGS**
Description: **Deposits Attached Grease**

Distance (ft): **77.3**
Structural Grade: **0**
O&M Grade: **2**
Clock Start/From: **7**
Clock To: **5**
1st Value:
2nd Value:
Value Percent: **5.000**
Continuous Index: **F01**
Within 8" of Joint: **NO**
Remarks:

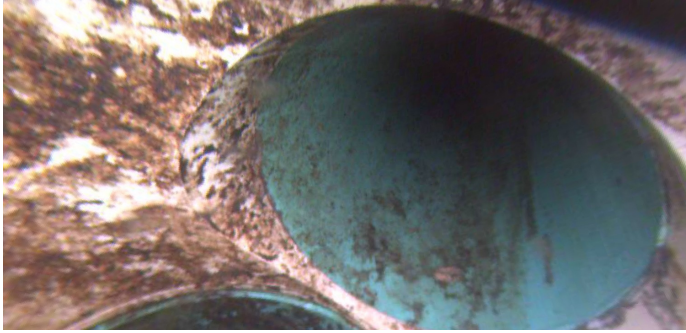
Code: **TF**
Description: **Tap Factory**

Distance (ft): **124.6**
Structural Grade: **0**
O&M Grade: **0**
Clock Start/From: **1**
Clock To:
1st Value: **4.000**
2nd Value:
Value Percent:
Continuous Index:
Within 8" of Joint:
Remarks:

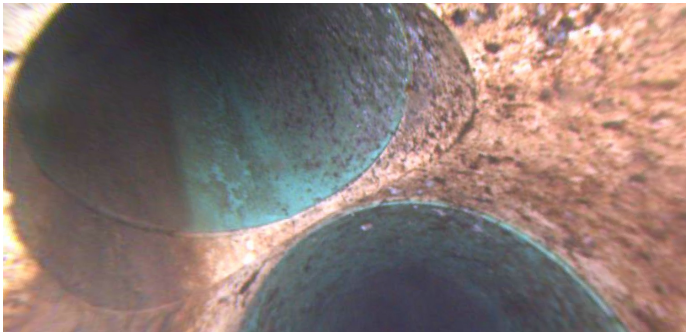
Code: **TF**
Description: **Tap Factory**

Distance (ft): **143.7**
Structural Grade: **0**
O&M Grade: **0**
Clock Start/From: **10**
Clock To:
1st Value: **4.000**
2nd Value:
Value Percent:
Continuous Index:
Within 8" of Joint:
Remarks:

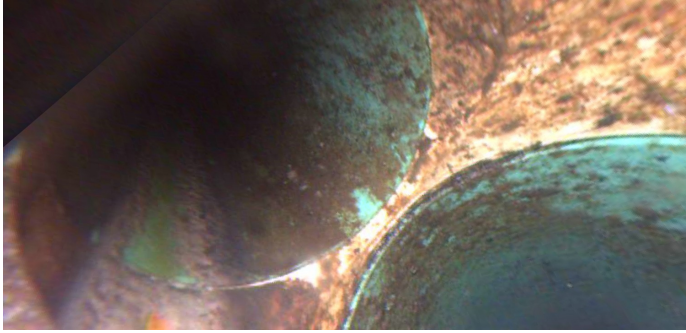
Code: **TF**
Description: **Tap Factory**

Distance (ft): **198.1**
Structural Grade: **0**
O&M Grade: **0**
Clock Start/From: **1**
Clock To:
1st Value: **4.000**
2nd Value:
Value Percent:
Continuous Index:
Within 8" of Joint:
Remarks:

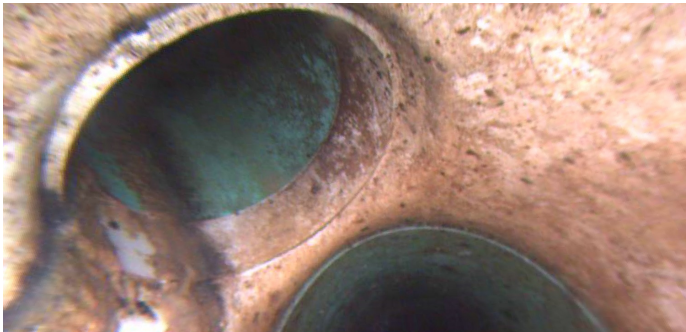
Code: **TF**
Description: **Tap Factory**

Distance (ft): **220.0**
Structural Grade: **0**
O&M Grade: **0**
Clock Start/From: **11**
Clock To:
1st Value: **4.000**
2nd Value:
Value Percent:
Continuous Index:
Within 8" of Joint:
Remarks:

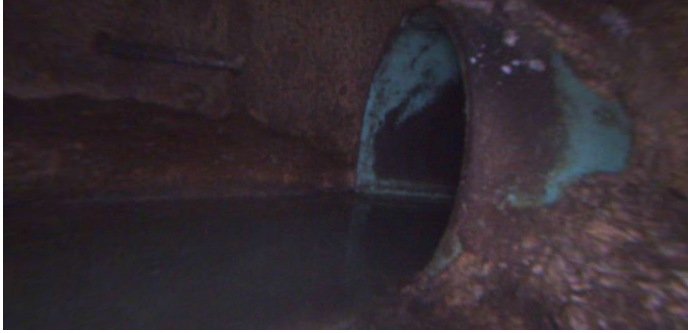
Code:	AMH
Description:	Manhole
Distance (ft):	292.2
Structural Grade:	0
O&M Grade:	0
Clock Start/From:	
Clock To:	
1st Value:	
2nd Value:	
Value Percent:	
Continuous Index:	
Within 8" of Joint:	NO
Remarks:	M-904-005
