Profile/Photo Observation Report

Street:	N Union St.	Flow Control:	Not Controlled
City:	Hobart, IN	Year Renewed:	
Location:	Other	Tape/Media #:	
Purpose:	Not Known	Dia/Height:	8"
Use:	Sanitary	Material:	PVC
Drain Area:	NA	Lining:	
Category:	NA		
Comment:

Location Details:		Direction of Survey:	Upstream
US MH:	M-904-005	DS MH:	M-904-004
		Total Length Surveyed (ft):	292.2

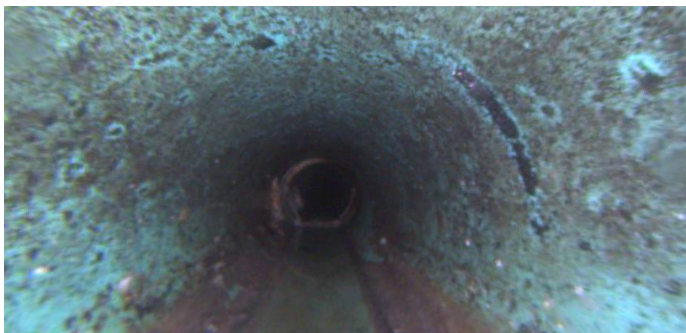
Code: **AMH**
Description: **Manhole**

Distance (ft): **.0**
Structural Grade: **0**
O&M Grade: **0**
Clock Start/From:
Clock To:
1st Value:
2nd Value:
Value Percent:
Continuous Index:
Within 8" of Joint: **NO**
Remarks: **M-904-004**

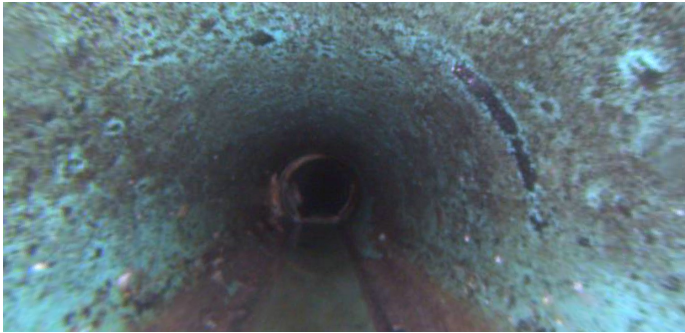
Code:	MWL
Description:	Water Level

Distance (ft):	.0
Structural Grade:	0
O&M Grade:	0
Clock Start/From:	
Clock To:	
1st Value:	
2nd Value:	
Value Percent:	5.000
Continuous Index:	
Within 8" of Joint:	NO
Remarks:

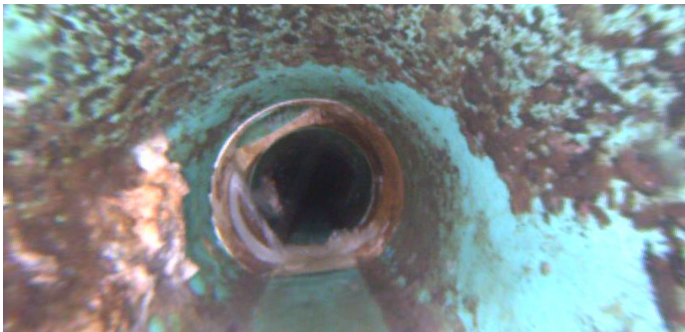
Code:	DAGS
Description:	Deposits Attached Grease

Distance (ft):	2.8
Structural Grade:	0
O&M Grade:	2
Clock Start/From:	8
Clock To:	10
1st Value:	
2nd Value:	
Value Percent:	5.000
Continuous Index:	
Within 8" of Joint:	NO
Remarks:

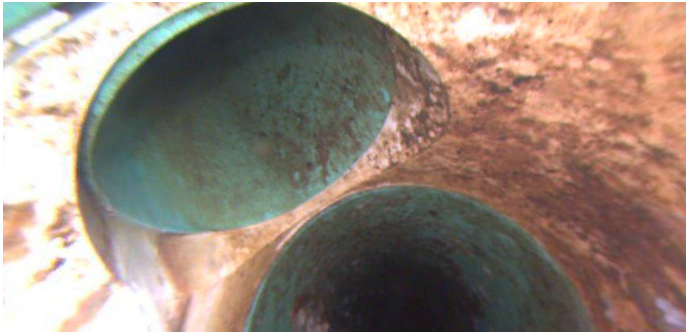
Code: **TF**
Description: **Tap Factory**

Distance (ft): **3.7**
Structural Grade: **0**
O&M Grade: **0**
Clock Start/From: **11**
Clock To:
1st Value: **4.000**
2nd Value:
Value Percent:
Continuous Index:
Within 8" of Joint:
Remarks:

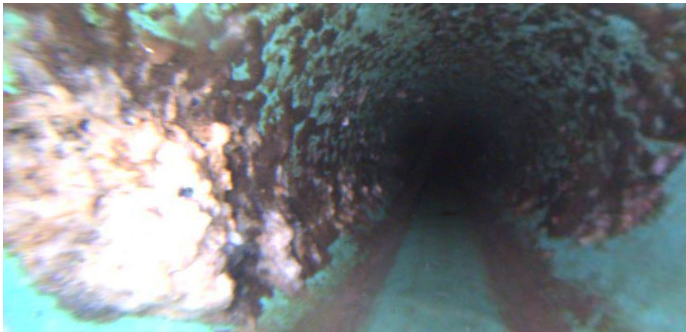
Code: **DAGS**
Description: **Deposits Attached Grease**

Distance (ft): **4.5**
Structural Grade: **0**
O&M Grade: **2**
Clock Start/From: **8**
Clock To: **10**
1st Value:
2nd Value:
Value Percent: **5.000**
Continuous Index:
Within 8" of Joint: **NO**
Remarks:

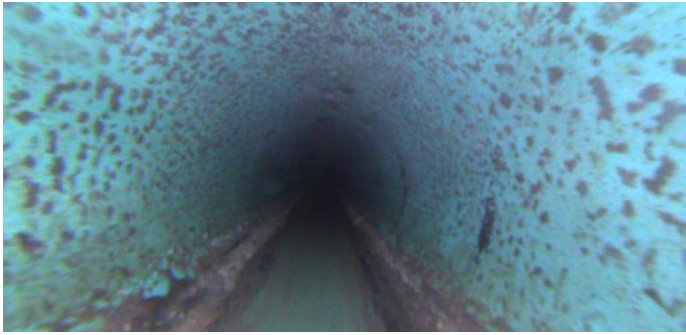
Code: **DAGS**
Description: **Deposits Attached Grease**

Distance (ft): **32.4**
Structural Grade: **0**
O&M Grade: **2**
Clock Start/From: **7**
Clock To: **5**
1st Value:
2nd Value:
Value Percent: **5.000**
Continuous Index: **S01**
Within 8" of Joint: **NO**
Remarks:

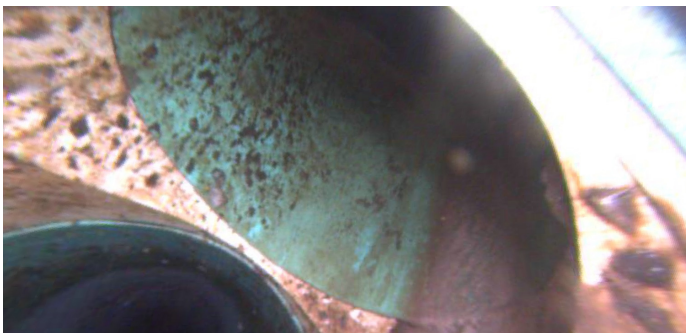
Code: **TF**
Description: **Tap Factory**

Distance (ft): **47.4**
Structural Grade: **0**
O&M Grade: **0**
Clock Start/From: **2**
Clock To:
1st Value: **4.000**
2nd Value:
Value Percent:
Continuous Index:
Within 8" of Joint:
Remarks:

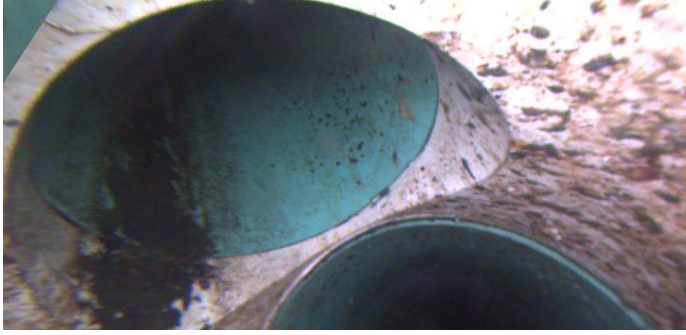
Code: **TF**
Description: **Tap Factory**

Distance (ft): **69.2**
Structural Grade: **0**
O&M Grade: **0**
Clock Start/From: **11**
Clock To:
1st Value: **4.000**
2nd Value:
Value Percent:
Continuous Index:
Within 8" of Joint:
Remarks:

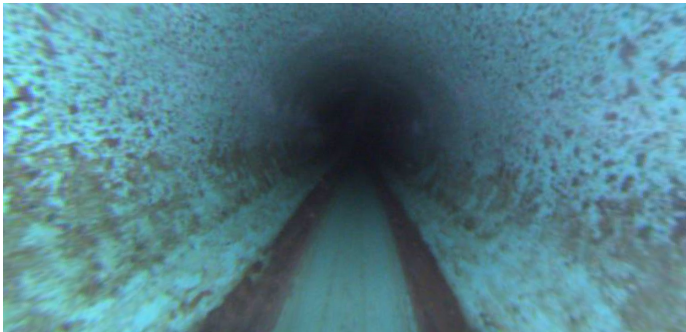
Code: **DAGS**
Description: **Deposits Attached Grease**

Distance (ft): **77.3**
Structural Grade: **0**
O&M Grade: **2**
Clock Start/From: **7**
Clock To: **5**
1st Value:
2nd Value:
Value Percent: **5.000**
Continuous Index: **F01**
Within 8" of Joint: **NO**
Remarks:

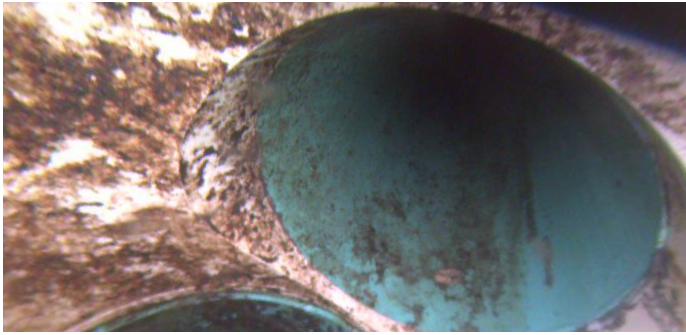
Code: **TF**
Description: **Tap Factory**

Distance (ft): **124.6**
Structural Grade: **0**
O&M Grade: **0**
Clock Start/From: **1**
Clock To:
1st Value: **4.000**
2nd Value:
Value Percent:
Continuous Index:
Within 8" of Joint:
Remarks:

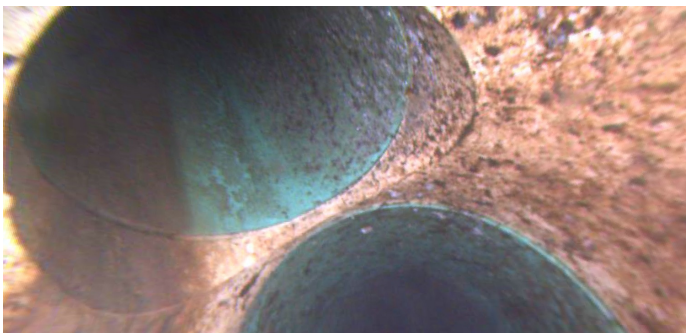
Code: **TF**
Description: **Tap Factory**

Distance (ft): **143.7**
Structural Grade: **0**
O&M Grade: **0**
Clock Start/From: **10**
Clock To:
1st Value: **4.000**
2nd Value:
Value Percent:
Continuous Index:
Within 8" of Joint:
Remarks:

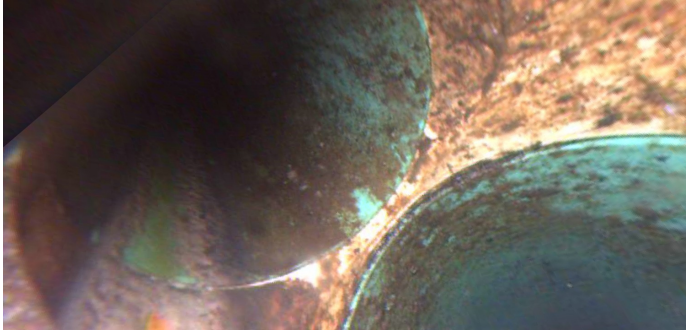
Code: **TF**
Description: **Tap Factory**

Distance (ft): **198.1**
Structural Grade: **0**
O&M Grade: **0**
Clock Start/From: **1**
Clock To:
1st Value: **4.000**
2nd Value:
Value Percent:
Continuous Index:
Within 8" of Joint:
Remarks:

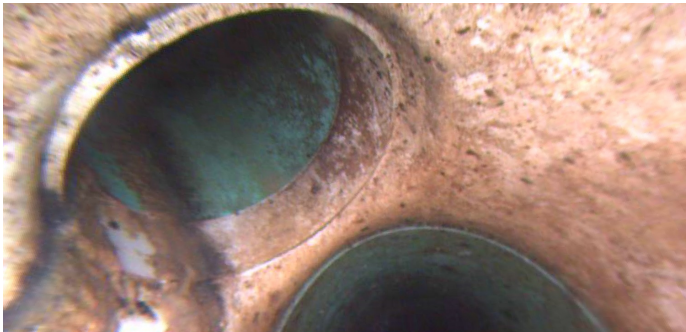
Code: **TF**
Description: **Tap Factory**

Distance (ft): **220.0**
Structural Grade: **0**
O&M Grade: **0**
Clock Start/From: **11**
Clock To:
1st Value: **4.000**
2nd Value:
Value Percent:
Continuous Index:
Within 8" of Joint:
Remarks:

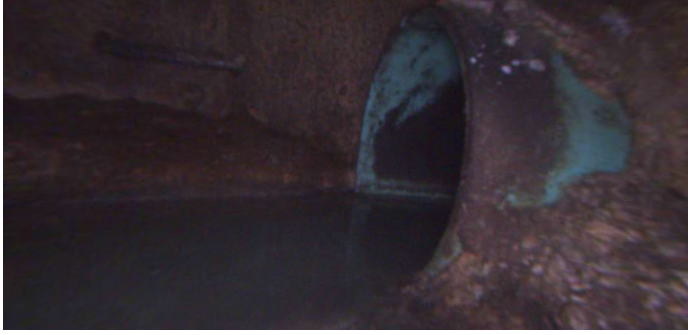
Code:	AMH
Description:	Manhole
Distance (ft):	292.2
Structural Grade:	0
O&M Grade:	0
Clock Start/From:	
Clock To:	
1st Value:	
2nd Value:	
Value Percent:	
Continuous Index:	
Within 8" of Joint:	NO
Remarks:	M-904-005
