## Profile/Photo Observation Report

Date:	<b>04/20/2018</b>	Weather:		Coding:	<b>PACP 4.2</b>
Pipe Length (ft):	<b>388.9</b>	Owner:	<b>City of Hobart</b>	Pre Clean:	<b>No Pre-Cleaning</b>
P.O.#:	<b>2004</b>	Surveyor:	<b>SAN</b>	PSR:	<b>P-904-005-006</b>
Customer:	<b>Red Zone</b>	Clean Date:		Shape:	<b>C</b>

Street:	<b>E Hickey St</b>	Flow Control:	<b>Not Controlled</b>
City:	<b>Hobart In</b>	Year Renewed:	
Location:	<b>Light Highway</b>	Tape/Media #:	<b>Deliverable 1</b>
Purpose:	<b>Routine Assessment</b>	Dia/Height:	<b>18"</b>
Use:	<b>Sanitary</b>	Material:	<b>PVC</b>
Drain Area:	<b>Northeast</b>	Lining:	
Category:	<b>NA</b>		
Comment:	<b>423-1/DSMH 006 is covered.</b>		
Location Details:	<b>Center of street</b>	Direction of Survey:	<b>Downstream</b>
US MH:	<b>M-904-005</b>	DS MH:	<b>M-904-006</b>
		Total Length Surveyed (ft):	<b>388.9</b>

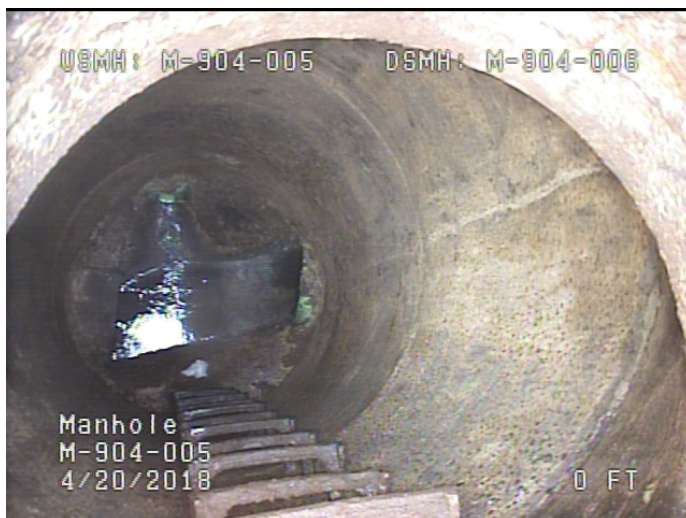
Code: **AMH**  
Description: **Manhole**

Distance (ft): **.0**  
Structural Grade: **0**  
O&M Grade: **0**  
Clock Start/From:  
Clock To:  
1st Value:  
2nd Value:  
Value Percent:  
Continuous Index:  
Within 8" of Joint: **NO**  
Remarks: **M-904-005**

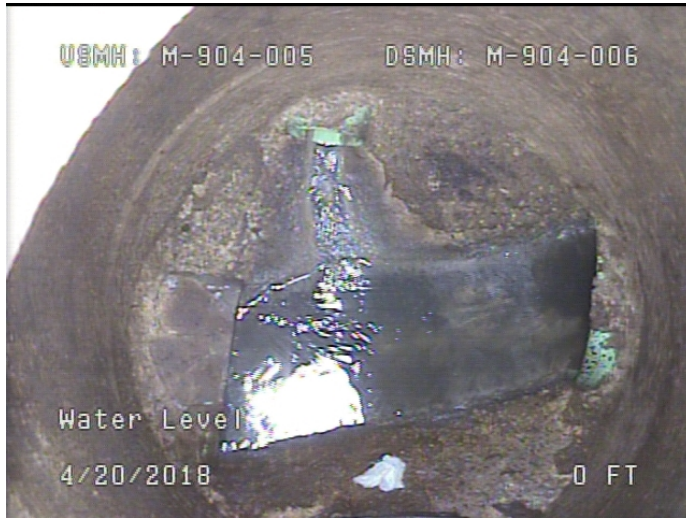
Code:	<b>MWL</b>
Description:	<b>Water Level</b>
Distance (ft):	<b>.0</b>
Structural Grade:	<b>0</b>
O&M Grade:	<b>0</b>
Clock Start/From:	
Clock To:	
1st Value:	
2nd Value:	
Value Percent:	<b>15.000</b>
Continuous Index:	
Within 8" of Joint:	<b>NO</b>
Remarks:

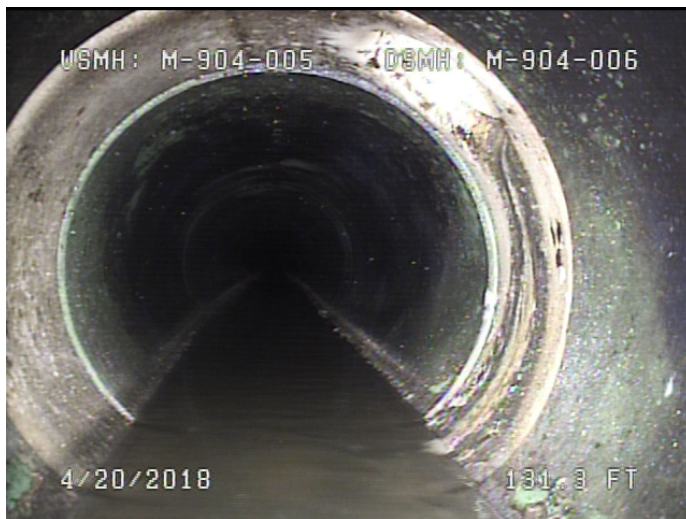
Code:	<b>TF</b>
Description:	<b>Tap Factory</b>
Distance (ft):	<b>131.3</b>
Structural Grade:	<b>0</b>
O&M Grade:	<b>0</b>
Clock Start/From:	<b>1</b>
Clock To:	
1st Value:	<b>4.000</b>
2nd Value:	
Value Percent:	
Continuous Index:	
Within 8" of Joint:	<b>NO</b>
Remarks:

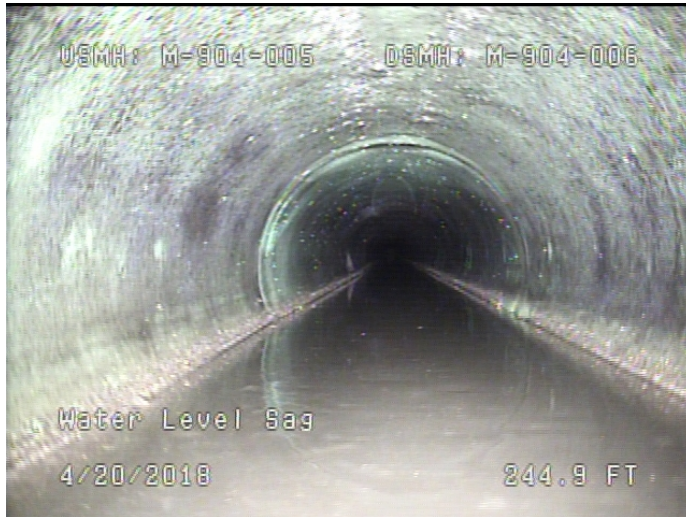
Code:	<b>MWLS</b>
Description:	<b>Water Level Sag</b>
Distance (ft):	<b>244.9</b>
Structural Grade:	<b>2</b>
O&M Grade:	<b>3</b>
Clock Start/From:	
Clock To:	
1st Value:	
2nd Value:	
Value Percent:	<b>25.000</b>
Continuous Index:	<b>S01</b>
Within 8" of Joint:	<b>NO</b>
Remarks:

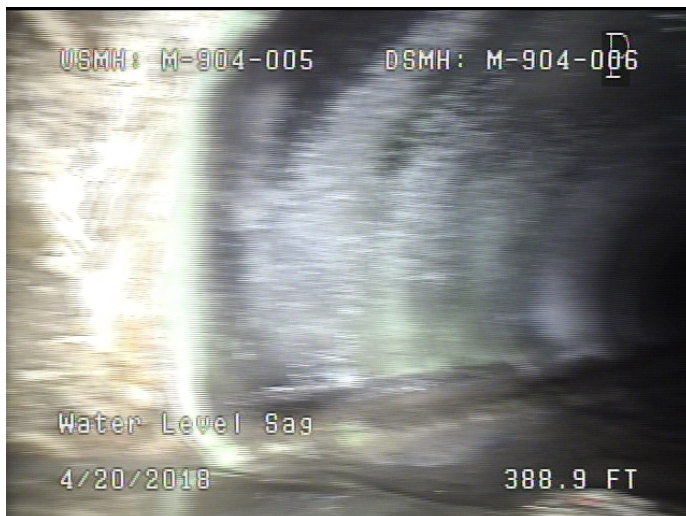
Code:	<b>MWLS</b>
Description:	<b>Water Level Sag</b>
Distance (ft):	<b>388.9</b>
Structural Grade:	<b>2</b>
O&M Grade:	<b>3</b>
Clock Start/From:	
Clock To:	
1st Value:	
2nd Value:	
Value Percent:	<b>25.000</b>
Continuous Index:	<b>F01</b>
Within 8" of Joint:	<b>NO</b>
Remarks:

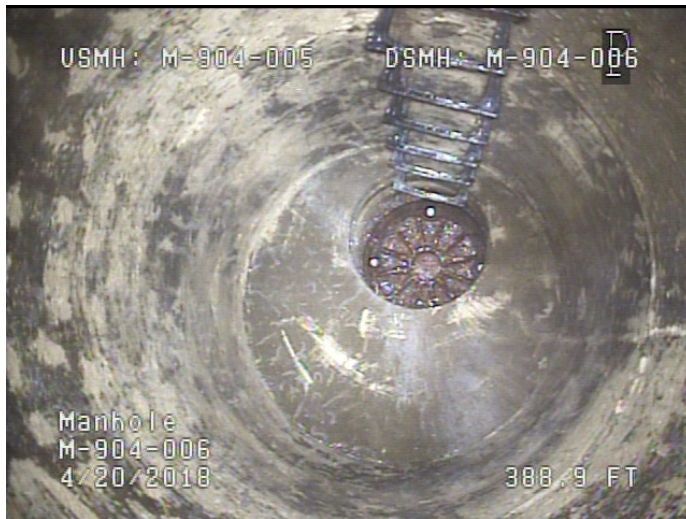
Code:	<b>AMH</b>
Description:	<b>Manhole</b>
Distance (ft):	<b>388.9</b>
Structural Grade:	<b>0</b>
O&M Grade:	<b>0</b>
Clock Start/From:	
Clock To:	
1st Value:	
2nd Value:	
Value Percent:	
Continuous Index:	
Within 8" of Joint:	<b>NO</b>
Remarks:	<b>M-904-006</b>
