Profile/Photo Observation Report

Date:	01/28/2025	Weather:		Coding:	PACP 7.0
Pipe Length (ft):	152.0	Owner:	City of Hobart	Pre Clean:	Heavy Cleaning
P.O.#:	YES502259	Surveyor:	S. Bucklin	PSR:	P-904-009-010
Customer:	City of Hobart	Clean Date:	12/04/2024	Shape:	C

Street:	Fraser Lane	Flow Control:	Not Controlled
City:	Hobart, IN	Year Renewed:	
Location:	Other	Tape/Media #:	
Purpose:	Sewer System Evaluation Survey (SS	Dia/Height:	18"
Use:	Sanitary Sewage Pipe	Material:	VCP
Drain Area:		Lining:	None
Category:	NA		
Comment:			
Location Details:	BIKE TRAIL	Direction of Survey:	Upstream
US MH:	M-904-009	DS MH:	M-904-010
		Total Length Surveyed (ft):	142.2

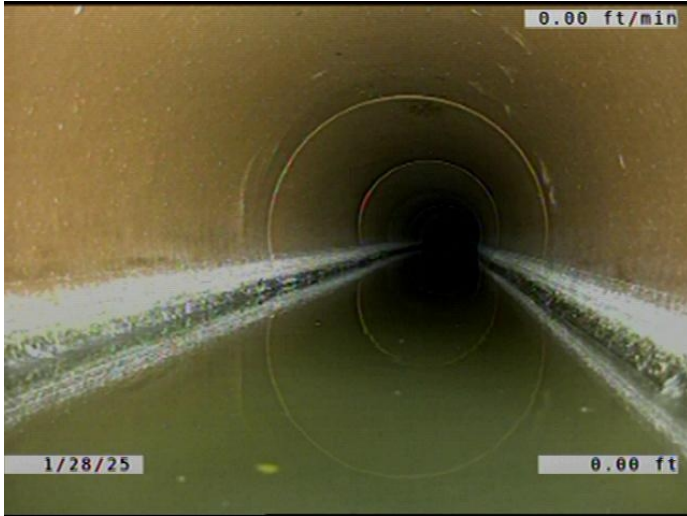
Code: **MWL**
Description: **Miscellaneous Water Level**

Distance (ft): **.0**
Structural Grade: **0**
O&M Grade: **0**
Clock Start/From:
Clock To:
1st Value:
2nd Value:
Value Percent: **30.000**
Continuous Index:
Within 8" of Joint: **NO**
Remarks:

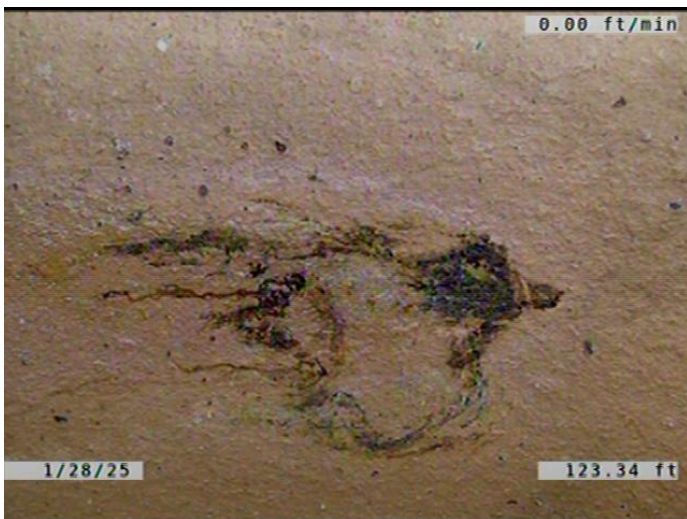
Code: **ISB**
Description: **Infiltration Stain Barrel**

Distance (ft): **123.3**
Structural Grade: **0**
O&M Grade: **1**
Clock Start/From: **9**
Clock To: **10**
1st Value:
2nd Value:
Value Percent:
Continuous Index:
Within 8" of Joint: **NO**
Remarks:
