Profile/Photo Observation Report

Street:	Fraser Ln.	Flow Control:	Not Controlled
City:	Hobart, IN	Year Renewed:	
Location:	Other	Tape/Media #:	
Purpose:	Not Known	Dia/Height:	10"
Use:	Sanitary	Material:	VCP
Drain Area:	NA	Lining:	
Category:	NA		
Comment:

Location Details:		Direction of Survey:	Upstream
US MH:	M-904-009	DS MH:	M-904-012
		Total Length Surveyed (ft):	37.4

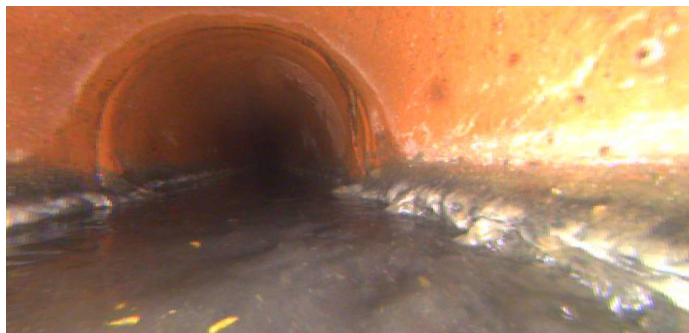
Code: **AMH**
 Description: **Manhole**
 Distance (ft): **.0**
 Structural Grade: **0**
 O&M Grade: **0**
 Clock Start/From:
 Clock To:
 1st Value:
 2nd Value:
 Value Percent:
 Continuous Index:
 Within 8" of Joint: **NO**
 Remarks: **M-904-012**

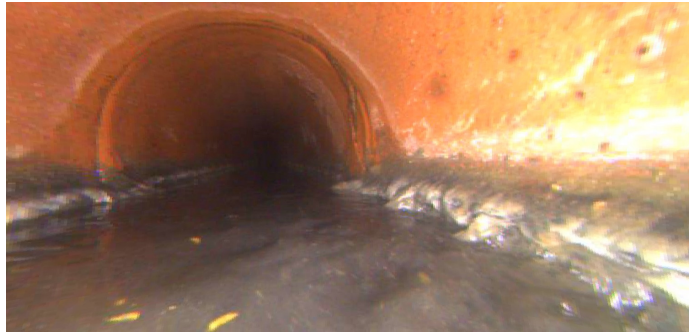
Code: **MWL**
Description: **Water Level**

Distance (ft): **.0**
Structural Grade: **0**
O&M Grade: **0**
Clock Start/From:
Clock To:
1st Value:
2nd Value:
Value Percent: **5.000**
Continuous Index:
Within 8" of Joint: **NO**
Remarks:

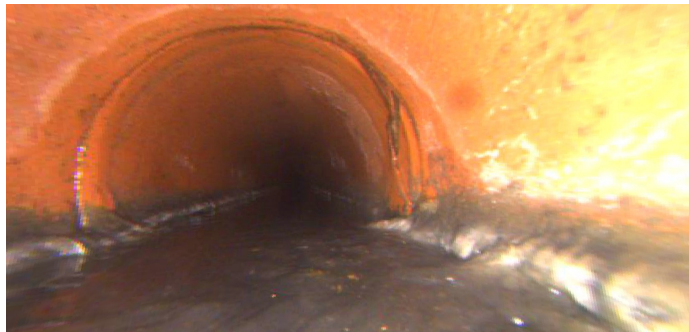
Code: **RFJ**
Description: **Roots Fine Joint**

Distance (ft): **.6**
Structural Grade: **0**
O&M Grade: **1**
Clock Start/From: **2**
Clock To: **5**
1st Value:
2nd Value:
Value Percent:
Continuous Index:
Within 8" of Joint: **YES**
Remarks:

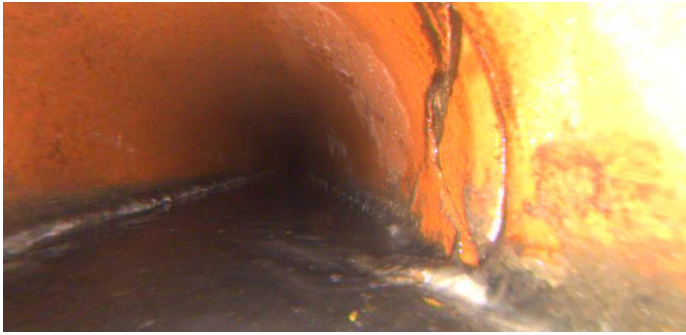
Code: **FS**
Description: **Fracture Spiral**

Distance (ft): **1.8**
Structural Grade: **3**
O&M Grade: **0**
Clock Start/From: **2**
Clock To: **4**
1st Value:
2nd Value:
Value Percent:
Continuous Index:
Within 8" of Joint: **YES**
Remarks:

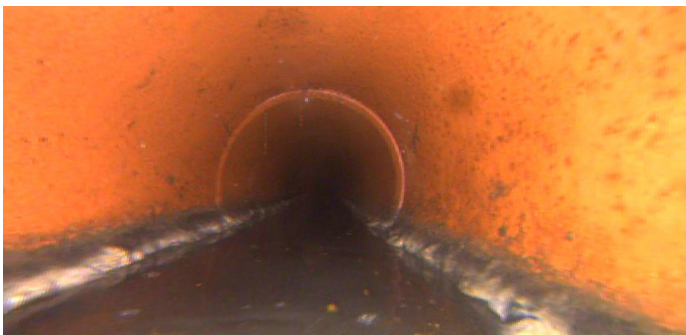
Code: **RFJ**
Description: **Roots Fine Joint**

Distance (ft): **5.8**
Structural Grade: **0**
O&M Grade: **1**
Clock Start/From: **11**
Clock To: **12**
1st Value:
2nd Value:
Value Percent:
Continuous Index:
Within 8" of Joint: **YES**
Remarks:

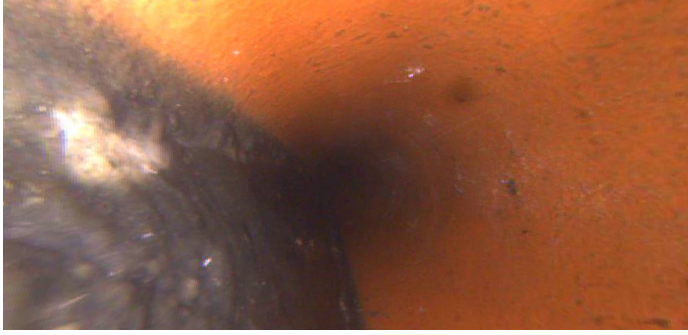
Code:	MSA
Description:	Abandoned Survey
Distance (ft):	37.4
Structural Grade:	0
O&M Grade:	0
Clock Start/From:	
Clock To:	
1st Value:	
2nd Value:	
Value Percent:	
Continuous Index:	
Within 8" of Joint:	NO
Remarks:	camera stopped
