Profile/Photo Observation Report

Date:	01/28/2025	Weather:		Coding:	PACP 7.0
Pipe Length (ft):	567.6	Owner:	City of Hobart	Pre Clean:	Heavy Cleaning
P.O.#:	YES502259	Surveyor:	S. Bucklin	PSR:	P-904-012-009
Customer:	City of Hobart	Clean Date:	11/27/2024	Shape:	C

Street:	Fraser Lane	Flow Control:	Not Controlled
City:	Hobart, IN	Year Renewed:	
Location:	Local rural streets with light traffic, t	Tape/Media #:	
Purpose:	Sewer System Evaluation Survey (SS	Dia/Height:	10"
Use:	Sanitary Sewage Pipe	Material:	VCP
Drain Area:		Lining:	None
Category:	NA		
Comment:

Location Details:		Direction of Survey:	Downstream
US MH:	M-904-012	DS MH:	M-904-009
		Total Length Surveyed (ft):	552.8

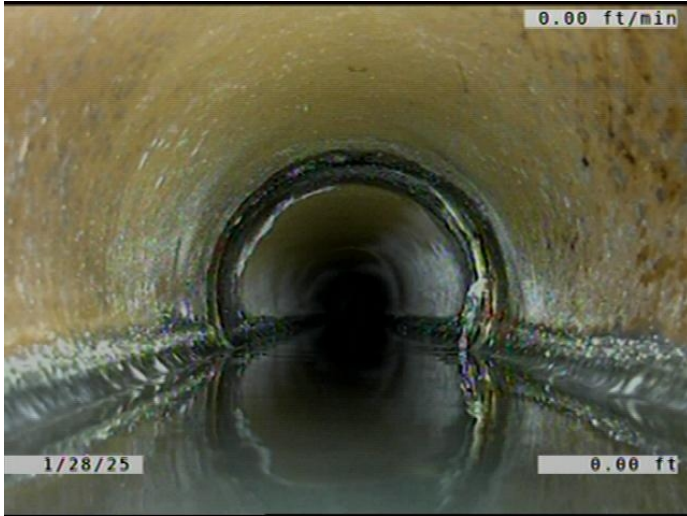
Code:	MWL
Description:	Miscellaneous Water Level
Distance (ft):	.0
Structural Grade:	0
O&M Grade:	0
Clock Start/From:	
Clock To:	
1st Value:	
2nd Value:	
Value Percent:	25.000
Continuous Index:	
Within 8" of Joint:	NO
Remarks:

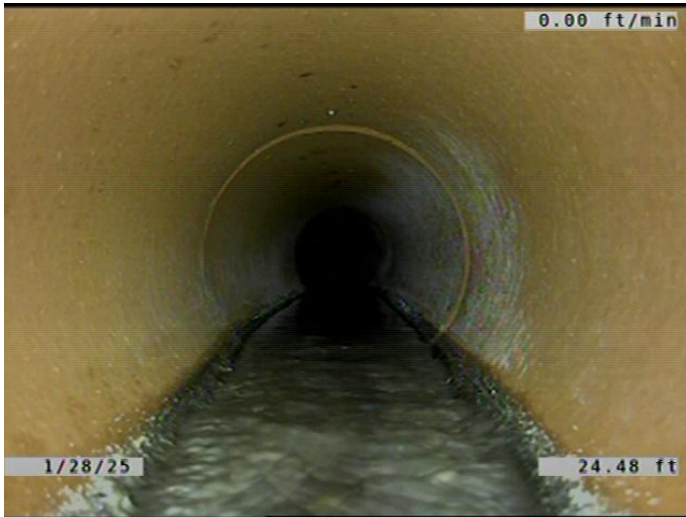
Code: **MWLS**
Description: **Miscellaneous Water Level Sag**

Distance (ft): **80.4**
Structural Grade: **2**
O&M Grade: **0**
Clock Start/From:
Clock To:
1st Value:
2nd Value:
Value Percent: **15.000**
Continuous Index: **S01**
Within 8" of Joint: **NO**
Remarks:

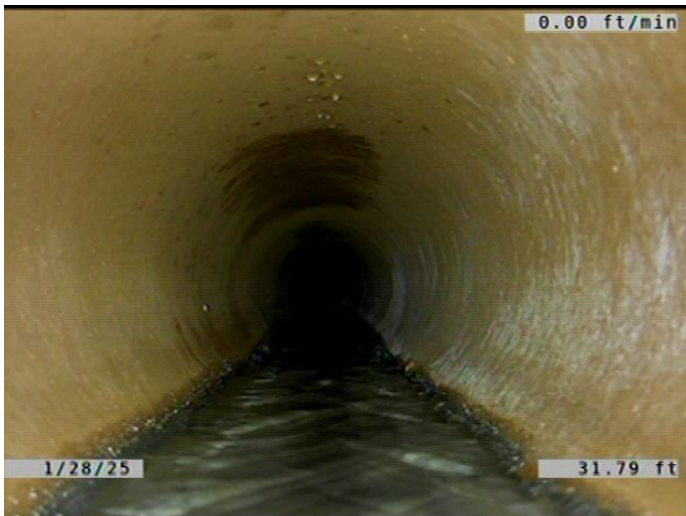
Code: **MWLS**
Description: **Miscellaneous Water Level Sag**

Distance (ft): **104.3**
Structural Grade: **2**
O&M Grade: **0**
Clock Start/From:
Clock To:
1st Value:
2nd Value:
Value Percent: **15.000**
Continuous Index: **F01**
Within 8" of Joint: **NO**
Remarks:

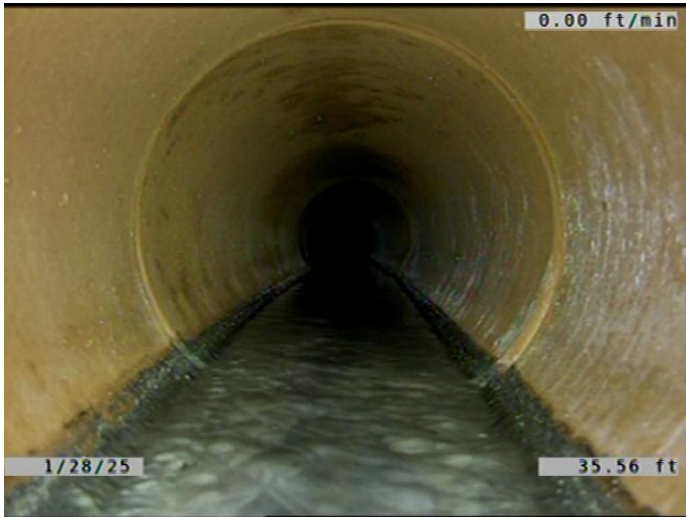
Code: **MWLS**
 Description: **Miscellaneous Water Level Sag**

Distance (ft): **116.8**
 Structural Grade: **2**
 O&M Grade: **0**
 Clock Start/From:
 Clock To:
 1st Value:
 2nd Value:
 Value Percent: **15.000**
 Continuous Index: **S02**
 Within 8" of Joint: **NO**
 Remarks:

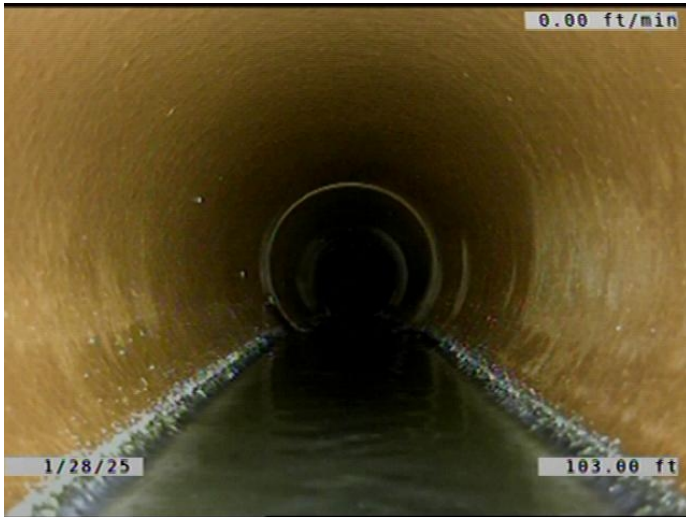
Code: **MWLS**
Description: **Miscellaneous Water Level Sag**

Distance (ft): **337.9**
Structural Grade: **2**
O&M Grade: **0**
Clock Start/From:
Clock To:
1st Value:
2nd Value:
Value Percent: **15.000**
Continuous Index: **F02**
Within 8" of Joint: **NO**
Remarks:

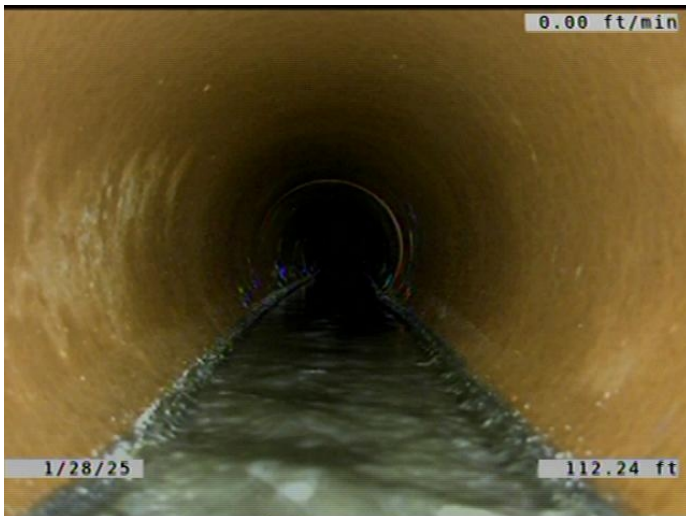
Code: **MWLS**
Description: **Miscellaneous Water Level Sag**

Distance (ft): **368.1**
Structural Grade: **2**
O&M Grade: **0**
Clock Start/From:
Clock To:
1st Value:
2nd Value:
Value Percent: **15.000**
Continuous Index: **S03**
Within 8" of Joint: **NO**
Remarks:

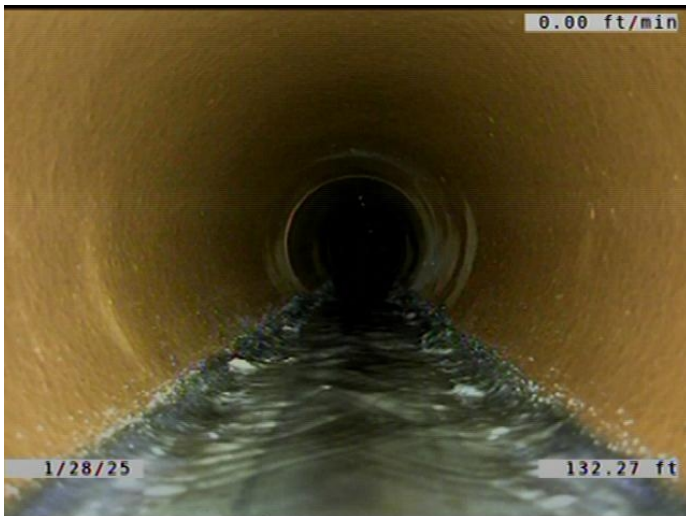
Code: **MWLS**
Description: **Miscellaneous Water Level Sag**

Distance (ft): **434.1**
Structural Grade: **2**
O&M Grade: **0**
Clock Start/From:
Clock To:
1st Value:
2nd Value:
Value Percent: **15.000**
Continuous Index: **F03**
Within 8" of Joint: **NO**
Remarks:
