Profile/Photo Observation Report

Street:	FRASER LN	Flow Control:	Not Controlled
City:	Hobart, IN	Year Renewed:	
Location:	Other	Tape/Media #:	
Purpose:	Not Known	Dia/Height:	10"
Use:	Sanitary	Material:	VCP
Drain Area:	NA	Lining:	
Category:	NA		
Comment:

Location Details:		Direction of Survey:	Downstream
US MH:	M-904-014	DS MH:	M-904-013
		Total Length Surveyed (ft):	4.6

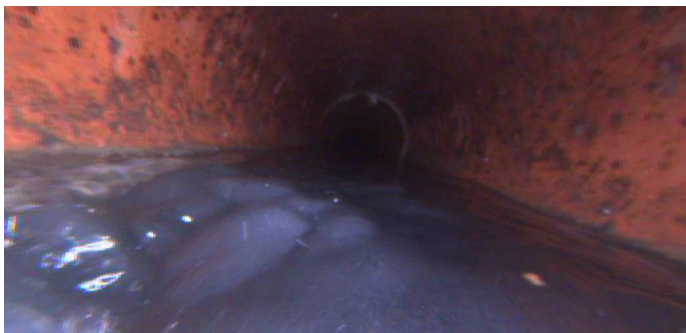
Code: **AMH**
Description: **Manhole**

Distance (ft): **.0**
Structural Grade: **0**
O&M Grade: **0**
Clock Start/From:
Clock To:
1st Value:
2nd Value:
Value Percent:
Continuous Index:
Within 8" of Joint: **NO**
Remarks: **M-904-014**

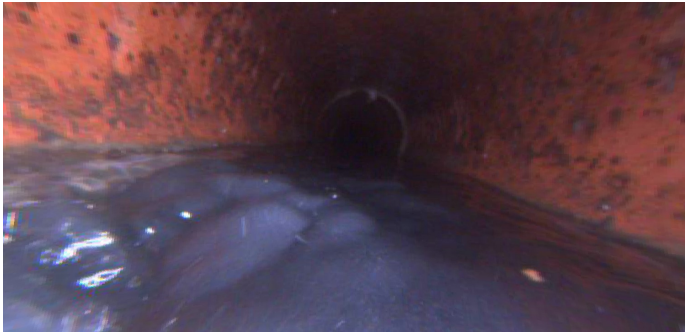
Code:	MWL
Description:	Water Level

Distance (ft):	.0
Structural Grade:	0
O&M Grade:	0
Clock Start/From:	
Clock To:	
1st Value:	
2nd Value:	
Value Percent:	30.000
Continuous Index:	
Within 8" of Joint:	NO
Remarks:

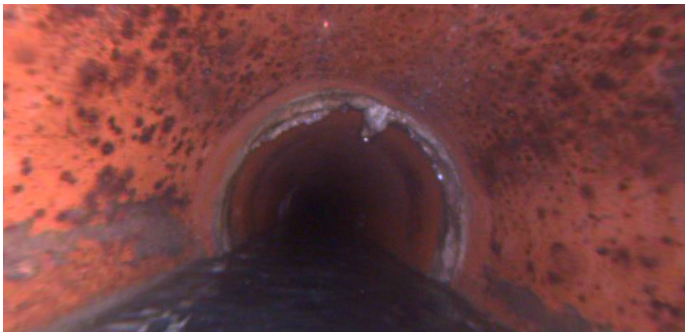
Code:	ID
Description:	Infil Dripper

Distance (ft):	2.9
Structural Grade:	0
O&M Grade:	3
Clock Start/From:	12
Clock To:	
1st Value:	
2nd Value:	
Value Percent:	
Continuous Index:	
Within 8" of Joint:	YES
Remarks:

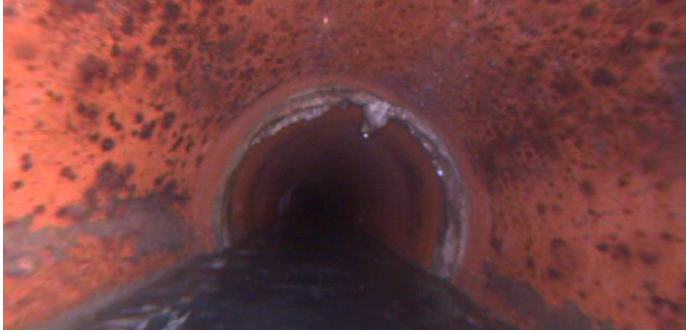
Code: **DAE**
Description: **Deposits Attached Encrustation**

Distance (ft): **2.9**
Structural Grade: **0**
O&M Grade: **2**
Clock Start/From: **8**
Clock To: **4**
1st Value:
2nd Value:
Value Percent: **5.000**
Continuous Index:
Within 8" of Joint: **YES**
Remarks:
