Profile/Photo Observation Report

Date:	04/15/2018	Weather:		Coding:	PACP 6.0
Pipe Length (ft):	248.4	Owner:	NA	Pre Clean:	Not Known
P.O.#:		Surveyor:	Selasie Honu	PSR:	P-904-014-013
Customer:		Clean Date:	01/01/1900	Shape:	C

Street:	Fraser Ln.	Flow Control:	Not Controlled
City:	Hobart, IN	Year Renewed:	
Location:	Other	Tape/Media #:	
Purpose:	Not Known	Dia/Height:	10"
Use:	Sanitary	Material:	VCP
Drain Area:	NA	Lining:	
Category:	NA		
Comment:

Location Details:		Direction of Survey:	Downstream
US MH:	M-904-014	DS MH:	M-904-013
		Total Length Surveyed (ft):	4.6

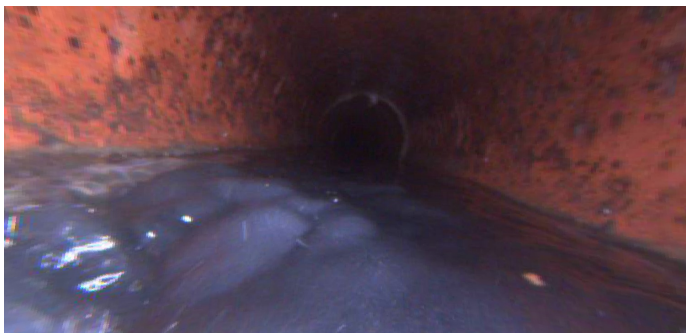
Code: **AMH**
Description: **Manhole**

Distance (ft): **.0**
Structural Grade: **0**
O&M Grade: **0**
Clock Start/From:
Clock To:
1st Value:
2nd Value:
Value Percent:
Continuous Index:
Within 8" of Joint: **NO**
Remarks: **M-904-014**

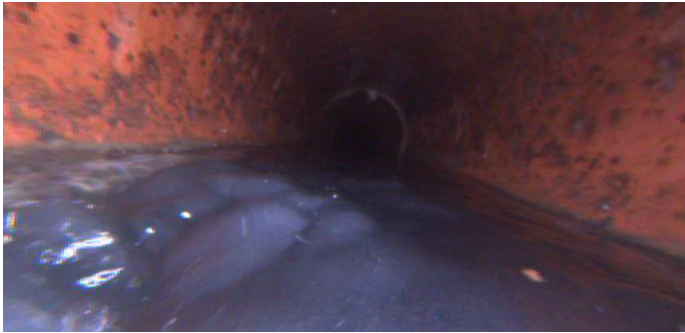
Code:	MWL
Description:	Water Level

Distance (ft):	.0
Structural Grade:	0
O&M Grade:	0
Clock Start/From:	
Clock To:	
1st Value:	
2nd Value:	
Value Percent:	30.000
Continuous Index:	
Within 8" of Joint:	NO
Remarks:

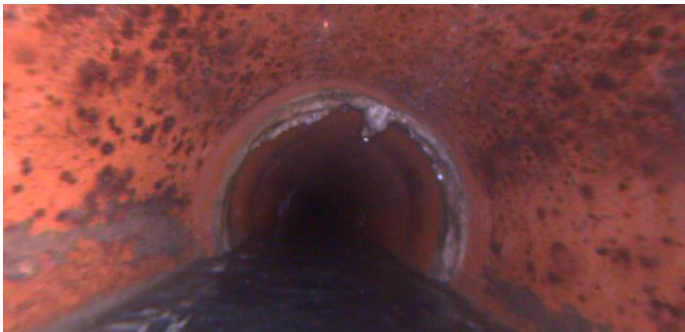
Code:	ID
Description:	Infil Dripper

Distance (ft):	2.9
Structural Grade:	0
O&M Grade:	3
Clock Start/From:	12
Clock To:	
1st Value:	
2nd Value:	
Value Percent:	
Continuous Index:	
Within 8" of Joint:	YES
Remarks:

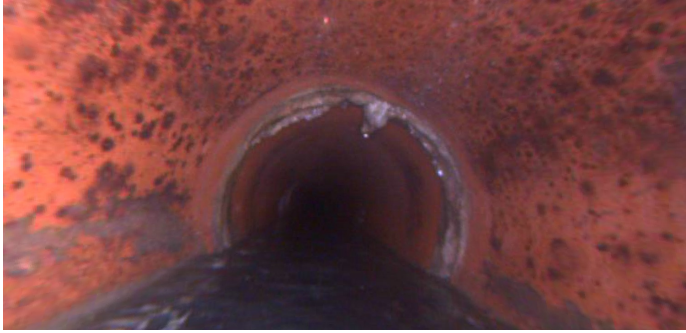
Code: **DAE**
Description: **Deposits Attached Encrustation**

Distance (ft): **2.9**
Structural Grade: **0**
O&M Grade: **2**
Clock Start/From: **8**
Clock To: **4**
1st Value:
2nd Value:
Value Percent: **5.000**
Continuous Index:
Within 8" of Joint: **YES**
Remarks:
