Profile/Photo Observation Report

Street:	FRASER LN	Flow Control:	Not Controlled
City:	Hobart, IN	Year Renewed:	
Location:	Other	Tape/Media #:	
Purpose:	Not Known	Dia/Height:	10"
Use:	Sanitary	Material:	VCP
Drain Area:	NA	Lining:	
Category:	NA		
Comment:

Location Details:		Direction of Survey:	Upstream
US MH:	M-904-015	DS MH:	M-904-014
		Total Length Surveyed (ft):	224.6

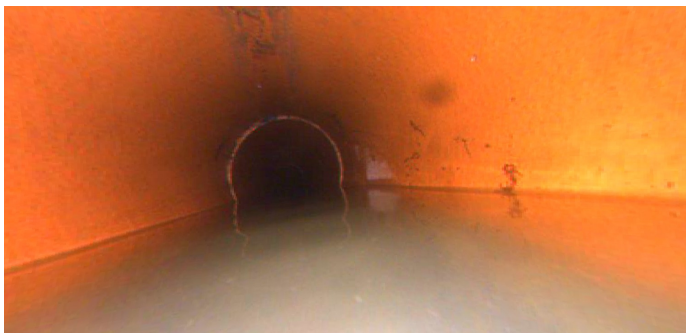
Code: **AMH**
Description: **Manhole**

Distance (ft): **.0**
Structural Grade: **0**
O&M Grade: **0**
Clock Start/From:
Clock To:
1st Value:
2nd Value:
Value Percent:
Continuous Index:
Within 8" of Joint: **NO**
Remarks: **M-904-014**

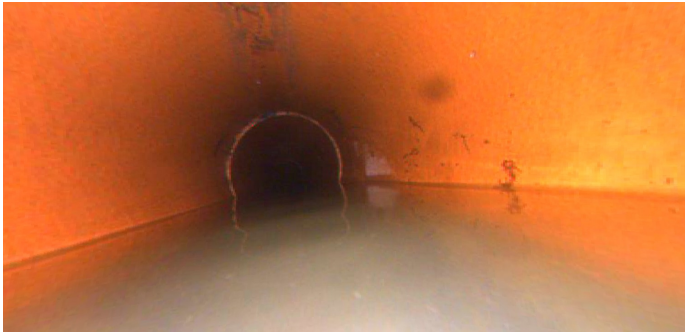
Code:	MWL
Description:	Water Level

Distance (ft):	.0
Structural Grade:	0
O&M Grade:	0
Clock Start/From:	
Clock To:	
1st Value:	
2nd Value:	
Value Percent:	5.000
Continuous Index:	
Within 8" of Joint:	NO
Remarks:

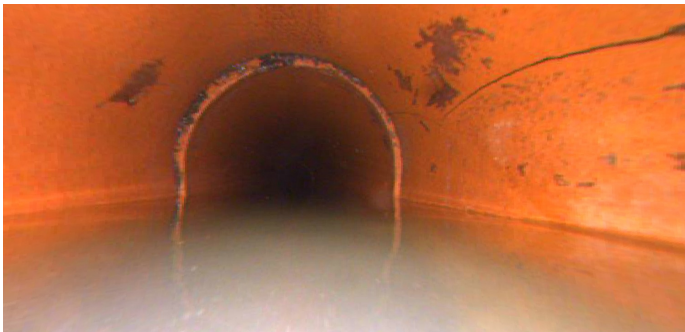
Code:	FL
Description:	Fracture Longitudinal

Distance (ft):	2.3
Structural Grade:	3
O&M Grade:	0
Clock Start/From:	3
Clock To:	
1st Value:	
2nd Value:	
Value Percent:	
Continuous Index:	
Within 8" of Joint:	NO
Remarks:

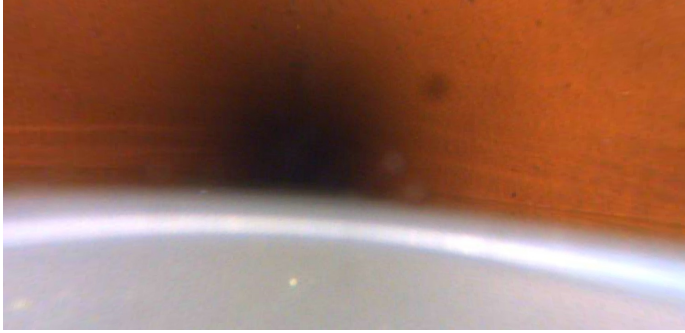
Code: **MWLS**
Description: **Water Level Sag**

Distance (ft): **48.3**
Structural Grade: **2**
O&M Grade: **3**
Clock Start/From:
Clock To:
1st Value:
2nd Value:
Value Percent: **15.000**
Continuous Index: **S01**
Within 8" of Joint: **NO**
Remarks:

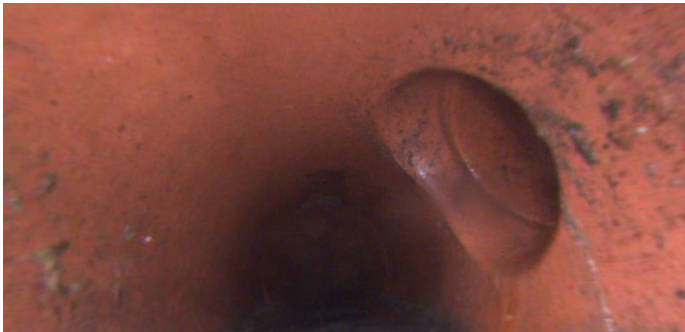
Code: **TF**
Description: **Tap Factory**

Distance (ft): **59.8**
Structural Grade: **0**
O&M Grade: **0**
Clock Start/From: **10**
Clock To:
1st Value: **4.000**
2nd Value:
Value Percent:
Continuous Index:
Within 8" of Joint:
Remarks:

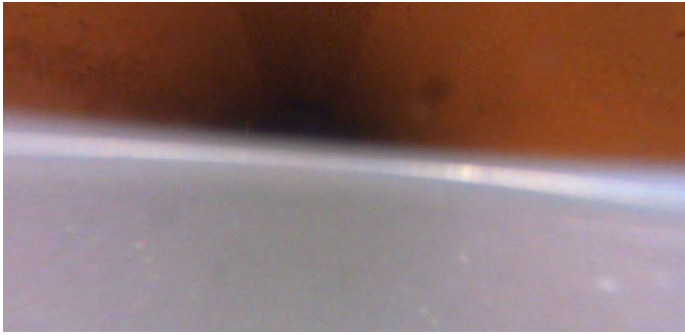
Code: **MWLS**
Description: **Water Level Sag**

Distance (ft): **102.6**
Structural Grade: **2**
O&M Grade: **3**
Clock Start/From:
Clock To:
1st Value:
2nd Value:
Value Percent: **15.000**
Continuous Index: **F01**
Within 8" of Joint: **NO**
Remarks:

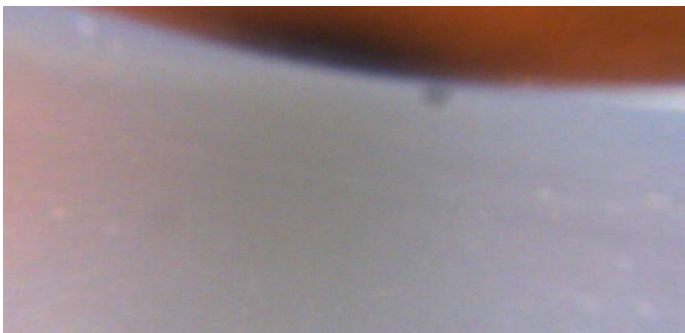
Code: **MWLS**
Description: **Water Level Sag**

Distance (ft): **120.8**
Structural Grade: **2**
O&M Grade: **3**
Clock Start/From:
Clock To:
1st Value:
2nd Value:
Value Percent: **15.000**
Continuous Index:
Within 8" of Joint: **NO**
Remarks:

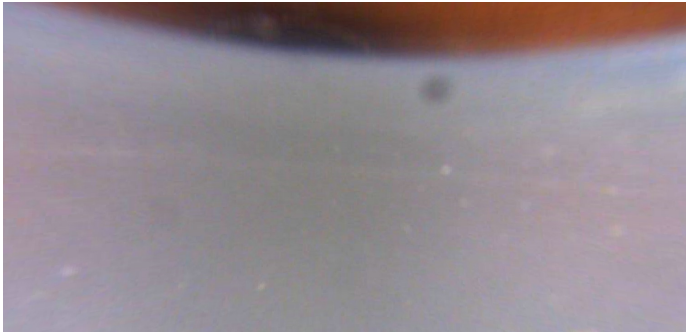
Code: **MWLS**
Description: **Water Level Sag**

Distance (ft): **128.1**
Structural Grade: **2**
O&M Grade: **3**
Clock Start/From:
Clock To:
1st Value:
2nd Value:
Value Percent: **15.000**
Continuous Index:
Within 8" of Joint: **NO**
Remarks:

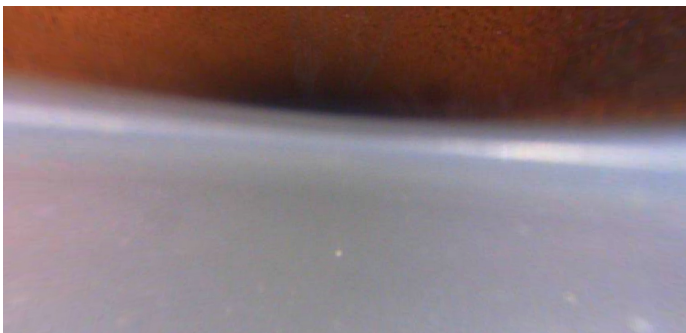
Code: **MWLS**
Description: **Water Level Sag**

Distance (ft): **132.2**
Structural Grade: **2**
O&M Grade: **3**
Clock Start/From:
Clock To:
1st Value:
2nd Value:
Value Percent: **15.000**
Continuous Index: **S02**
Within 8" of Joint: **NO**
Remarks:

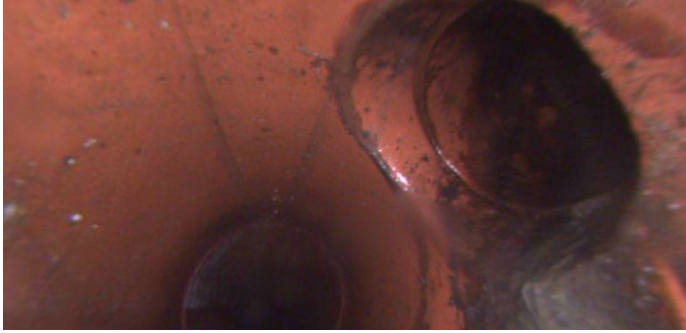
Code: **TF**
Description: **Tap Factory**

Distance (ft): **136.5**
Structural Grade: **0**
O&M Grade: **0**
Clock Start/From: **10**
Clock To:
1st Value: **4.000**
2nd Value:
Value Percent:
Continuous Index:
Within 8" of Joint:
Remarks:

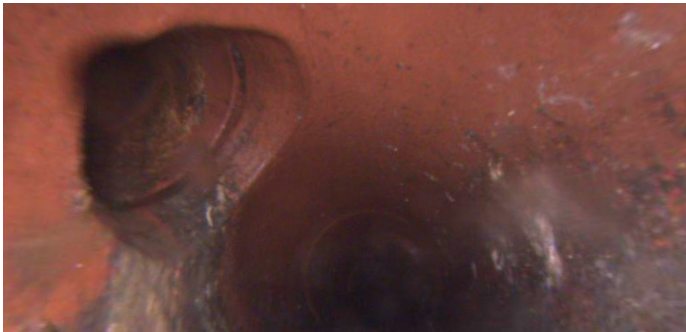
Code: **TF**
Description: **Tap Factory**

Distance (ft): **138.7**
Structural Grade: **0**
O&M Grade: **0**
Clock Start/From: **2**
Clock To:
1st Value: **4.000**
2nd Value:
Value Percent:
Continuous Index:
Within 8" of Joint:
Remarks:

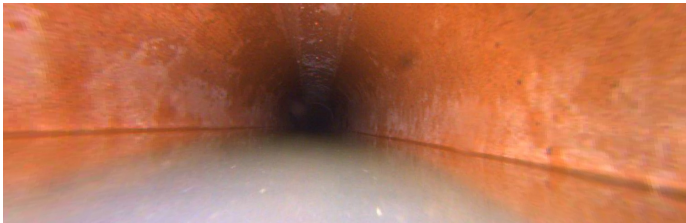
Code: **MWLS**
Description: **Water Level Sag**

Distance (ft): **144.6**
Structural Grade: **2**
O&M Grade: **3**
Clock Start/From:
Clock To:
1st Value:
2nd Value:
Value Percent: **15.000**
Continuous Index: **F02**
Within 8" of Joint: **NO**
Remarks:

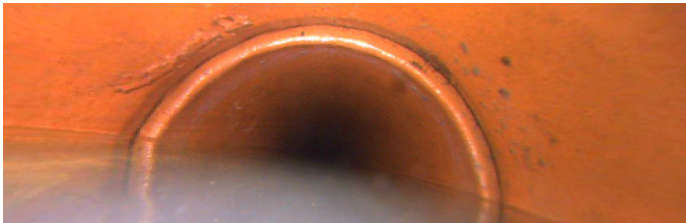
Code: **FC**
Description: **Fracture Circumferential**

Distance (ft): **173.2**
Structural Grade: **2**
O&M Grade: **0**
Clock Start/From: **9**
Clock To: **11**
1st Value:
2nd Value:
Value Percent:
Continuous Index:
Within 8" of Joint: **YES**
Remarks:

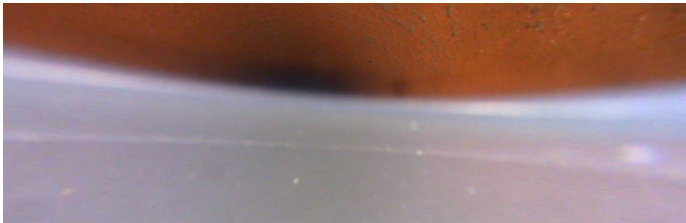
Code: **MWLS**
Description: **Water Level Sag**

Distance (ft): **199.6**
Structural Grade: **2**
O&M Grade: **3**
Clock Start/From:
Clock To:
1st Value:
2nd Value:
Value Percent: **10.000**
Continuous Index:
Within 8" of Joint: **NO**
Remarks:

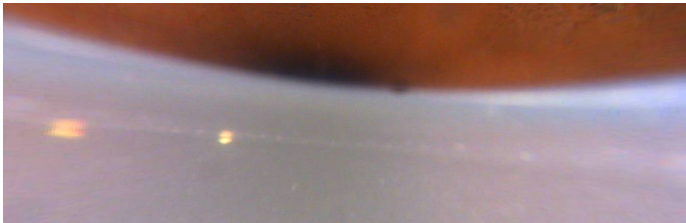
Code: **MWLS**
Description: **Water Level Sag**

Distance (ft): **201.1**
Structural Grade: **2**
O&M Grade: **3**
Clock Start/From:
Clock To:
1st Value:
2nd Value:
Value Percent: **10.000**
Continuous Index:
Within 8" of Joint: **NO**
Remarks:

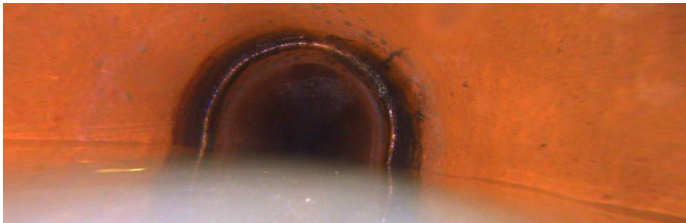
Code: **IW**
Description: **Infil Weeper**

Distance (ft): **202.8**
Structural Grade: **0**
O&M Grade: **2**
Clock Start/From: **7**
Clock To: **5**
1st Value:
2nd Value:
Value Percent:
Continuous Index:
Within 8" of Joint: **YES**
Remarks:

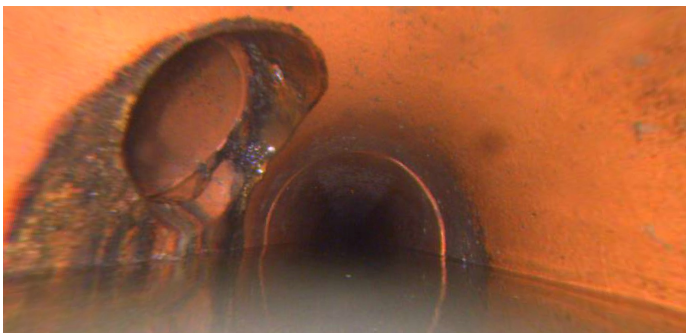
Code: **TFA**
Description: **Tap Factory Active**

Distance (ft): **209.3**
Structural Grade: **0**
O&M Grade: **0**
Clock Start/From: **10**
Clock To:
1st Value: **4.000**
2nd Value:
Value Percent:
Continuous Index:
Within 8" of Joint:
Remarks:

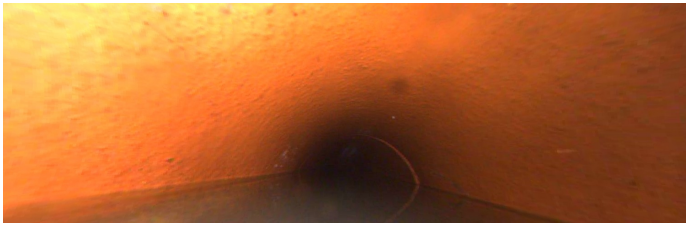
Code: **AMH**
Description: **Manhole**

Distance (ft): **224.6**
Structural Grade: **0**
O&M Grade: **0**
Clock Start/From:
Clock To:
1st Value:
2nd Value:
Value Percent:
Continuous Index:
Within 8" of Joint: **NO**
Remarks: **M-904-015**
