Profile/Photo Observation Report

Date:	04/15/2018	Weather:		Coding:	PACP 6.0
Pipe Length (ft):	253.2	Owner:	NA	Pre Clean:	Not Known
P.O.#:		Surveyor:	Selasie Honu	PSR:	P-904-015-014
Customer:		Clean Date:	01/01/1900	Shape:	C

Street:	Fraser Ln.	Flow Control:	Not Controlled
City:	Hobart, IN	Year Renewed:	
Location:	Other	Tape/Media #:	
Purpose:	Not Known	Dia/Height:	10"
Use:	Sanitary	Material:	VCP
Drain Area:	NA	Lining:	
Category:	NA		
Comment:

Location Details:		Direction of Survey:	Upstream
US MH:	M-904-015	DS MH:	M-904-014
		Total Length Surveyed (ft):	224.6

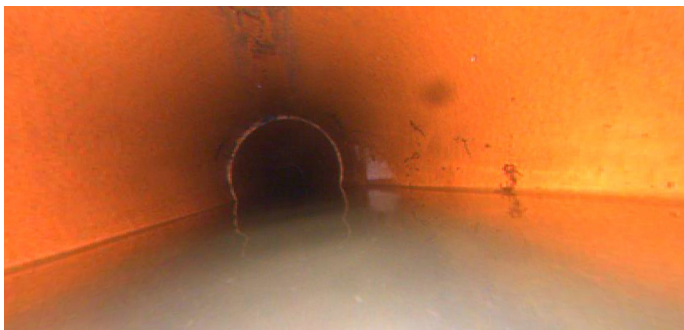
Code: **AMH**
Description: **Manhole**

Distance (ft): **.0**
Structural Grade: **0**
O&M Grade: **0**
Clock Start/From:
Clock To:
1st Value:
2nd Value:
Value Percent:
Continuous Index:
Within 8" of Joint: **NO**
Remarks: **M-904-014**

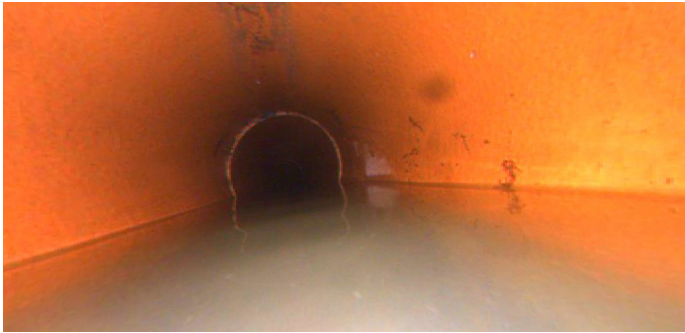
Code:	MWL
Description:	Water Level

Distance (ft):	.0
Structural Grade:	0
O&M Grade:	0
Clock Start/From:	
Clock To:	
1st Value:	
2nd Value:	
Value Percent:	5.000
Continuous Index:	
Within 8" of Joint:	NO
Remarks:

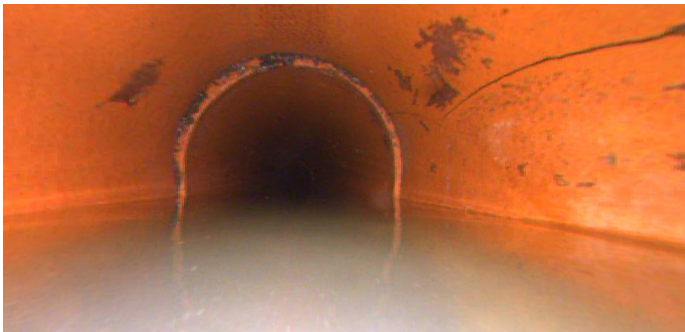
Code:	FL
Description:	Fracture Longitudinal

Distance (ft):	2.3
Structural Grade:	3
O&M Grade:	0
Clock Start/From:	3
Clock To:	
1st Value:	
2nd Value:	
Value Percent:	
Continuous Index:	
Within 8" of Joint:	NO
Remarks:

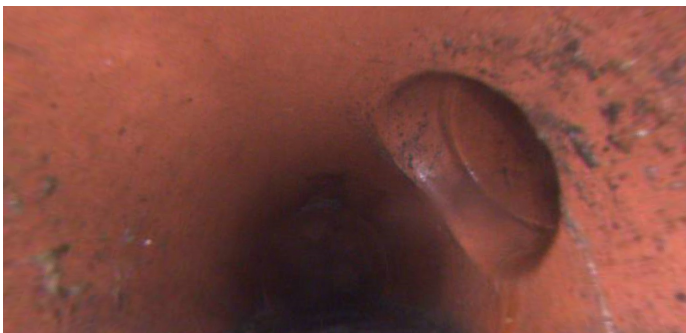
Code: **TF**
Description: **Tap Factory**

Distance (ft): **59.8**
Structural Grade: **0**
O&M Grade: **0**
Clock Start/From: **10**
Clock To:
1st Value: **4.000**
2nd Value:
Value Percent:
Continuous Index:
Within 8" of Joint:
Remarks:

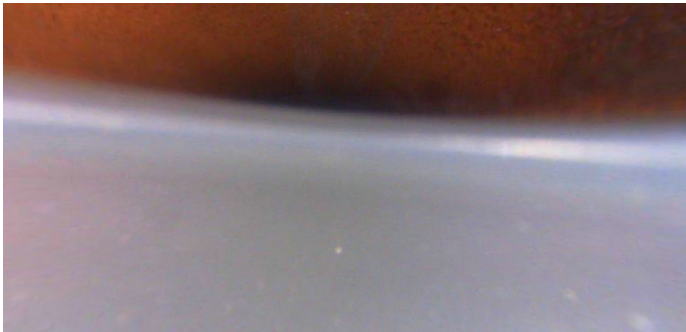
Code: **MWLS**
Description: **Water Level Sag**

Distance (ft): **132.2**
Structural Grade: **2**
O&M Grade: **3**
Clock Start/From:
Clock To:
1st Value:
2nd Value:
Value Percent: **15.000**
Continuous Index: **S02**
Within 8" of Joint: **NO**
Remarks:

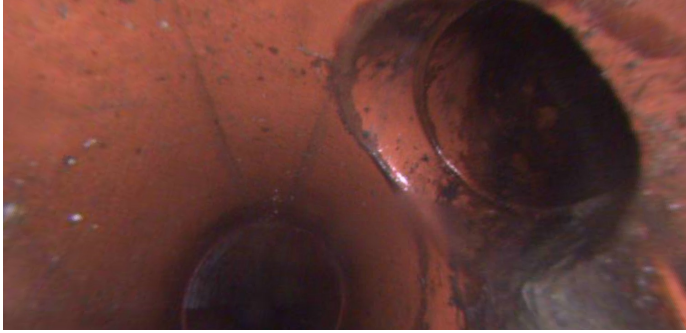
Code: **TF**
Description: **Tap Factory**

Distance (ft): **136.5**
Structural Grade: **0**
O&M Grade: **0**
Clock Start/From: **10**
Clock To:
1st Value: **4.000**
2nd Value:
Value Percent:
Continuous Index:
Within 8" of Joint:
Remarks:

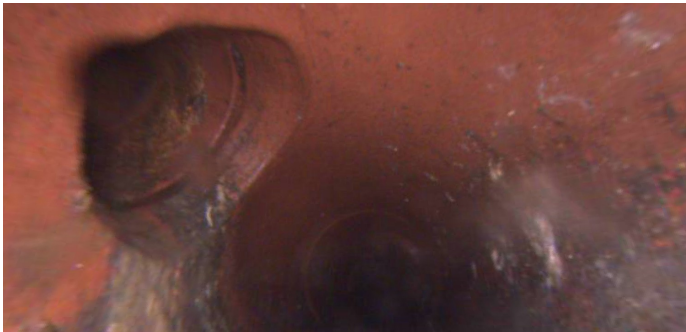
Code: **TF**
Description: **Tap Factory**

Distance (ft): **138.7**
Structural Grade: **0**
O&M Grade: **0**
Clock Start/From: **2**
Clock To:
1st Value: **4.000**
2nd Value:
Value Percent:
Continuous Index:
Within 8" of Joint:
Remarks:

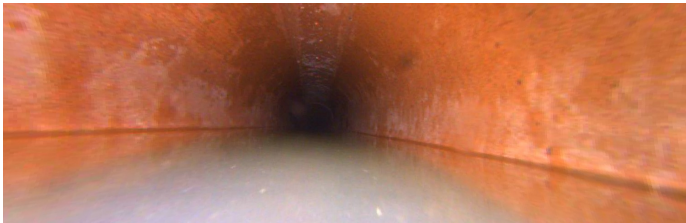
Code: **MWLS**
Description: **Water Level Sag**

Distance (ft): **144.6**
Structural Grade: **2**
O&M Grade: **3**
Clock Start/From:
Clock To:
1st Value:
2nd Value:
Value Percent: **15.000**
Continuous Index: **F02**
Within 8" of Joint: **NO**
Remarks:

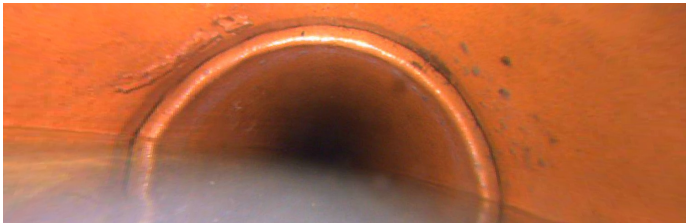
Code: **FC**
Description: **Fracture Circumferential**

Distance (ft): **173.2**
Structural Grade: **2**
O&M Grade: **0**
Clock Start/From: **9**
Clock To: **11**
1st Value:
2nd Value:
Value Percent:
Continuous Index:
Within 8" of Joint: **YES**
Remarks:

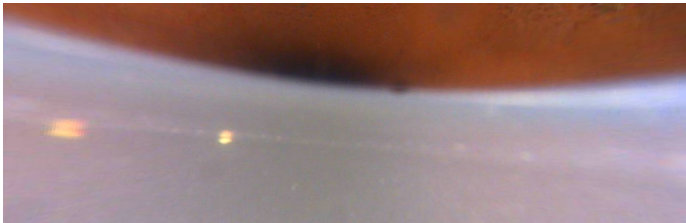
Code: **MWLS**
Description: **Water Level Sag**

Distance (ft): **201.1**
Structural Grade: **2**
O&M Grade: **3**
Clock Start/From:
Clock To:
1st Value:
2nd Value:
Value Percent: **10.000**
Continuous Index:
Within 8" of Joint: **NO**
Remarks:

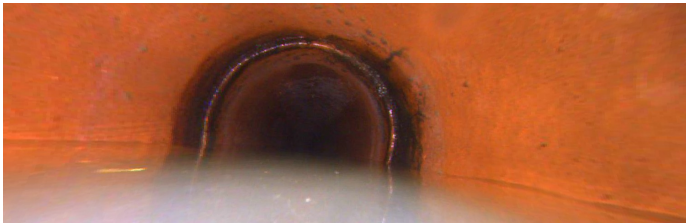
Code: **IW**
Description: **Infil Weeper**

Distance (ft): **202.8**
Structural Grade: **0**
O&M Grade: **2**
Clock Start/From: **7**
Clock To: **5**
1st Value:
2nd Value:
Value Percent:
Continuous Index:
Within 8" of Joint: **YES**
Remarks:

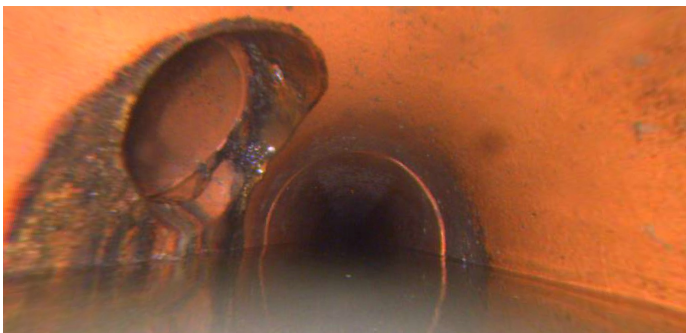
Code: **TFA**
Description: **Tap Factory Active**

Distance (ft): **209.3**
Structural Grade: **0**
O&M Grade: **0**
Clock Start/From: **10**
Clock To:
1st Value: **4.000**
2nd Value:
Value Percent:
Continuous Index:
Within 8" of Joint:
Remarks:
