Profile/Photo Observation Report

Date:	04/15/2018	Weather:		Coding:	PACP 6.0
Pipe Length (ft):	253.2	Owner:	NA	Pre Clean:	Not Known
P.O.#:		Surveyor:	Selasie Honu	PSR:	P-904-015-014
Customer:		Clean Date:	01/01/1900	Shape:	C

Street:	FRASER LN	Flow Control:	Not Controlled
City:	Hobart, IN	Year Renewed:	
Location:	Other	Tape/Media #:	
Purpose:	Not Known	Dia/Height:	10"
Use:	Sanitary	Material:	VCP
Drain Area:	NA	Lining:	
Category:	NA		
Comment:

Location Details:		Direction of Survey:	Downstream
US MH:	M-904-015	DS MH:	M-904-014
		Total Length Surveyed (ft):	36.5

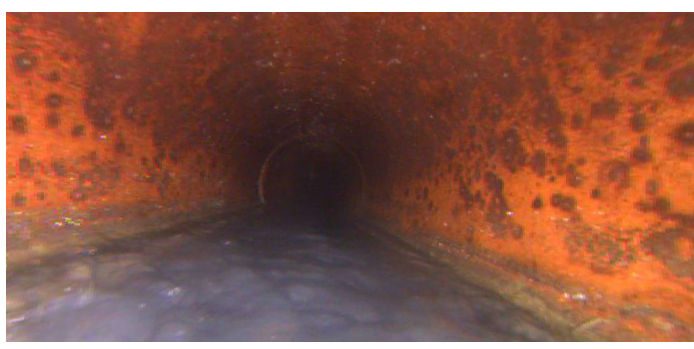
Code: **AMH**
Description: **Manhole**

Distance (ft): **.0**
Structural Grade: **0**
O&M Grade: **0**
Clock Start/From:
Clock To:
1st Value:
2nd Value:
Value Percent:
Continuous Index:
Within 8" of Joint: **NO**
Remarks: **M-904-015**

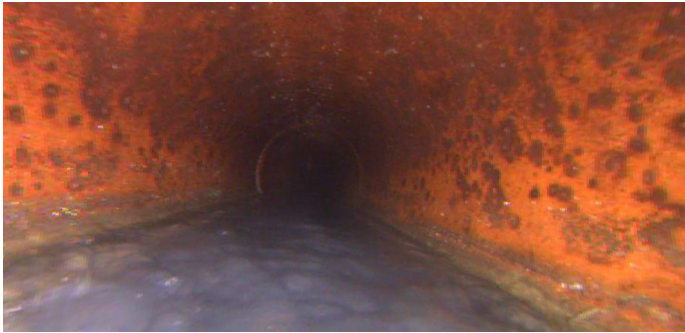
Code:	MWL
Description:	Water Level

Distance (ft):	.0
Structural Grade:	0
O&M Grade:	0
Clock Start/From:	
Clock To:	
1st Value:	
2nd Value:	
Value Percent:	5.000
Continuous Index:	
Within 8" of Joint:	NO
Remarks:

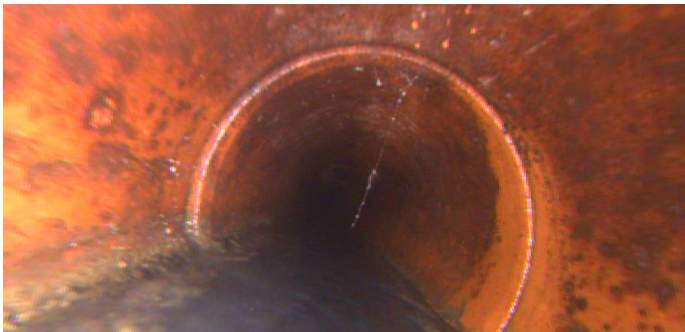
Code:	RFJ
Description:	Roots Fine Joint

Distance (ft):	2.7
Structural Grade:	0
O&M Grade:	1
Clock Start/From:	1
Clock To:	
1st Value:	
2nd Value:	
Value Percent:	
Continuous Index:	
Within 8" of Joint:	YES
Remarks:

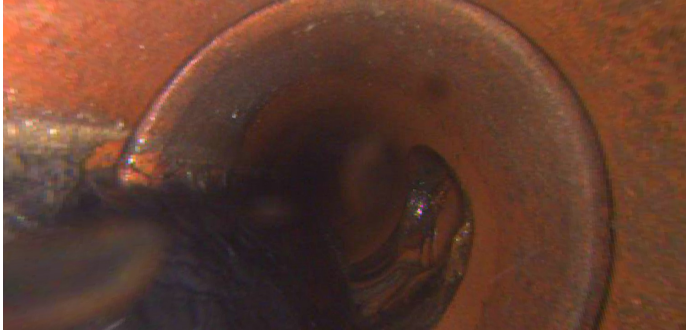
Code: **TF**
Description: **Tap Factory**

Distance (ft): **36.5**
Structural Grade: **0**
O&M Grade: **0**
Clock Start/From: **3**
Clock To:
1st Value: **4.000**
2nd Value:
Value Percent:
Continuous Index:
Within 8" of Joint:
Remarks:

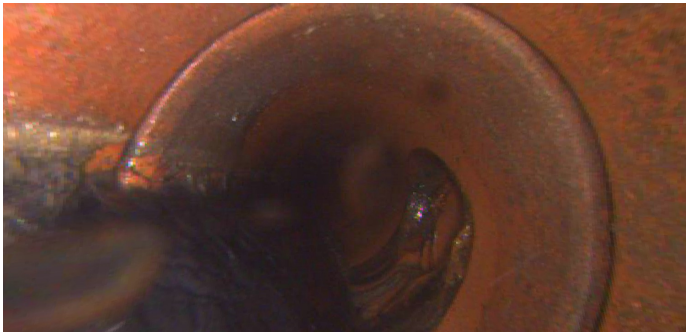
Code: **MSA**
Description: **Abandoned Survey**

Distance (ft): **36.5**
Structural Grade: **0**
O&M Grade: **0**
Clock Start/From:
Clock To:
1st Value:
2nd Value:
Value Percent:
Continuous Index:
Within 8" of Joint: **NO**
Remarks: **camera stopped**
