Profile/Photo Observation Report

Street:	FRASER LN	Flow Control:	Not Controlled
City:	Hobart, IN	Year Renewed:	
Location:	Other	Tape/Media #:	
Purpose:	Not Known	Dia/Height:	10"
Use:	Sanitary	Material:	VCP
Drain Area:	NA	Lining:	
Category:	NA		
Comment:

Location Details:		Direction of Survey:	Upstream
US MH:	M-904-016	DS MH:	M-904-015
		Total Length Surveyed (ft):	4.1

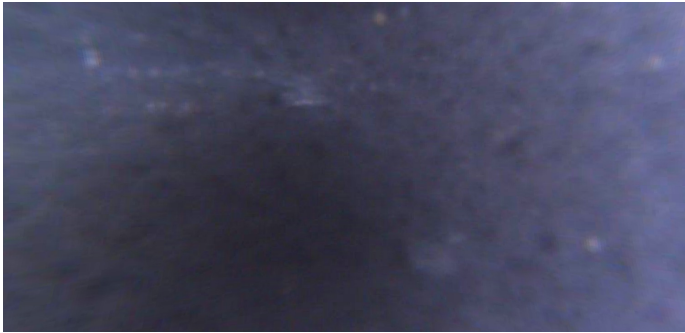
Code:	AMH
Description:	Manhole

Distance (ft):	.0
Structural Grade:	0
O&M Grade:	0
Clock Start/From:	
Clock To:	
1st Value:	
2nd Value:	
Value Percent:	
Continuous Index:	
Within 8" of Joint:	NO
Remarks:	M-904-015

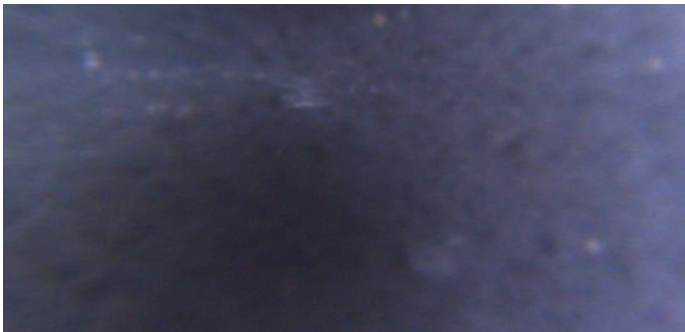
Code:	MWL
Description:	Water Level

Distance (ft):	.0
Structural Grade:	0
O&M Grade:	0
Clock Start/From:	
Clock To:	
1st Value:	
2nd Value:	
Value Percent:	5.000
Continuous Index:	
Within 8" of Joint:	NO
Remarks:

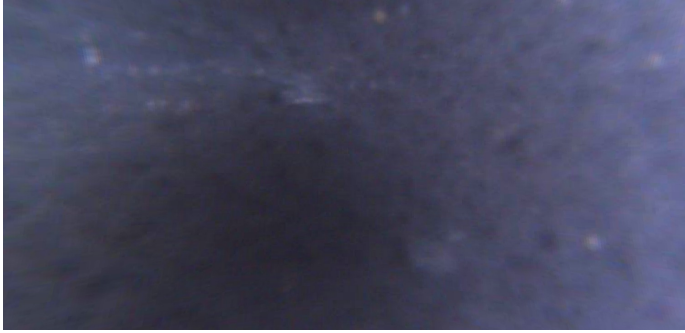
Code: **MWLS**
Description: **Water Level Sag**

Distance (ft): **.0**
Structural Grade: **2**
O&M Grade: **3**
Clock Start/From:
Clock To:
1st Value:
2nd Value:
Value Percent: **10.000**
Continuous Index: **S01**
Within 8" of Joint: **NO**
Remarks:

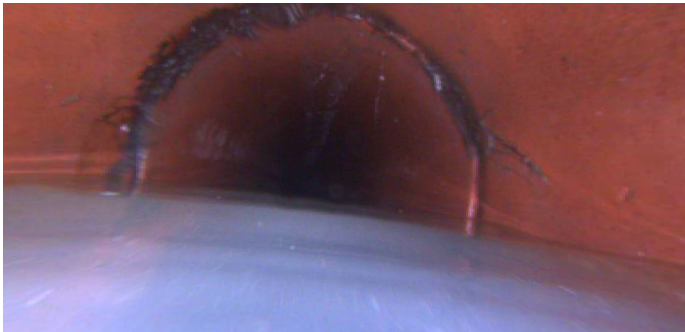
Code: **RFJ**
Description: **Roots Fine Joint**

Distance (ft): **4.1**
Structural Grade: **0**
O&M Grade: **1**
Clock Start/From: **8**
Clock To: **4**
1st Value:
2nd Value:
Value Percent:
Continuous Index:
Within 8" of Joint: **YES**
Remarks:

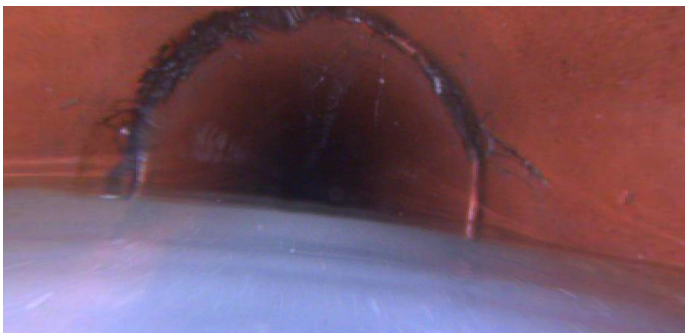
Code: **MWLS**
Description: **Water Level Sag**

Distance (ft): **4.1**
Structural Grade: **2**
O&M Grade: **3**
Clock Start/From:
Clock To:
1st Value:
2nd Value:
Value Percent: **10.000**
Continuous Index: **F01**
Within 8" of Joint: **NO**
Remarks:
