## Profile/Photo Observation Report

Street:	<b>FRASER LN</b>	Flow Control:	<b>Not Controlled</b>
City:	<b>Hobart, IN</b>	Year Renewed:	
Location:	<b>Other</b>	Tape/Media #:	
Purpose:	<b>Not Known</b>	Dia/Height:	<b>10"</b>
Use:	<b>Sanitary</b>	Material:	<b>VCP</b>
Drain Area:	<b>NA</b>	Lining:	
Category:	<b>NA</b>		
Comment:

Location Details:		Direction of Survey:	<b>Upstream</b>
US MH:	<b>M-904-017</b>	DS MH:	<b>M-904-018</b>
		Total Length Surveyed (ft):	<b>253.8</b>

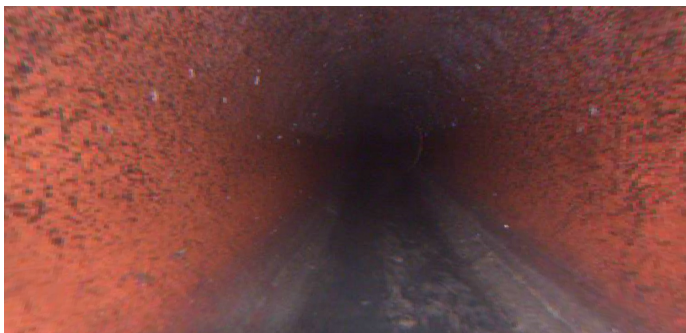
Code: **AMH**  
Description: **Manhole**

Distance (ft): **.0**  
Structural Grade: **0**  
O&M Grade: **0**  
Clock Start/From:  
Clock To:  
1st Value:  
2nd Value:  
Value Percent:  
Continuous Index:  
Within 8" of Joint: **NO**  
Remarks: **M-904-018**

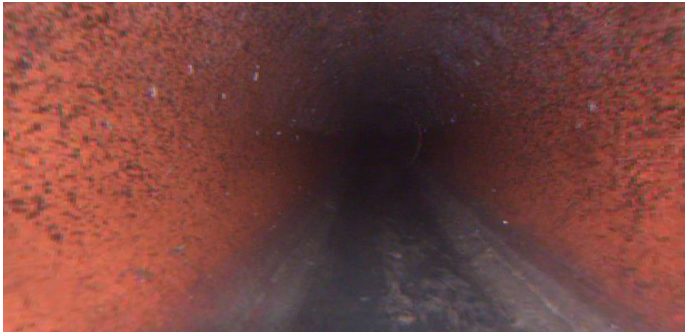
Code:	<b>MWL</b>
Description:	<b>Water Level</b>

Distance (ft):	<b>.0</b>
Structural Grade:	<b>0</b>
O&M Grade:	<b>0</b>
Clock Start/From:	
Clock To:	
1st Value:	
2nd Value:	
Value Percent:	<b>5.000</b>
Continuous Index:	
Within 8" of Joint:	<b>NO</b>
Remarks:	<b>M-904-017</b>

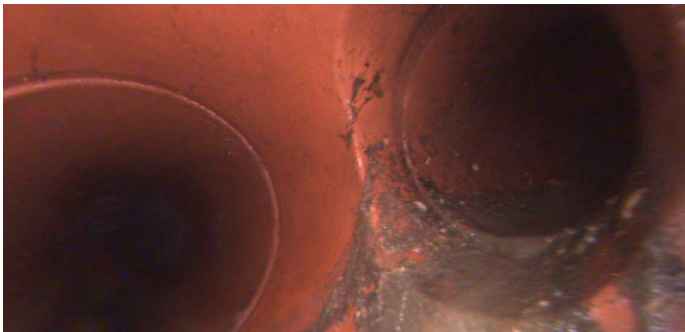
Code:	<b>TF</b>
Description:	<b>Tap Factory</b>

Distance (ft):	<b>24.6</b>
Structural Grade:	<b>0</b>
O&M Grade:	<b>0</b>
Clock Start/From:	<b>9</b>
Clock To:	
1st Value:	<b>4.000</b>
2nd Value:	
Value Percent:	
Continuous Index:	
Within 8" of Joint:	
Remarks:

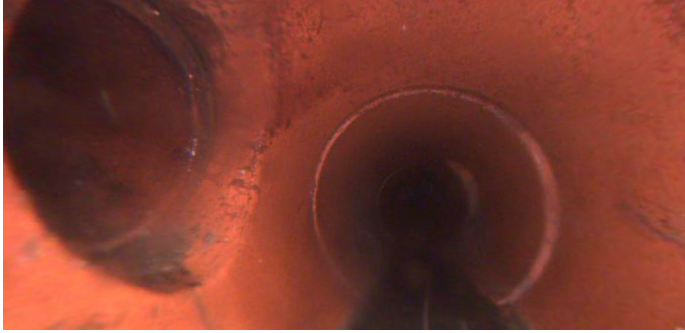
Code: **TF**  
Description: **Tap Factory**

Distance (ft): **26.7**  
Structural Grade: **0**  
O&M Grade: **0**  
Clock Start/From: **3**  
Clock To:  
1st Value: **4.000**  
2nd Value:  
Value Percent:  
Continuous Index:  
Within 8" of Joint:  
Remarks:

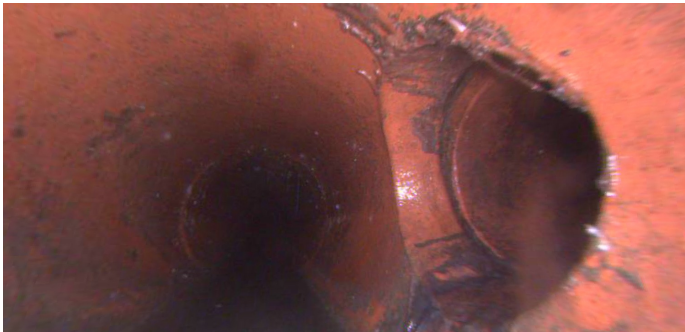
Code: **TFD**  
Description: **Tap Factory Defective**

Distance (ft): **72.7**  
Structural Grade: **0**  
O&M Grade: **2**  
Clock Start/From: **3**  
Clock To:  
1st Value: **4.000**  
2nd Value:  
Value Percent:  
Continuous Index:  
Within 8" of Joint:  
Remarks: **rfl**

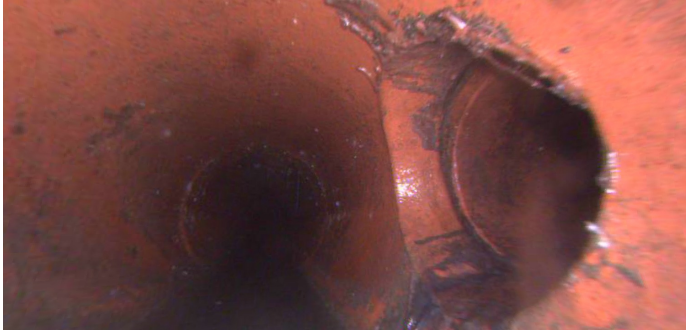
Code: **RFL**  
Description: **Roots Fine Lateral**

Distance (ft): **72.7**  
Structural Grade: **0**  
O&M Grade: **1**  
Clock Start/From: **2**  
Clock To: **4**  
1st Value:  
2nd Value:  
Value Percent:  
Continuous Index:  
Within 8" of Joint: **NO**  
Remarks:

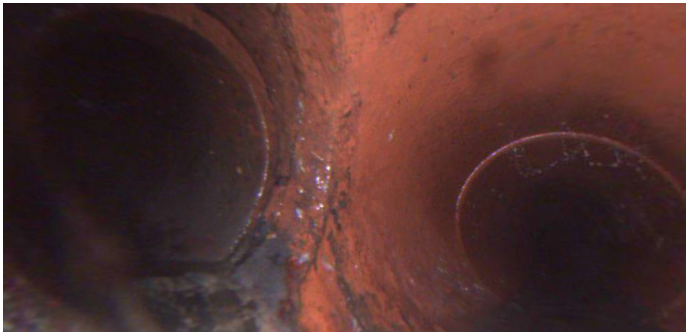
Code: **TFA**  
Description: **Tap Factory Active**

Distance (ft): **124.8**  
Structural Grade: **0**  
O&M Grade: **0**  
Clock Start/From: **9**  
Clock To:  
1st Value: **4.000**  
2nd Value:  
Value Percent:  
Continuous Index:  
Within 8" of Joint:  
Remarks:

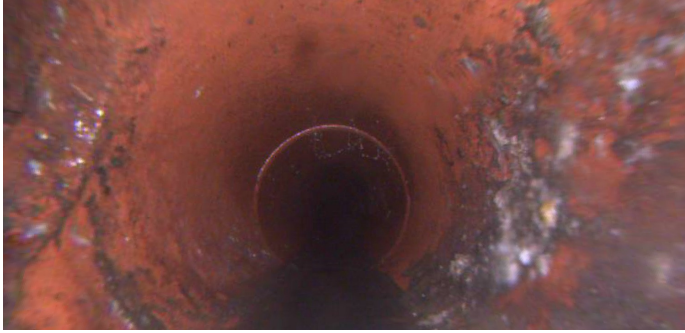
Code: **DAGS**  
Description: **Deposits Attached Grease**

Distance (ft): **124.8**  
Structural Grade: **0**  
O&M Grade: **2**  
Clock Start/From: **8**  
Clock To: **4**  
1st Value:  
2nd Value:  
Value Percent: **5.000**  
Continuous Index:  
Within 8" of Joint: **NO**  
Remarks:

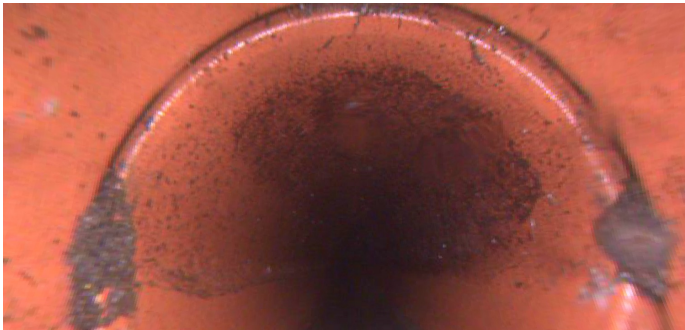
Code: **RFJ**  
Description: **Roots Fine Joint**

Distance (ft): **135.7**  
Structural Grade: **0**  
O&M Grade: **1**  
Clock Start/From: **9**  
Clock To: **3**  
1st Value:  
2nd Value:  
Value Percent:  
Continuous Index:  
Within 8" of Joint: **YES**  
Remarks:

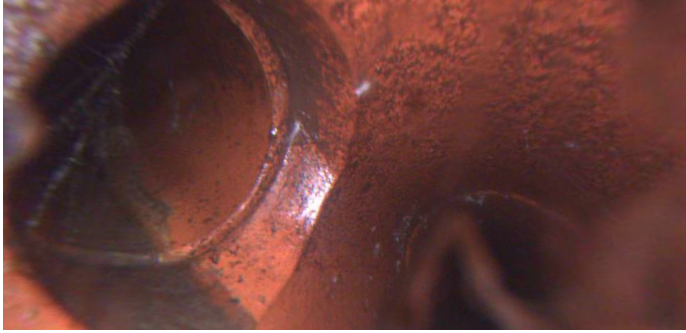
Code: **TFA**  
Description: **Tap Factory Active**

Distance (ft): **231.1**  
Structural Grade: **0**  
O&M Grade: **0**  
Clock Start/From: **10**  
Clock To:  
1st Value: **4.000**  
2nd Value:  
Value Percent:  
Continuous Index:  
Within 8" of Joint:  
Remarks:

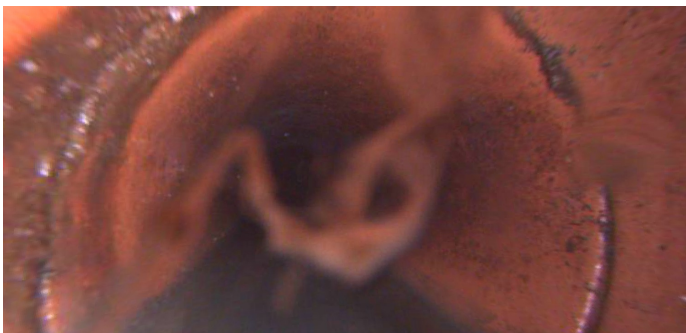
Code: **IW**  
Description: **Infil Weeper**

Distance (ft): **247.2**  
Structural Grade: **0**  
O&M Grade: **2**  
Clock Start/From: **8**  
Clock To: **11**  
1st Value:  
2nd Value:  
Value Percent:  
Continuous Index:  
Within 8" of Joint: **YES**  
Remarks:

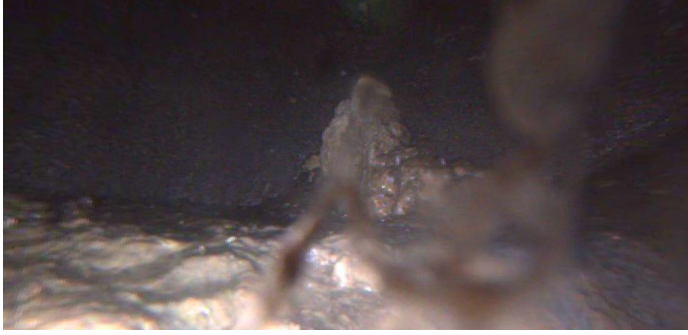
Code:	AMH
Description:	Manhole
Distance (ft):	253.8
Structural Grade:	0
O&M Grade:	0
Clock Start/From:	
Clock To:	
1st Value:	
2nd Value:	
Value Percent:	
Continuous Index:	
Within 8" of Joint:	NO
Remarks:	M-904-017
