Profile/Photo Observation Report

Date:	04/16/2018	Weather:		Coding:	PACP 6.0
Pipe Length (ft):	259.8	Owner:	NA	Pre Clean:	Not Known
P.O.#:		Surveyor:	Selasie Honu	PSR:	P-904-018-017
Customer:		Clean Date:	01/01/1900	Shape:	C

Street:	Fraser Ln.	Flow Control:	Not Controlled
City:	Hobart, IN	Year Renewed:	
Location:	Other	Tape/Media #:	
Purpose:	Not Known	Dia/Height:	10"
Use:	Sanitary	Material:	VCP
Drain Area:	NA	Lining:	
Category:	NA		
Comment:

Location Details:		Direction of Survey:	Upstream
US MH:	M-904-017	DS MH:	M-904-018
		Total Length Surveyed (ft):	253.8

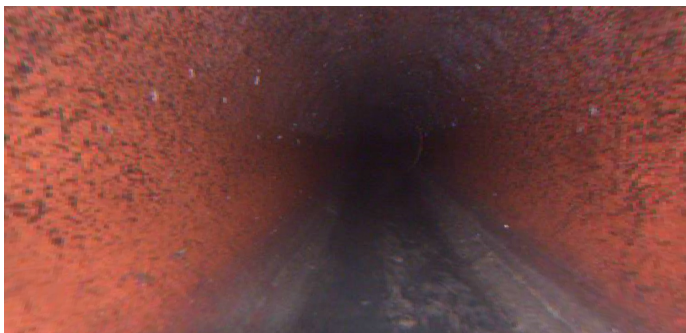
Code: **AMH**
Description: **Manhole**

Distance (ft): **.0**
Structural Grade: **0**
O&M Grade: **0**
Clock Start/From:
Clock To:
1st Value:
2nd Value:
Value Percent:
Continuous Index:
Within 8" of Joint: **NO**
Remarks: **M-904-018**

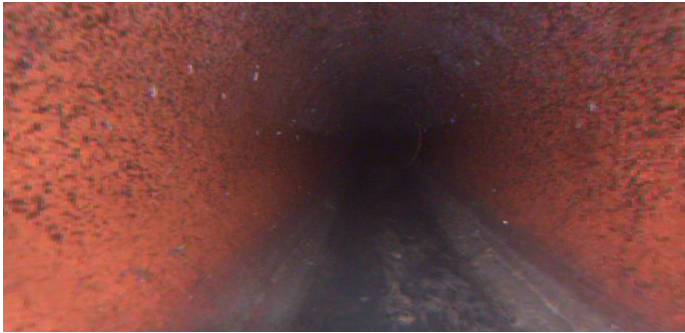
Code:	MWL
Description:	Water Level

Distance (ft):	.0
Structural Grade:	0
O&M Grade:	0
Clock Start/From:	
Clock To:	
1st Value:	
2nd Value:	
Value Percent:	5.000
Continuous Index:	
Within 8" of Joint:	NO
Remarks:	M-904-017

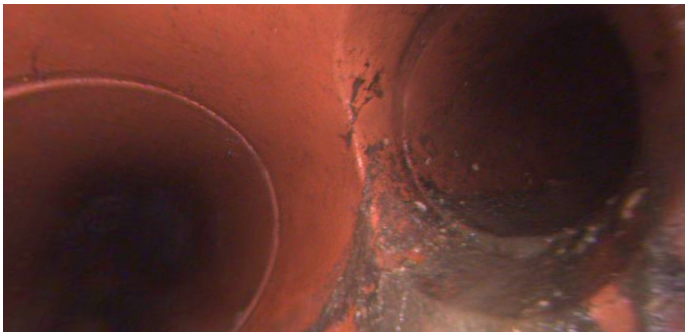
Code:	TF
Description:	Tap Factory

Distance (ft):	24.6
Structural Grade:	0
O&M Grade:	0
Clock Start/From:	9
Clock To:	
1st Value:	4.000
2nd Value:	
Value Percent:	
Continuous Index:	
Within 8" of Joint:	
Remarks:

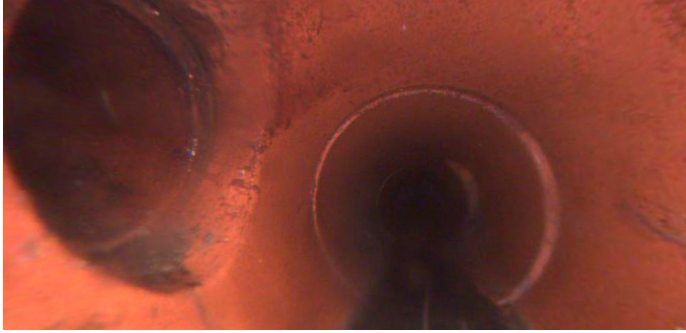
Code: **TF**
Description: **Tap Factory**

Distance (ft): **26.7**
Structural Grade: **0**
O&M Grade: **0**
Clock Start/From: **3**
Clock To:
1st Value: **4.000**
2nd Value:
Value Percent:
Continuous Index:
Within 8" of Joint:
Remarks:

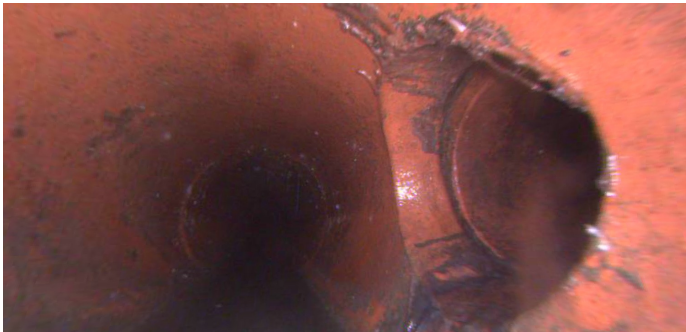
Code: **TFD**
Description: **Tap Factory Defective**

Distance (ft): **72.7**
Structural Grade: **0**
O&M Grade: **2**
Clock Start/From: **3**
Clock To:
1st Value: **4.000**
2nd Value:
Value Percent:
Continuous Index:
Within 8" of Joint:
Remarks: **rfl**

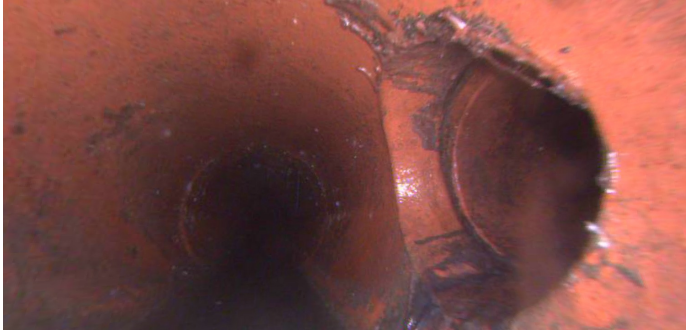
Code: **RFL**
Description: **Roots Fine Lateral**

Distance (ft): **72.7**
Structural Grade: **0**
O&M Grade: **1**
Clock Start/From: **2**
Clock To: **4**
1st Value:
2nd Value:
Value Percent:
Continuous Index:
Within 8" of Joint: **NO**
Remarks:

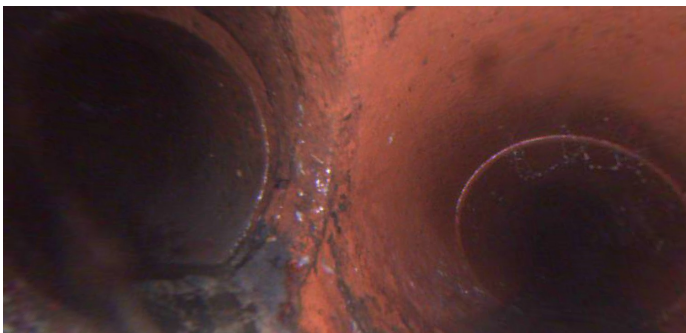
Code: **TFA**
Description: **Tap Factory Active**

Distance (ft): **124.8**
Structural Grade: **0**
O&M Grade: **0**
Clock Start/From: **9**
Clock To:
1st Value: **4.000**
2nd Value:
Value Percent:
Continuous Index:
Within 8" of Joint:
Remarks:

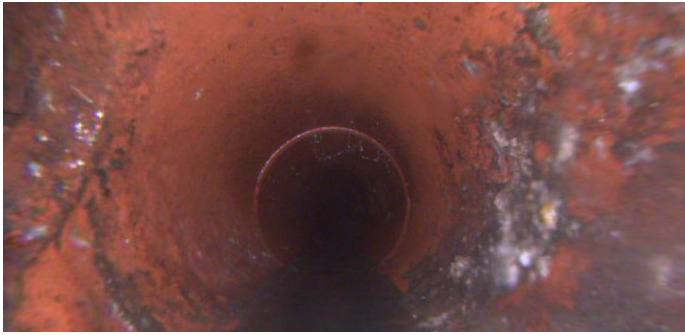
Code: **DAGS**
Description: **Deposits Attached Grease**

Distance (ft): **124.8**
Structural Grade: **0**
O&M Grade: **2**
Clock Start/From: **8**
Clock To: **4**
1st Value:
2nd Value:
Value Percent: **5.000**
Continuous Index:
Within 8" of Joint: **NO**
Remarks:

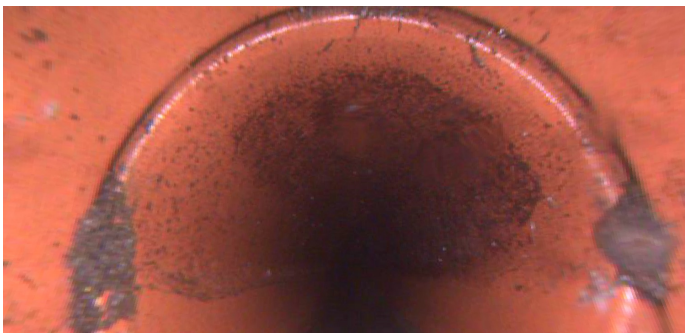
Code: **RFJ**
Description: **Roots Fine Joint**

Distance (ft): **135.7**
Structural Grade: **0**
O&M Grade: **1**
Clock Start/From: **9**
Clock To: **3**
1st Value:
2nd Value:
Value Percent:
Continuous Index:
Within 8" of Joint: **YES**
Remarks:

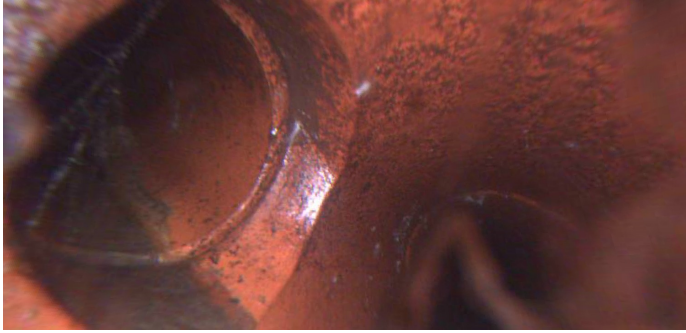
Code: **TFA**
Description: **Tap Factory Active**

Distance (ft): **231.1**
Structural Grade: **0**
O&M Grade: **0**
Clock Start/From: **10**
Clock To:
1st Value: **4.000**
2nd Value:
Value Percent:
Continuous Index:
Within 8" of Joint:
Remarks:

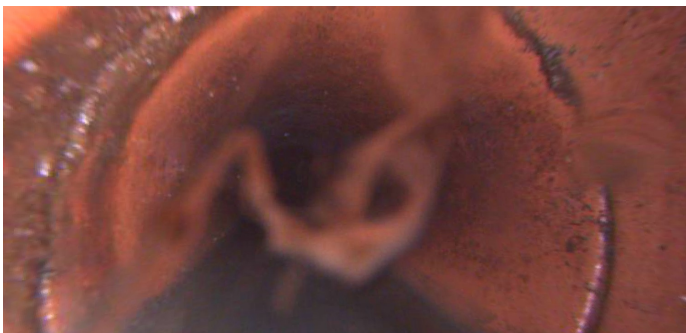
Code: **IW**
Description: **Infil Weeper**

Distance (ft): **247.2**
Structural Grade: **0**
O&M Grade: **2**
Clock Start/From: **8**
Clock To: **11**
1st Value:
2nd Value:
Value Percent:
Continuous Index:
Within 8" of Joint: **YES**
Remarks:

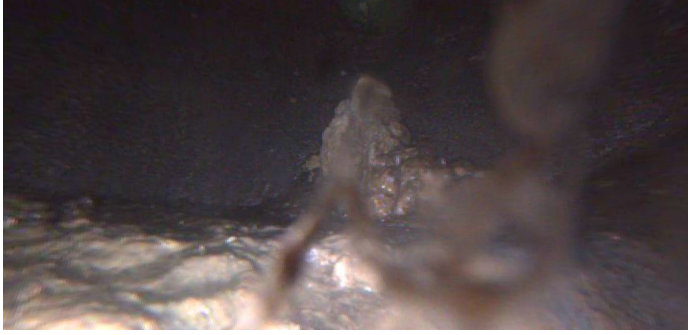
Code:	AMH
Description:	Manhole
Distance (ft):	253.8
Structural Grade:	0
O&M Grade:	0
Clock Start/From:	
Clock To:	
1st Value:	
2nd Value:	
Value Percent:	
Continuous Index:	
Within 8" of Joint:	NO
Remarks:	M-904-017
