## Profile/Photo Observation Report

Street:	<b>FRASER LN</b>	Flow Control:	<b>Not Controlled</b>
City:	<b>Hobart, IN</b>	Year Renewed:	
Location:	<b>Other</b>	Tape/Media #:	
Purpose:	<b>Not Known</b>	Dia/Height:	<b>10"</b>
Use:	<b>Sanitary</b>	Material:	<b>VCP</b>
Drain Area:	<b>NA</b>	Lining:	
Category:	<b>NA</b>		
Comment:

Location Details:		Direction of Survey:	<b>Upstream</b>
US MH:	<b>M-904-018</b>	DS MH:	<b>M-904-019</b>
		Total Length Surveyed (ft):	<b>224.6</b>

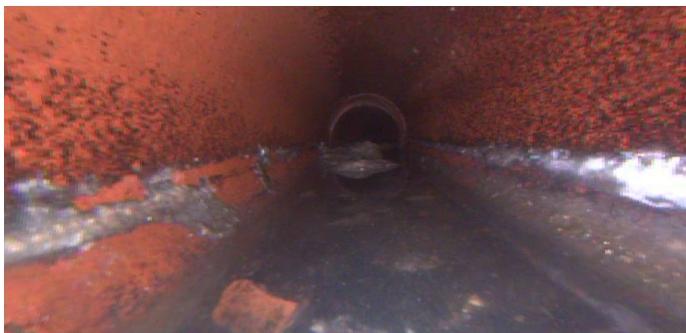
Code: **AMH**  
Description: **Manhole**

Distance (ft): **.0**  
Structural Grade: **0**  
O&M Grade: **0**  
Clock Start/From:  
Clock To:  
1st Value:  
2nd Value:  
Value Percent:  
Continuous Index:  
Within 8" of Joint: **NO**  
Remarks: **M-904-019**

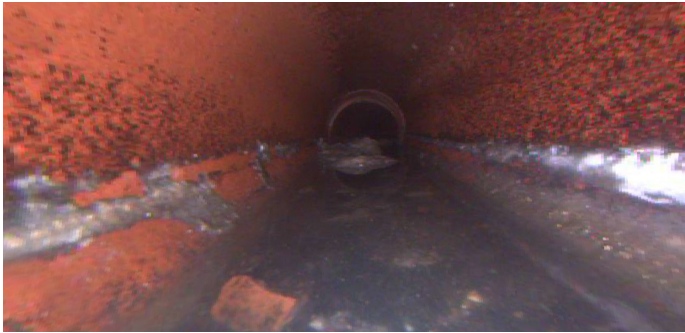
Code:	<b>MWL</b>
Description:	<b>Water Level</b>

Distance (ft):	<b>.0</b>
Structural Grade:	<b>0</b>
O&M Grade:	<b>0</b>
Clock Start/From:	
Clock To:	
1st Value:	
2nd Value:	
Value Percent:	<b>5.000</b>
Continuous Index:	
Within 8" of Joint:	<b>NO</b>
Remarks:

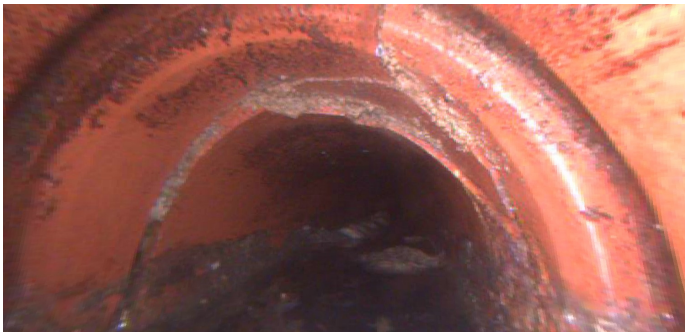
Code:	<b>FM</b>
Description:	<b>Fracture Multiple</b>

Distance (ft):	<b>3.6</b>
Structural Grade:	<b>4</b>
O&M Grade:	<b>0</b>
Clock Start/From:	<b>7</b>
Clock To:	<b>5</b>
1st Value:	
2nd Value:	
Value Percent:	
Continuous Index:	
Within 8" of Joint:	<b>YES</b>
Remarks:

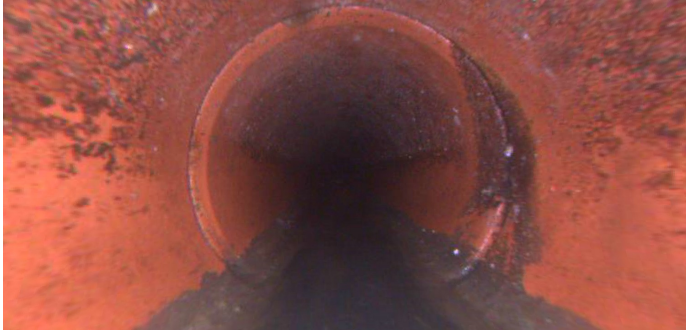
Code: **IW**  
Description: **Infil Weeper**

Distance (ft): **92.7**  
Structural Grade: **0**  
O&M Grade: **2**  
Clock Start/From: **1**  
Clock To: **4**  
1st Value:  
2nd Value:  
Value Percent:  
Continuous Index:  
Within 8" of Joint: **YES**  
Remarks:

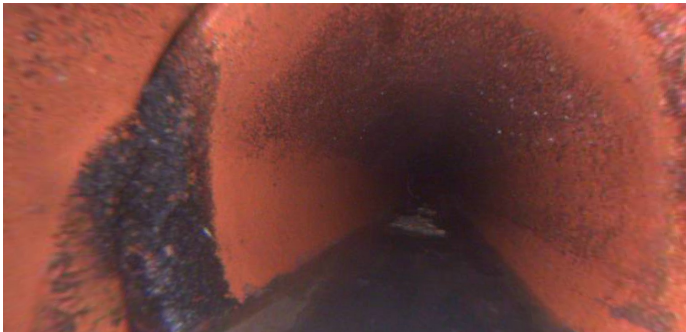
Code: **IW**  
Description: **Infil Weeper**

Distance (ft): **98.0**  
Structural Grade: **0**  
O&M Grade: **2**  
Clock Start/From: **8**  
Clock To: **11**  
1st Value:  
2nd Value:  
Value Percent:  
Continuous Index:  
Within 8" of Joint: **YES**  
Remarks:

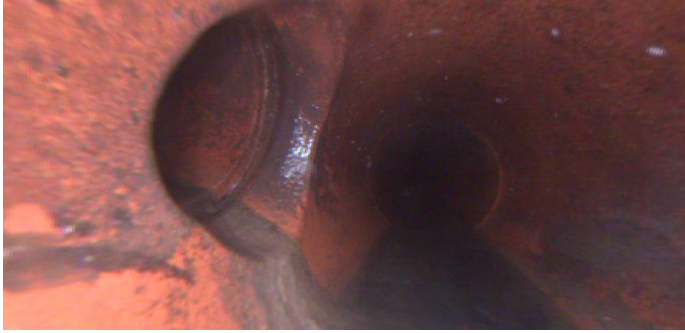
Code: **TF**  
Description: **Tap Factory**

Distance (ft): **103.5**  
Structural Grade: **0**  
O&M Grade: **0**  
Clock Start/From: **9**  
Clock To:  
1st Value: **4.000**  
2nd Value:  
Value Percent:  
Continuous Index:  
Within 8" of Joint:  
Remarks:

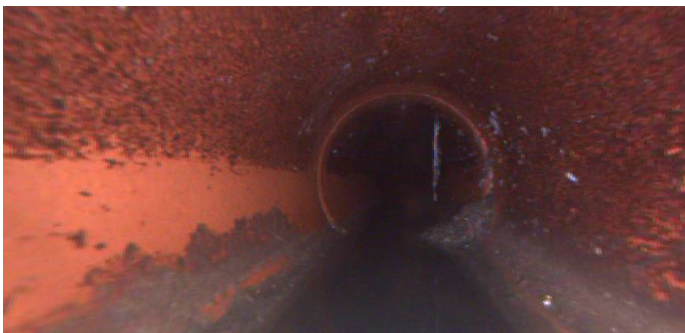
Code: **DNF**  
Description: **Deposits Ingressed Fine**

Distance (ft): **185.7**  
Structural Grade: **0**  
O&M Grade: **2**  
Clock Start/From: **3**  
Clock To: **6**  
1st Value:  
2nd Value:  
Value Percent: **10.000**  
Continuous Index:  
Within 8" of Joint: **YES**  
Remarks:

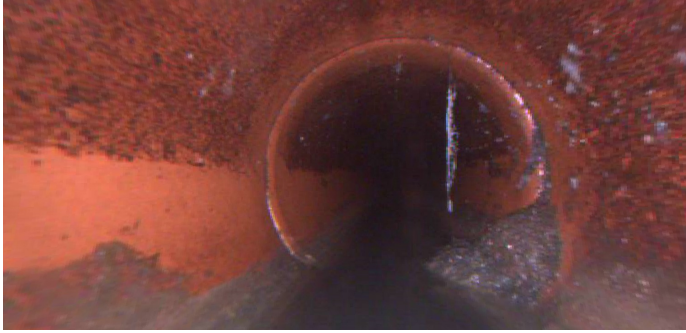
Code: **RFJ**  
Description: **Roots Fine Joint**

Distance (ft): **186.2**  
Structural Grade: **0**  
O&M Grade: **1**  
Clock Start/From: **1**  
Clock To:  
1st Value:  
2nd Value:  
Value Percent:  
Continuous Index:  
Within 8" of Joint: **YES**  
Remarks:

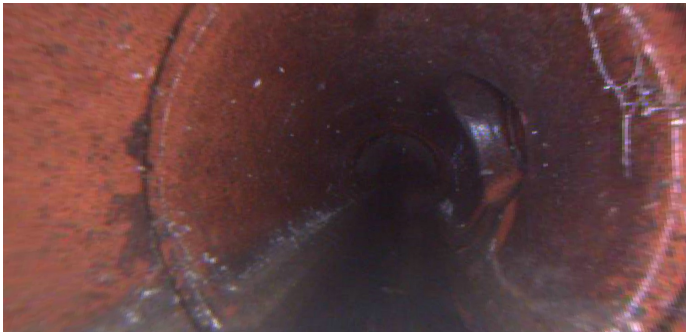
Code: **TF**  
Description: **Tap Factory**

Distance (ft): **216.5**  
Structural Grade: **0**  
O&M Grade: **0**  
Clock Start/From: **3**  
Clock To:  
1st Value: **4.000**  
2nd Value:  
Value Percent:  
Continuous Index:  
Within 8" of Joint:  
Remarks:

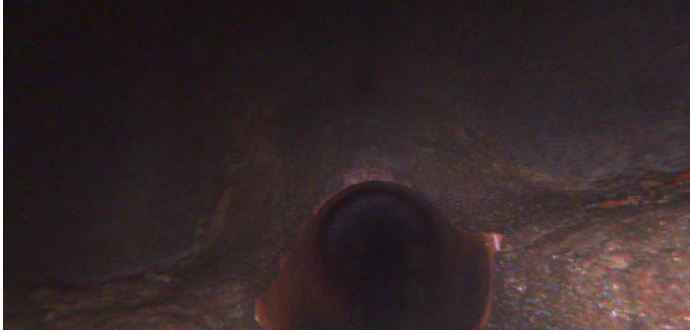
Code:	AMH
Description:	Manhole
Distance (ft):	224.6
Structural Grade:	0
O&M Grade:	0
Clock Start/From:	
Clock To:	
1st Value:	
2nd Value:	
Value Percent:	
Continuous Index:	
Within 8" of Joint:	NO
Remarks:	M-904-018
