Profile/Photo Observation Report

Date:	04/16/2018	Weather:		Coding:	PACP 6.0
Pipe Length (ft):	227.5	Owner:	NA	Pre Clean:	Not Known
P.O.#:		Surveyor:	Selasie Honu	PSR:	P-904-019-018
Customer:		Clean Date:	01/01/1900	Shape:	C

Street:	Fraser Ln.	Flow Control:	Not Controlled
City:	Hobart, IN	Year Renewed:	
Location:	Other	Tape/Media #:	
Purpose:	Not Known	Dia/Height:	10"
Use:	Sanitary	Material:	VCP
Drain Area:	NA	Lining:	
Category:	NA		
Comment:

Location Details:		Direction of Survey:	Upstream
US MH:	M-904-018	DS MH:	M-904-019
		Total Length Surveyed (ft):	224.6

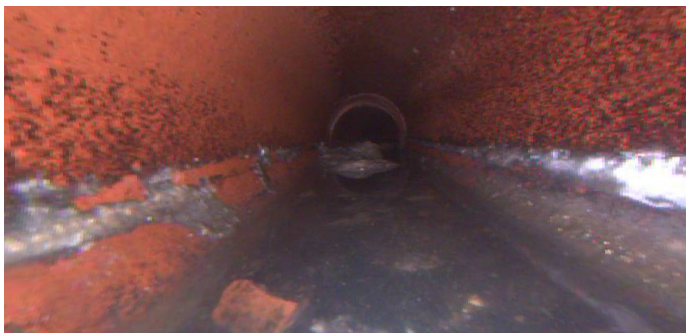
Code: **AMH**
Description: **Manhole**

Distance (ft): **.0**
Structural Grade: **0**
O&M Grade: **0**
Clock Start/From:
Clock To:
1st Value:
2nd Value:
Value Percent:
Continuous Index:
Within 8" of Joint: **NO**
Remarks: **M-904-019**

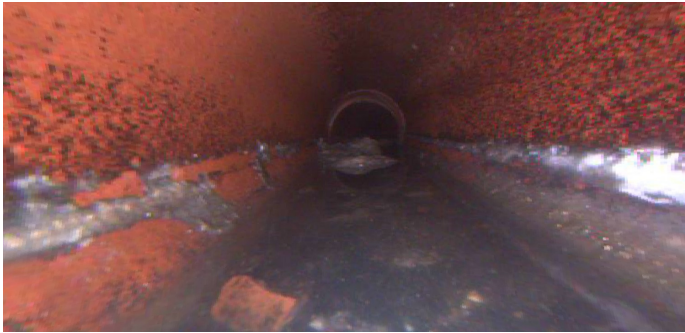
Code:	MWL
Description:	Water Level

Distance (ft):	.0
Structural Grade:	0
O&M Grade:	0
Clock Start/From:	
Clock To:	
1st Value:	
2nd Value:	
Value Percent:	5.000
Continuous Index:	
Within 8" of Joint:	NO
Remarks:

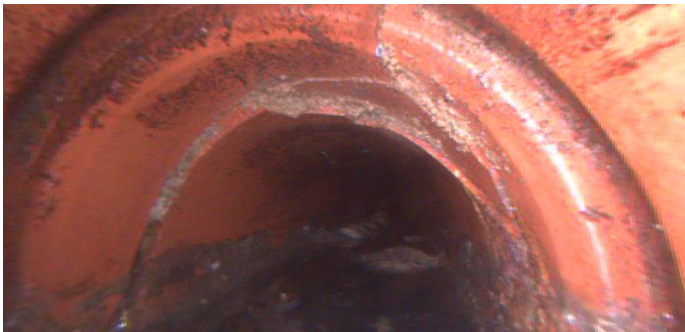
Code:	FM
Description:	Fracture Multiple

Distance (ft):	3.6
Structural Grade:	4
O&M Grade:	0
Clock Start/From:	7
Clock To:	5
1st Value:	
2nd Value:	
Value Percent:	
Continuous Index:	
Within 8" of Joint:	YES
Remarks:

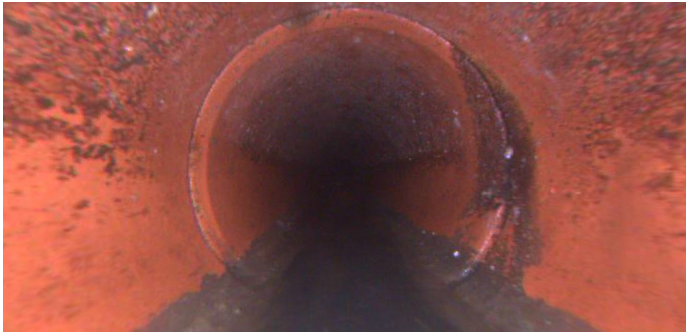
Code: **IW**
Description: **Infil Weeper**

Distance (ft): **92.7**
Structural Grade: **0**
O&M Grade: **2**
Clock Start/From: **1**
Clock To: **4**
1st Value:
2nd Value:
Value Percent:
Continuous Index:
Within 8" of Joint: **YES**
Remarks:

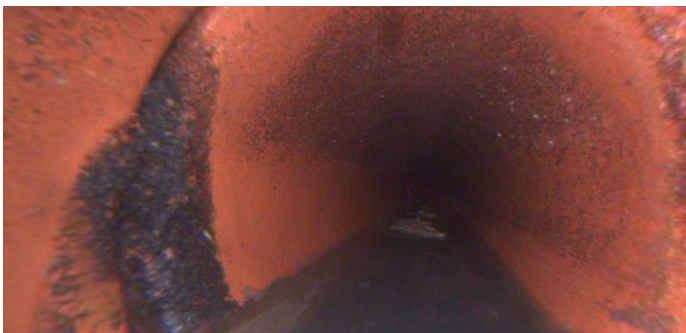
Code: **IW**
Description: **Infil Weeper**

Distance (ft): **98.0**
Structural Grade: **0**
O&M Grade: **2**
Clock Start/From: **8**
Clock To: **11**
1st Value:
2nd Value:
Value Percent:
Continuous Index:
Within 8" of Joint: **YES**
Remarks:

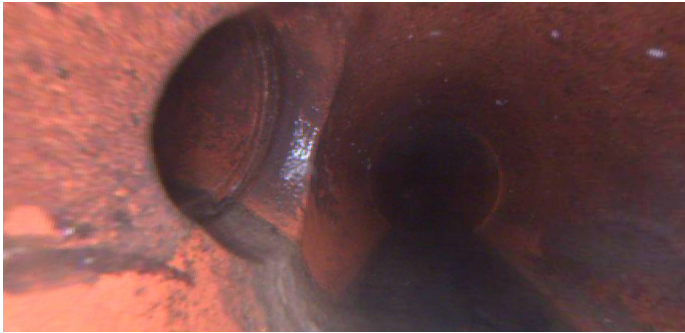
Code: **TF**
Description: **Tap Factory**

Distance (ft): **103.5**
Structural Grade: **0**
O&M Grade: **0**
Clock Start/From: **9**
Clock To:
1st Value: **4.000**
2nd Value:
Value Percent:
Continuous Index:
Within 8" of Joint:
Remarks:

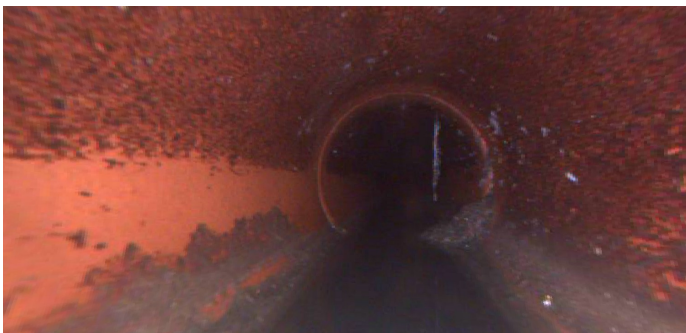
Code: **DNF**
Description: **Deposits Ingressed Fine**

Distance (ft): **185.7**
Structural Grade: **0**
O&M Grade: **2**
Clock Start/From: **3**
Clock To: **6**
1st Value:
2nd Value:
Value Percent: **10.000**
Continuous Index:
Within 8" of Joint: **YES**
Remarks:

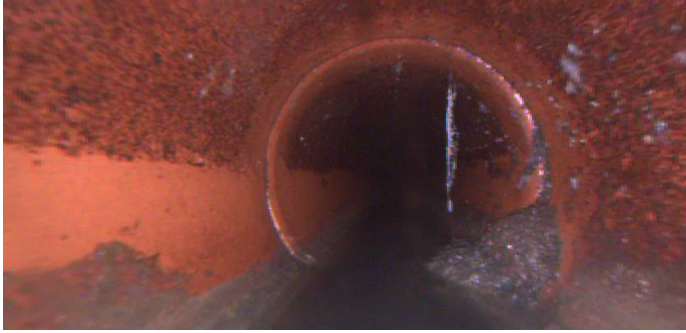
Code: **RFJ**
Description: **Roots Fine Joint**

Distance (ft): **186.2**
Structural Grade: **0**
O&M Grade: **1**
Clock Start/From: **1**
Clock To:
1st Value:
2nd Value:
Value Percent:
Continuous Index:
Within 8" of Joint: **YES**
Remarks:

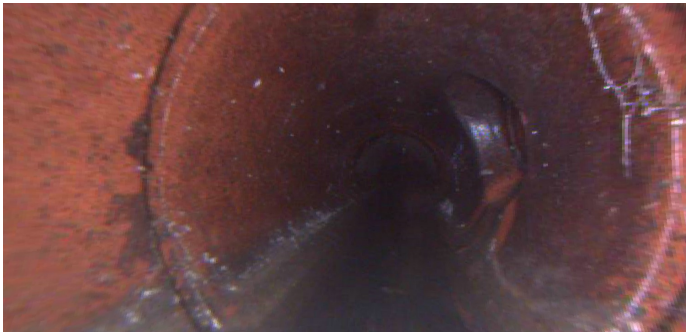
Code: **TF**
Description: **Tap Factory**

Distance (ft): **216.5**
Structural Grade: **0**
O&M Grade: **0**
Clock Start/From: **3**
Clock To:
1st Value: **4.000**
2nd Value:
Value Percent:
Continuous Index:
Within 8" of Joint:
Remarks:

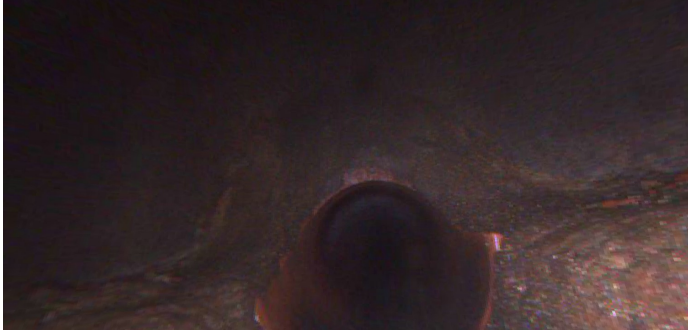
Code:	AMH
Description:	Manhole
Distance (ft):	224.6
Structural Grade:	0
O&M Grade:	0
Clock Start/From:	
Clock To:	
1st Value:	
2nd Value:	
Value Percent:	
Continuous Index:	
Within 8" of Joint:	NO
Remarks:	M-904-018
