Profile/Photo Observation Report

Street:	FRASER LN	Flow Control:	Not Controlled
City:	Hobart, IN	Year Renewed:	
Location:	Other	Tape/Media #:	
Purpose:	Not Known	Dia/Height:	10"
Use:	Sanitary	Material:	VCP
Drain Area:	NA	Lining:	
Category:	NA		
Comment:

Location Details:		Direction of Survey:	Upstream
US MH:	M-904-019	DS MH:	M-904-020
		Total Length Surveyed (ft):	150.0

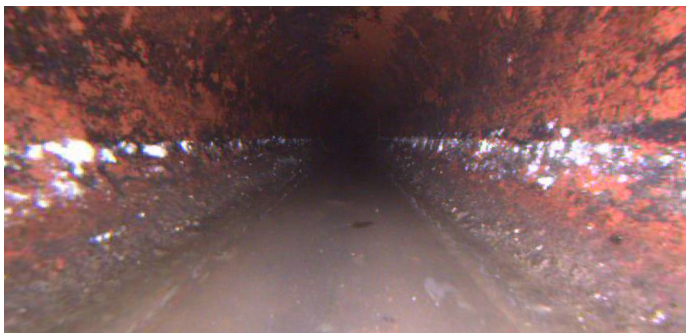
Code: **DAGS**
Description: **Deposits Attached Grease**

Distance (ft): **.0**
Structural Grade: **0**
O&M Grade: **2**
Clock Start/From: **8**
Clock To: **4**
1st Value:
2nd Value:
Value Percent: **5.000**
Continuous Index: **S01**
Within 8" of Joint: **NO**
Remarks:

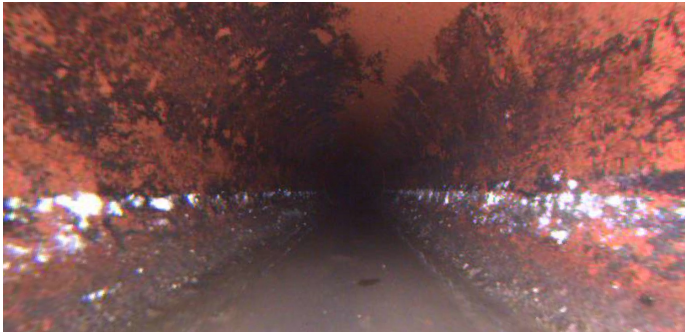
Code:	AMH
Description:	Manhole

Distance (ft):	.0
Structural Grade:	0
O&M Grade:	0
Clock Start/From:	
Clock To:	
1st Value:	
2nd Value:	
Value Percent:	
Continuous Index:	
Within 8" of Joint:	NO
Remarks:	M-904-020

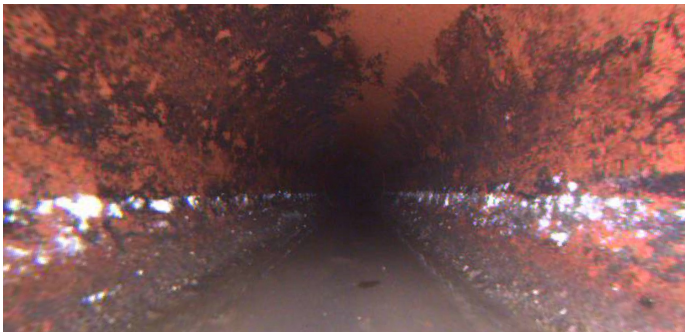
Code:	MWL
Description:	Water Level

Distance (ft):	.0
Structural Grade:	0
O&M Grade:	0
Clock Start/From:	
Clock To:	
1st Value:	
2nd Value:	
Value Percent:	10.000
Continuous Index:	
Within 8" of Joint:	NO
Remarks:

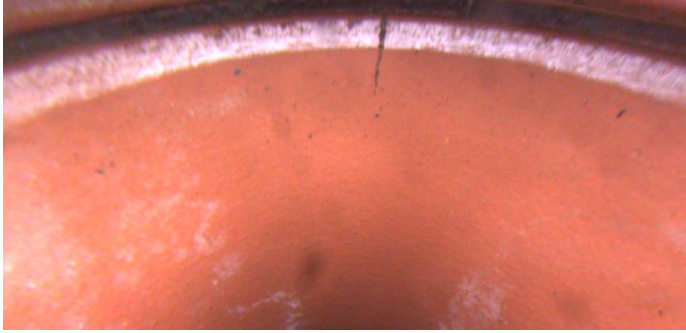
Code: **CL**
Description: **Crack Longitudinal**

Distance (ft): **29.2**
Structural Grade: **2**
O&M Grade: **0**
Clock Start/From: **12**
Clock To:
1st Value:
2nd Value:
Value Percent:
Continuous Index:
Within 8" of Joint: **YES**
Remarks:

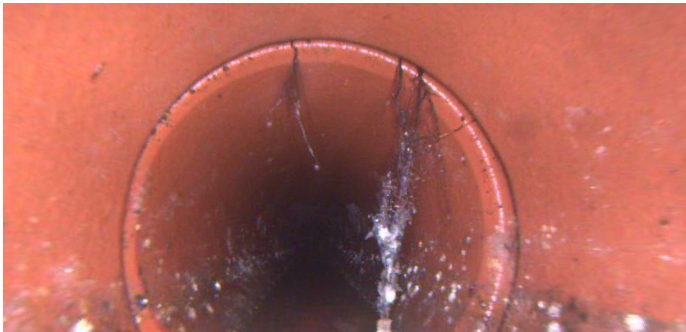
Code: **RFJ**
Description: **Roots Fine Joint**

Distance (ft): **43.7**
Structural Grade: **0**
O&M Grade: **1**
Clock Start/From: **12**
Clock To: **2**
1st Value:
2nd Value:
Value Percent:
Continuous Index:
Within 8" of Joint: **YES**
Remarks:

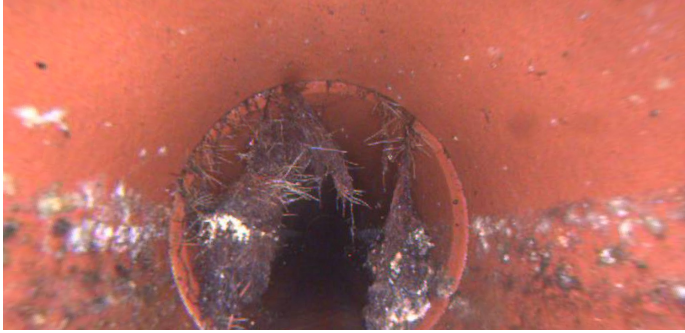
Code: **RMJ**
Description: **Roots Medium Joint**

Distance (ft): **53.4**
Structural Grade: **0**
O&M Grade: **3**
Clock Start/From: **7**
Clock To: **5**
1st Value:
2nd Value:
Value Percent: **10.000**
Continuous Index:
Within 8" of Joint: **YES**
Remarks:

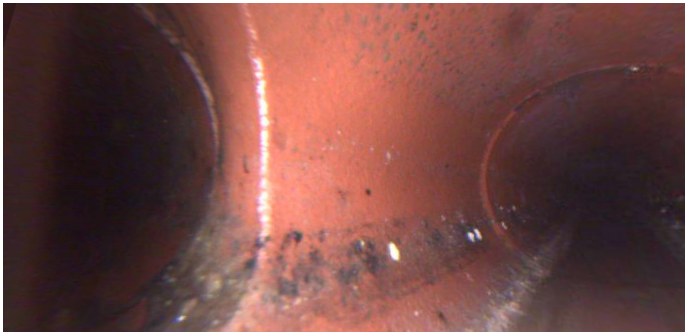
Code: **TF**
Description: **Tap Factory**

Distance (ft): **59.8**
Structural Grade: **0**
O&M Grade: **0**
Clock Start/From: **8**
Clock To:
1st Value: **4.000**
2nd Value:
Value Percent:
Continuous Index:
Within 8" of Joint:
Remarks:

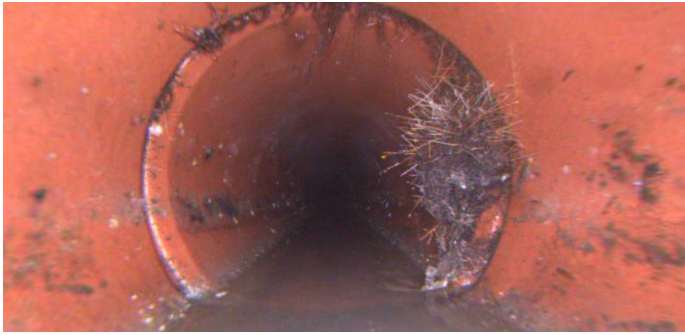
Code: **RFJ**
Description: **Roots Fine Joint**

Distance (ft): **70.5**
Structural Grade: **0**
O&M Grade: **1**
Clock Start/From: **10**
Clock To: **5**
1st Value:
2nd Value:
Value Percent:
Continuous Index:
Within 8" of Joint: **YES**
Remarks:

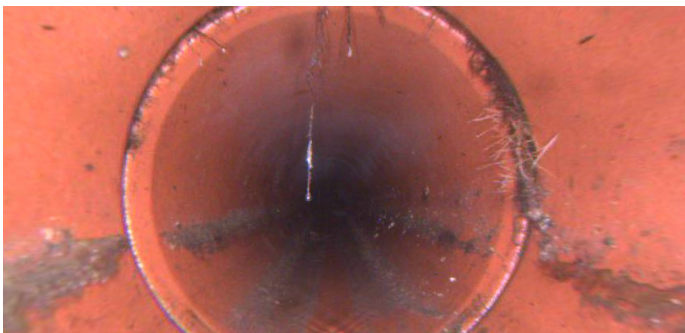
Code: **RFJ**
Description: **Roots Fine Joint**

Distance (ft): **75.5**
Structural Grade: **0**
O&M Grade: **1**
Clock Start/From: **10**
Clock To: **4**
1st Value:
2nd Value:
Value Percent:
Continuous Index:
Within 8" of Joint: **YES**
Remarks:

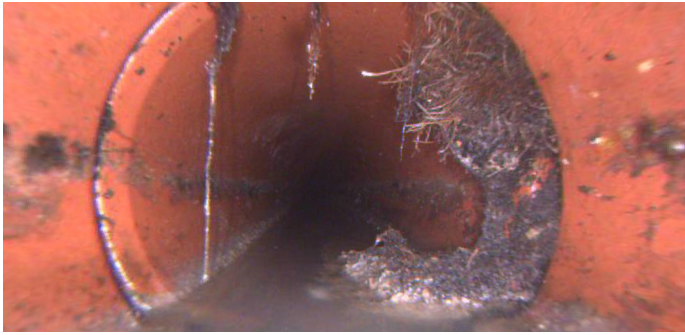
Code: **RMJ**
Description: **Roots Medium Joint**

Distance (ft): **80.5**
Structural Grade: **0**
O&M Grade: **3**
Clock Start/From: **10**
Clock To: **5**
1st Value:
2nd Value:
Value Percent: **10.000**
Continuous Index:
Within 8" of Joint: **YES**
Remarks:

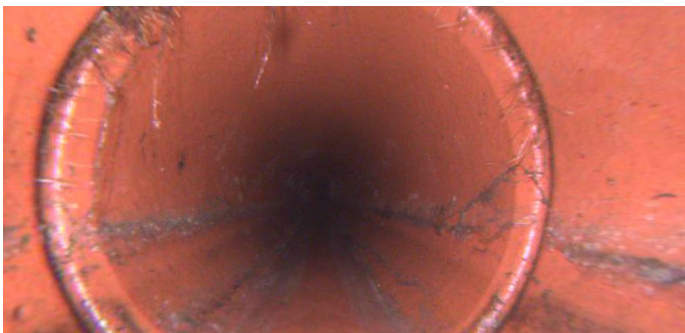
Code: **RFJ**
Description: **Roots Fine Joint**

Distance (ft): **90.6**
Structural Grade: **0**
O&M Grade: **1**
Clock Start/From: **7**
Clock To: **5**
1st Value:
2nd Value:
Value Percent:
Continuous Index:
Within 8" of Joint: **YES**
Remarks:

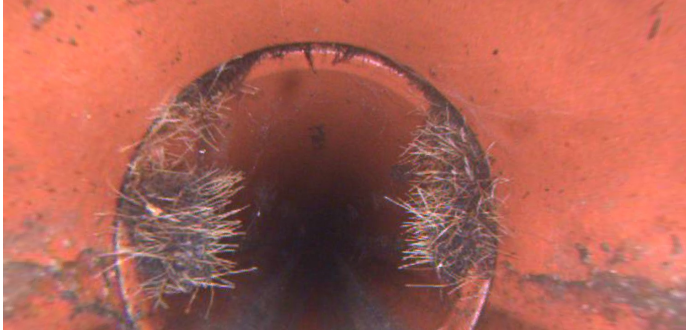
Code: **RMJ**
Description: **Roots Medium Joint**

Distance (ft): **95.4**
Structural Grade: **0**
O&M Grade: **3**
Clock Start/From: **8**
Clock To: **4**
1st Value:
2nd Value:
Value Percent: **10.000**
Continuous Index:
Within 8" of Joint: **YES**
Remarks:

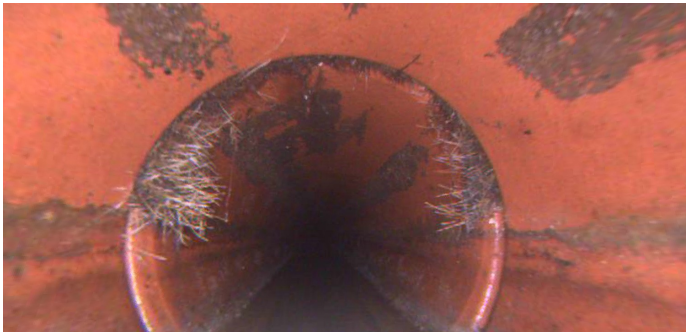
Code: **RFJ**
Description: **Roots Fine Joint**

Distance (ft): **100.4**
Structural Grade: **0**
O&M Grade: **1**
Clock Start/From: **9**
Clock To: **4**
1st Value:
2nd Value:
Value Percent:
Continuous Index:
Within 8" of Joint: **YES**
Remarks:

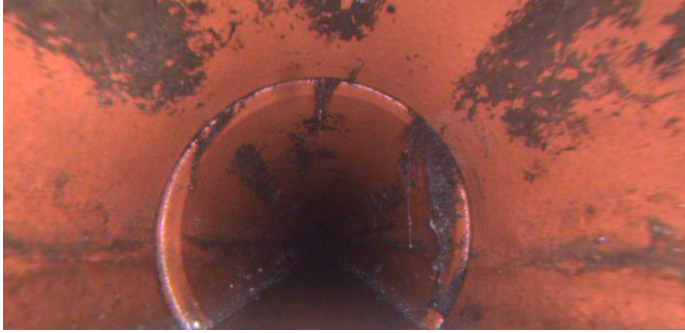
Code: **RFJ**
Description: **Roots Fine Joint**

Distance (ft): **115.2**
Structural Grade: **0**
O&M Grade: **1**
Clock Start/From: **10**
Clock To: **5**
1st Value:
2nd Value:
Value Percent:
Continuous Index:
Within 8" of Joint: **YES**
Remarks:

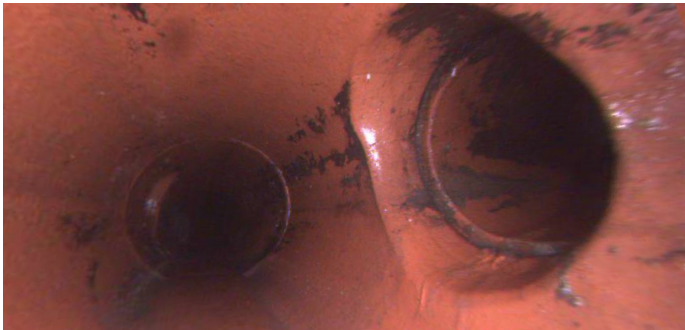
Code: **TF**
Description: **Tap Factory**

Distance (ft): **136.3**
Structural Grade: **0**
O&M Grade: **0**
Clock Start/From: **3**
Clock To:
1st Value: **4.000**
2nd Value:
Value Percent:
Continuous Index:
Within 8" of Joint:
Remarks:

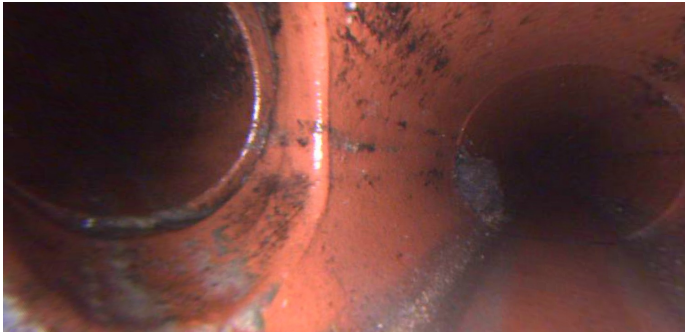
Code: **TF**
Description: **Tap Factory**

Distance (ft): **138.5**
Structural Grade: **0**
O&M Grade: **0**
Clock Start/From: **9**
Clock To:
1st Value: **4.000**
2nd Value:
Value Percent:
Continuous Index:
Within 8" of Joint:
Remarks:

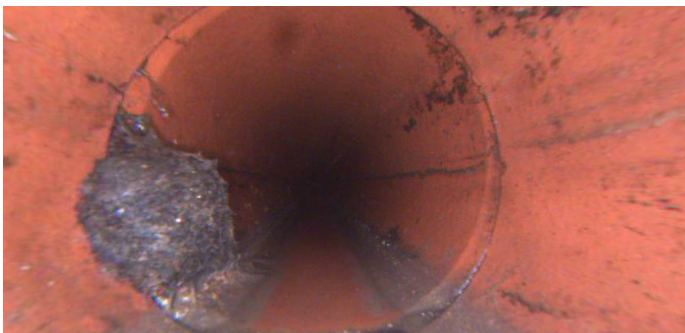
Code: **RMJ**
Description: **Roots Medium Joint**

Distance (ft): **139.3**
Structural Grade: **0**
O&M Grade: **3**
Clock Start/From: **7**
Clock To: **9**
1st Value:
2nd Value:
Value Percent: **10.000**
Continuous Index:
Within 8" of Joint: **YES**
Remarks:

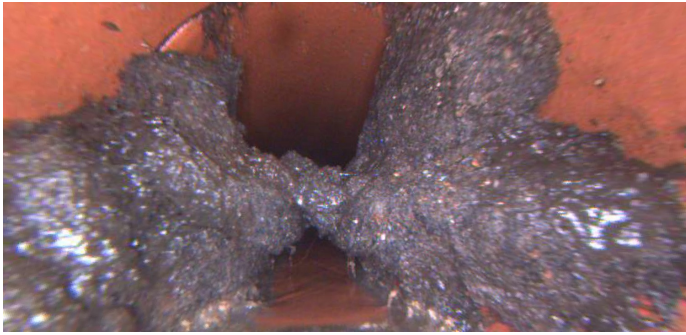
Code: **RMJ**
Description: **Roots Medium Joint**

Distance (ft): **149.3**
Structural Grade: **0**
O&M Grade: **3**
Clock Start/From: **7**
Clock To: **5**
1st Value:
2nd Value:
Value Percent: **35.000**
Continuous Index:
Within 8" of Joint: **YES**
Remarks:

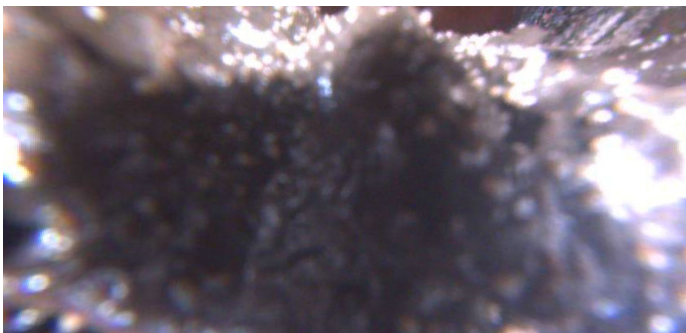
Code: **DAGS**
Description: **Deposits Attached Grease**

Distance (ft): **149.9**
Structural Grade: **0**
O&M Grade: **2**
Clock Start/From: **8**
Clock To: **4**
1st Value:
2nd Value:
Value Percent: **5.000**
Continuous Index: **F01**
Within 8" of Joint: **NO**
Remarks:

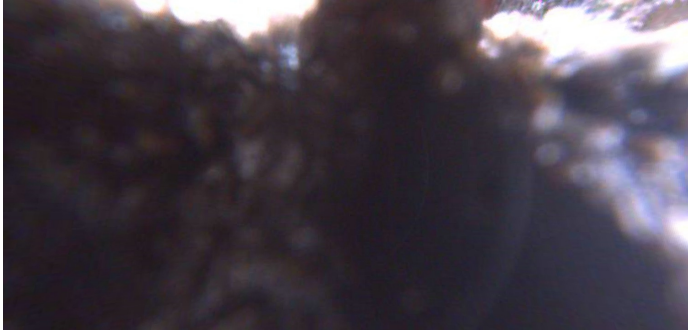
Code:	MSA
Description:	Abandoned Survey
Distance (ft):	150.0
Structural Grade:	0
O&M Grade:	0
Clock Start/From:	
Clock To:	
1st Value:	
2nd Value:	
Value Percent:	
Continuous Index:	
Within 8" of Joint:	NO
Remarks:	RMJ
