Profile/Photo Observation Report

Date:	04/15/2018	Weather:		Coding:	PACP 6.0
Pipe Length (ft):	283.5	Owner:	NA	Pre Clean:	Not Known
P.O.#:		Surveyor:	Mark Ruby	PSR:	P-904-020-019
Customer:		Clean Date:	01/01/1900	Shape:	C

Street:	Fraser Ln.	Flow Control:	Not Controlled
City:	Hobart, IN	Year Renewed:	
Location:	Other	Tape/Media #:	
Purpose:	Not Known	Dia/Height:	10"
Use:	Sanitary	Material:	VCP
Drain Area:	NA	Lining:	
Category:	NA		
Comment:

Location Details:		Direction of Survey:	Upstream
US MH:	M-904-019	DS MH:	M-904-020
		Total Length Surveyed (ft):	150.0

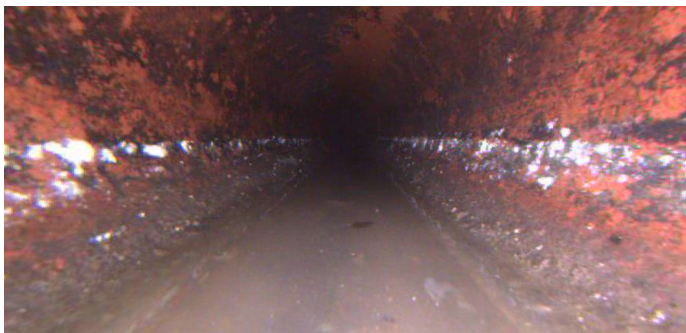
Code: **DAGS**
Description: **Deposits Attached Grease**

Distance (ft): **.0**
Structural Grade: **0**
O&M Grade: **2**
Clock Start/From: **8**
Clock To: **4**
1st Value:
2nd Value:
Value Percent: **5.000**
Continuous Index: **S01**
Within 8" of Joint: **NO**
Remarks:

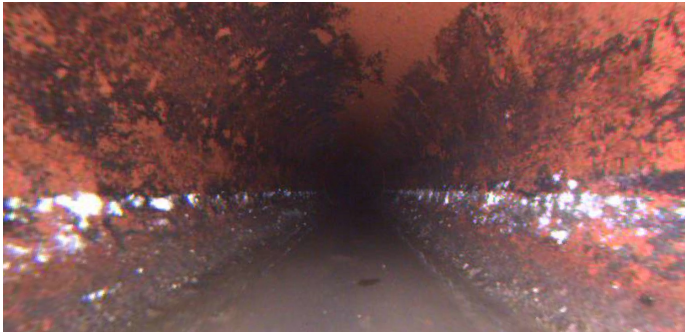
Code:	AMH
Description:	Manhole

Distance (ft):	.0
Structural Grade:	0
O&M Grade:	0
Clock Start/From:	
Clock To:	
1st Value:	
2nd Value:	
Value Percent:	
Continuous Index:	
Within 8" of Joint:	NO
Remarks:	M-904-020

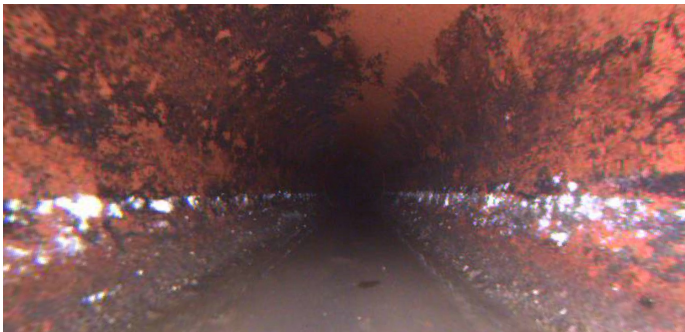
Code:	MWL
Description:	Water Level

Distance (ft):	.0
Structural Grade:	0
O&M Grade:	0
Clock Start/From:	
Clock To:	
1st Value:	
2nd Value:	
Value Percent:	10.000
Continuous Index:	
Within 8" of Joint:	NO
Remarks:

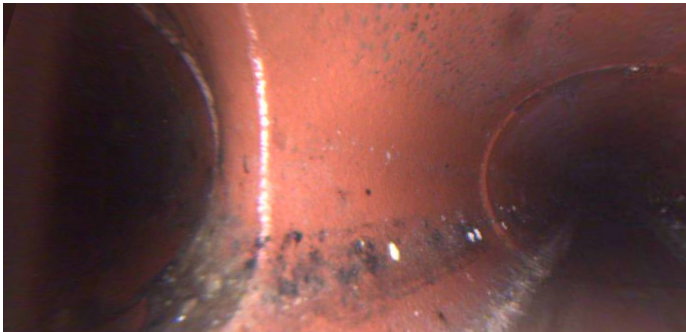
Code: **TF**
Description: **Tap Factory**

Distance (ft): **59.8**
Structural Grade: **0**
O&M Grade: **0**
Clock Start/From: **8**
Clock To:
1st Value: **4.000**
2nd Value:
Value Percent:
Continuous Index:
Within 8" of Joint:
Remarks:

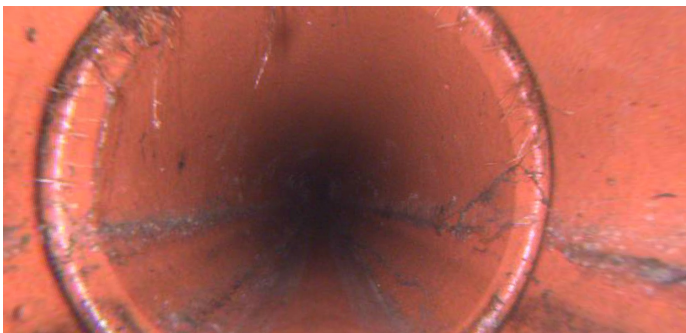
Code: **RFJ**
Description: **Roots Fine Joint**

Distance (ft): **90.6**
Structural Grade: **0**
O&M Grade: **1**
Clock Start/From: **7**
Clock To: **5**
1st Value:
2nd Value:
Value Percent:
Continuous Index:
Within 8" of Joint: **YES**
Remarks:

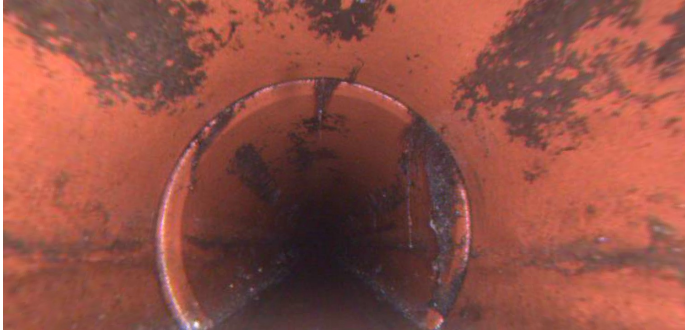
Code: **RFJ**
Description: **Roots Fine Joint**

Distance (ft): **115.2**
Structural Grade: **0**
O&M Grade: **1**
Clock Start/From: **10**
Clock To: **5**
1st Value:
2nd Value:
Value Percent:
Continuous Index:
Within 8" of Joint: **YES**
Remarks:

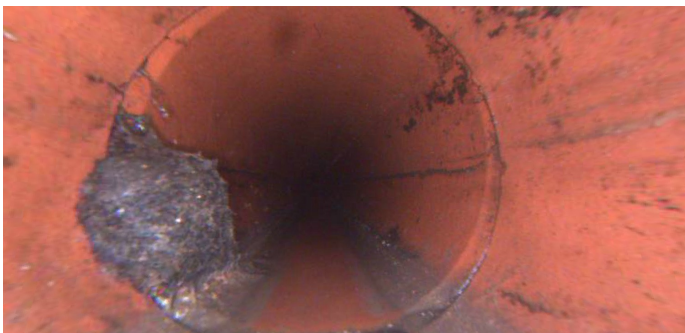
Code: **RMJ**
Description: **Roots Medium Joint**

Distance (ft): **139.3**
Structural Grade: **0**
O&M Grade: **3**
Clock Start/From: **7**
Clock To: **9**
1st Value:
2nd Value:
Value Percent: **10.000**
Continuous Index:
Within 8" of Joint: **YES**
Remarks:
