## Profile/Photo Observation Report

Street:	<b>FRASER LN</b>	Flow Control:	<b>Not Controlled</b>
City:	<b>Hobart, IN</b>	Year Renewed:	
Location:	<b>Other</b>	Tape/Media #:	
Purpose:	<b>Not Known</b>	Dia/Height:	<b>10"</b>
Use:	<b>Sanitary</b>	Material:	<b>VCP</b>
Drain Area:	<b>NA</b>	Lining:	
Category:	<b>NA</b>		
Comment:

Location Details:		Direction of Survey:	<b>Downstream</b>
US MH:	<b>M-904-019</b>	DS MH:	<b>M-904-020</b>
		Total Length Surveyed (ft):	<b>126.3</b>

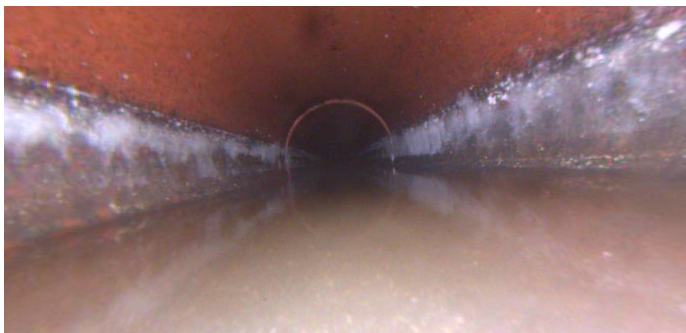
Code: **DAGS**  
Description: **Deposits Attached Grease**

Distance (ft): **.0**  
Structural Grade: **0**  
O&M Grade: **2**  
Clock Start/From: **8**  
Clock To: **4**  
1st Value:  
2nd Value:  
Value Percent: **5.000**  
Continuous Index: **S01**  
Within 8" of Joint: **NO**  
Remarks:

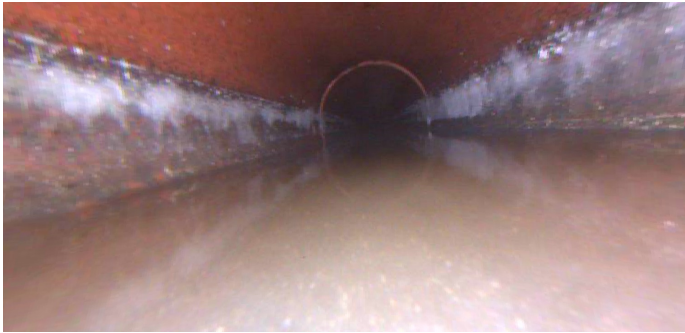
Code:	<b>AMH</b>
Description:	<b>Manhole</b>

Distance (ft):	<b>.0</b>
Structural Grade:	<b>0</b>
O&M Grade:	<b>0</b>
Clock Start/From:	
Clock To:	
1st Value:	
2nd Value:	
Value Percent:	
Continuous Index:	
Within 8" of Joint:	<b>NO</b>
Remarks:	<b>M-904-019</b>

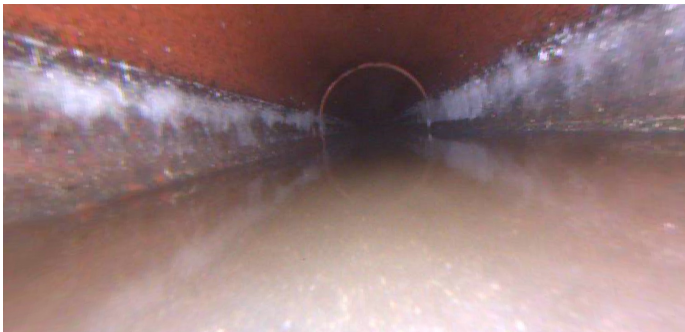
Code:	<b>MWL</b>
Description:	<b>Water Level</b>

Distance (ft):	<b>.0</b>
Structural Grade:	<b>0</b>
O&M Grade:	<b>0</b>
Clock Start/From:	
Clock To:	
1st Value:	
2nd Value:	
Value Percent:	<b>40.000</b>
Continuous Index:	
Within 8" of Joint:	<b>NO</b>
Remarks:

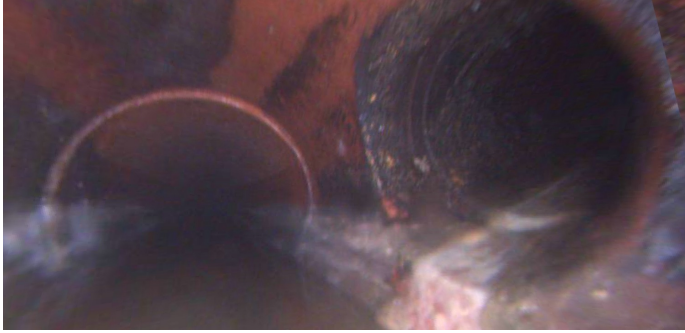
Code: **TFA**  
Description: **Tap Factory Active**

Distance (ft): **14.0**  
Structural Grade: **0**  
O&M Grade: **0**  
Clock Start/From: **3**  
Clock To:  
1st Value: **4.000**  
2nd Value:  
Value Percent:  
Continuous Index:  
Within 8" of Joint:  
Remarks:

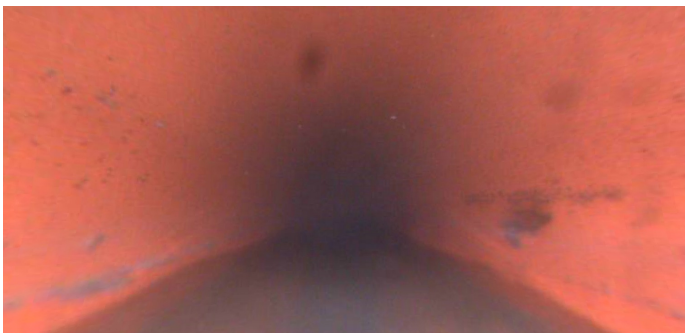
Code: **DAGS**  
Description: **Deposits Attached Grease**

Distance (ft): **26.3**  
Structural Grade: **0**  
O&M Grade: **2**  
Clock Start/From: **8**  
Clock To: **4**  
1st Value:  
2nd Value:  
Value Percent: **5.000**  
Continuous Index: **F01**  
Within 8" of Joint: **NO**  
Remarks:

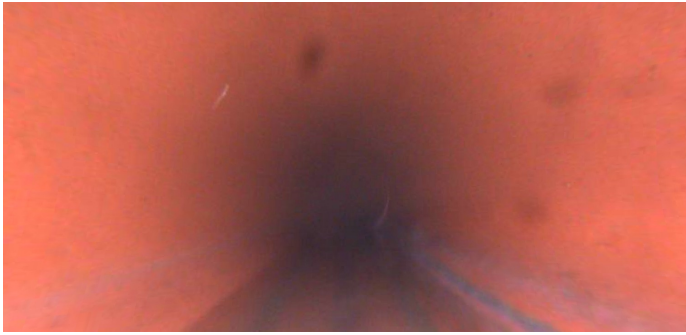
Code: **MWL**  
Description: **Water Level**

Distance (ft): **37.4**  
Structural Grade: **0**  
O&M Grade: **0**  
Clock Start/From:  
Clock To:  
1st Value:  
2nd Value:  
Value Percent: **5.000**  
Continuous Index:  
Within 8" of Joint: **NO**  
Remarks:

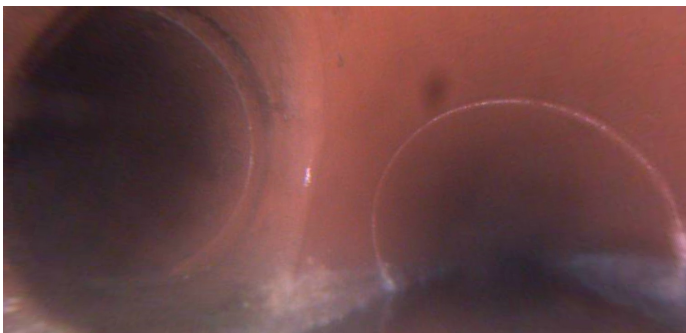
Code: **TF**  
Description: **Tap Factory**

Distance (ft): **60.9**  
Structural Grade: **0**  
O&M Grade: **0**  
Clock Start/From: **9**  
Clock To:  
1st Value: **4.000**  
2nd Value:  
Value Percent:  
Continuous Index:  
Within 8" of Joint:  
Remarks:

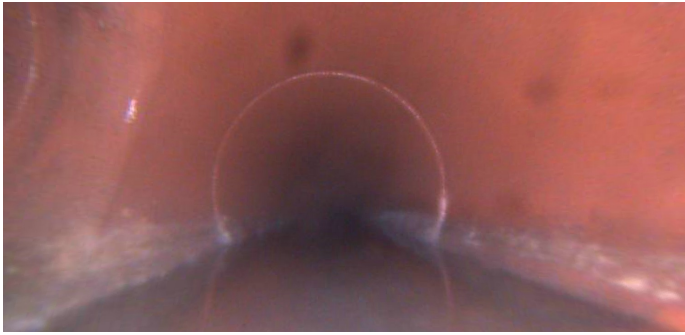
Code: **MWL**  
Description: **Water Level**

Distance (ft): **60.9**  
Structural Grade: **0**  
O&M Grade: **0**  
Clock Start/From:  
Clock To:  
1st Value:  
2nd Value:  
Value Percent: **20.000**  
Continuous Index:  
Within 8" of Joint: **NO**  
Remarks:

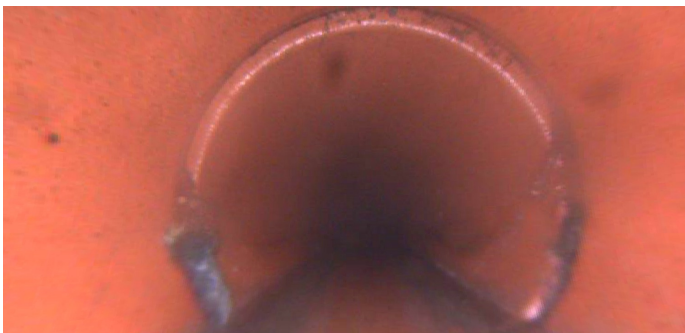
Code: **RFJ**  
Description: **Roots Fine Joint**

Distance (ft): **106.1**  
Structural Grade: **0**  
O&M Grade: **1**  
Clock Start/From: **7**  
Clock To: **5**  
1st Value:  
2nd Value:  
Value Percent:  
Continuous Index:  
Within 8" of Joint: **YES**  
Remarks:

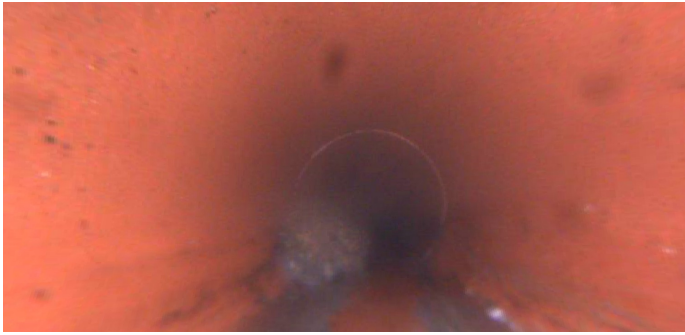
Code: **RMB**  
Description: **Roots Medium Barrel**

Distance (ft): **115.1**  
Structural Grade: **0**  
O&M Grade: **4**  
Clock Start/From: **6**  
Clock To: **9**  
1st Value:  
2nd Value:  
Value Percent: **20.000**  
Continuous Index:  
Within 8" of Joint: **NO**  
Remarks:

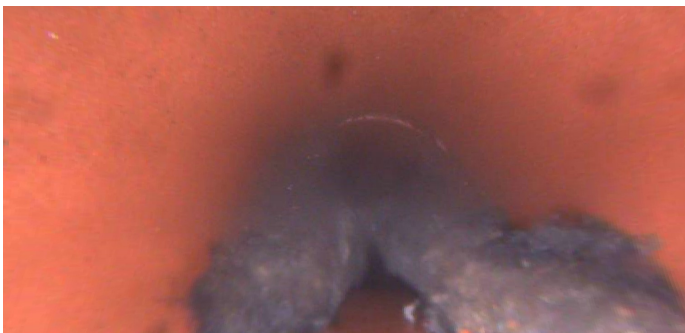
Code: **RBJ**  
Description: **Roots Ball Joint**

Distance (ft): **125.3**  
Structural Grade: **0**  
O&M Grade: **4**  
Clock Start/From: **7**  
Clock To: **5**  
1st Value:  
2nd Value:  
Value Percent: **80.000**  
Continuous Index:  
Within 8" of Joint: **YES**  
Remarks:

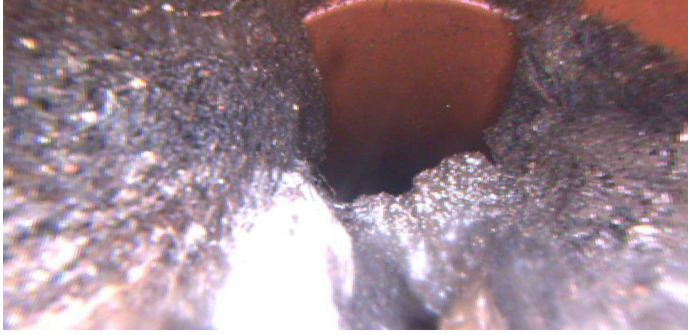
Code:	<b>MSA</b>
Description:	<b>Abandoned Survey</b>
Distance (ft):	<b>126.3</b>
Structural Grade:	<b>0</b>
O&M Grade:	<b>0</b>
Clock Start/From:	
Clock To:	
1st Value:	
2nd Value:	
Value Percent:	
Continuous Index:	
Within 8" of Joint:	<b>NO</b>
Remarks:	<b>ROOT INFILTRATION</b>
