Profile/Photo Observation Report

Street:	Fraser Ln.	Flow Control:	Not Controlled
City:	Hobart, IN	Year Renewed:	
Location:	Other	Tape/Media #:	
Purpose:	Not Known	Dia/Height:	10"
Use:	Sanitary	Material:	VCP
Drain Area:	NA	Lining:	
Category:	NA		
Comment:

Location Details:		Direction of Survey:	Downstream
US MH:	M-904-021	DS MH:	M-904-016
		Total Length Surveyed (ft):	209.4

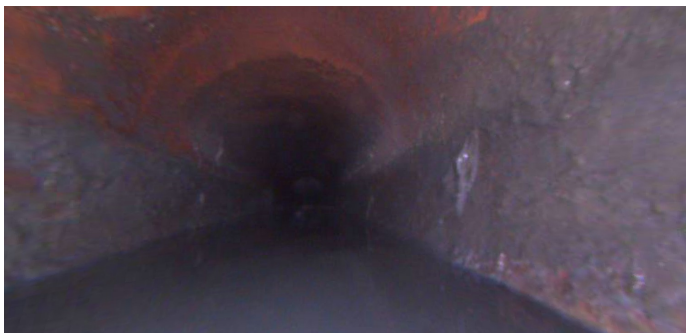
Code: **DAGS**
Description: **Deposits Attached Grease**

Distance (ft): **.0**
Structural Grade: **0**
O&M Grade: **2**
Clock Start/From: **8**
Clock To: **4**
1st Value:
2nd Value:
Value Percent: **5.000**
Continuous Index: **S01**
Within 8" of Joint: **NO**
Remarks:

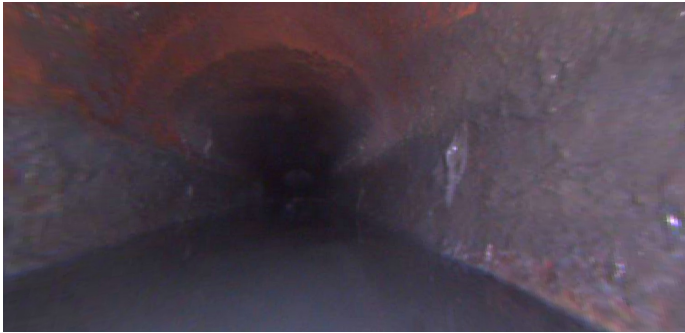
Code:	AMH
Description:	Manhole

Distance (ft):	.0
Structural Grade:	0
O&M Grade:	0
Clock Start/From:	
Clock To:	
1st Value:	
2nd Value:	
Value Percent:	
Continuous Index:	
Within 8" of Joint:	NO
Remarks:	M-904-021

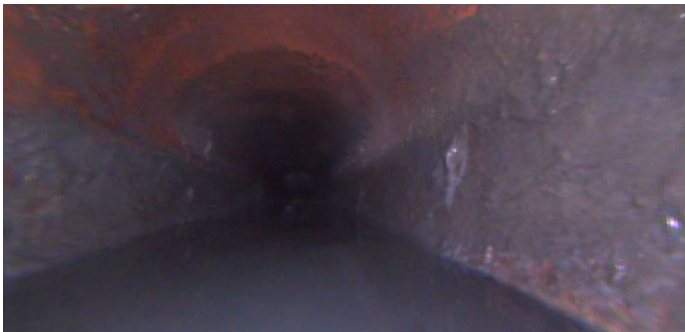
Code:	MWL
Description:	Water Level

Distance (ft):	.0
Structural Grade:	0
O&M Grade:	0
Clock Start/From:	
Clock To:	
1st Value:	
2nd Value:	
Value Percent:	5.000
Continuous Index:	
Within 8" of Joint:	NO
Remarks:

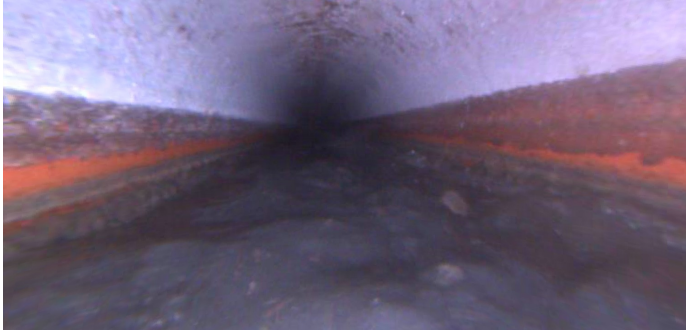
Code: **MWL**
Description: **Water Level**

Distance (ft): **19.8**
Structural Grade: **0**
O&M Grade: **0**
Clock Start/From:
Clock To:
1st Value:
2nd Value:
Value Percent: **40.000**
Continuous Index:
Within 8" of Joint: **NO**
Remarks:

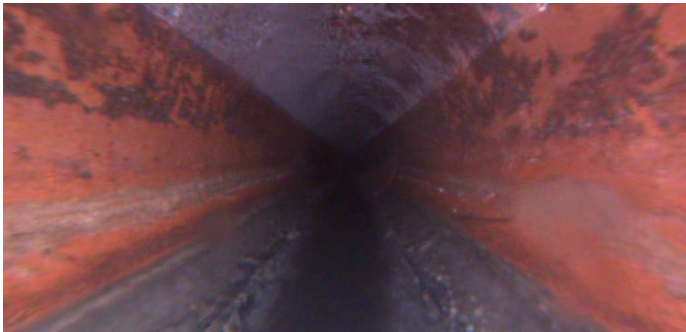
Code: **MWL**
Description: **Water Level**

Distance (ft): **181.6**
Structural Grade: **0**
O&M Grade: **0**
Clock Start/From:
Clock To:
1st Value:
2nd Value:
Value Percent: **5.000**
Continuous Index:
Within 8" of Joint: **NO**
Remarks:

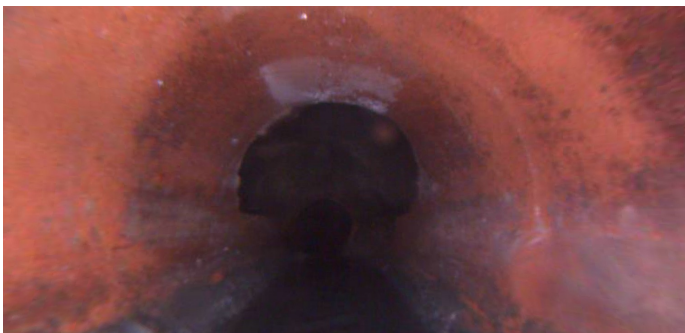
Code: **DAGS**
Description: **Deposits Attached Grease**

Distance (ft): **206.7**
Structural Grade: **0**
O&M Grade: **2**
Clock Start/From: **7**
Clock To: **5**
1st Value:
2nd Value:
Value Percent: **5.000**
Continuous Index: **F02**
Within 8" of Joint: **NO**
Remarks:

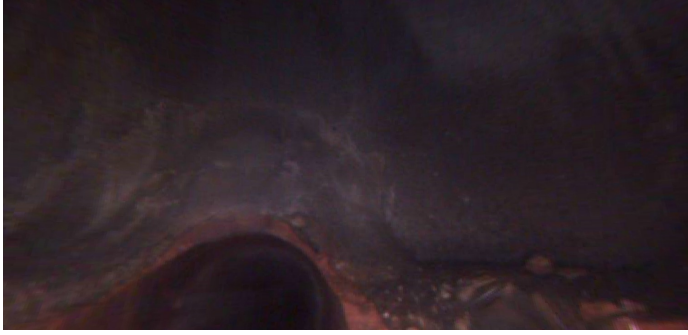
Code:	AMH
Description:	Manhole
Distance (ft):	209.4
Structural Grade:	0
O&M Grade:	0
Clock Start/From:	
Clock To:	
1st Value:	
2nd Value:	
Value Percent:	
Continuous Index:	
Within 8" of Joint:	NO
Remarks:	M-904-016
