Profile/Photo Observation Report

Street:	FRASER LN	Flow Control:	Not Controlled
City:	Hobart, IN	Year Renewed:	
Location:	Other	Tape/Media #:	
Purpose:	Not Known	Dia/Height:	10"
Use:	Sanitary	Material:	VCP
Drain Area:	NA	Lining:	
Category:	NA		
Comment:

Location Details:		Direction of Survey:	Downstream
US MH:	M-904-021	DS MH:	M-904-022
		Total Length Surveyed (ft):	20.4

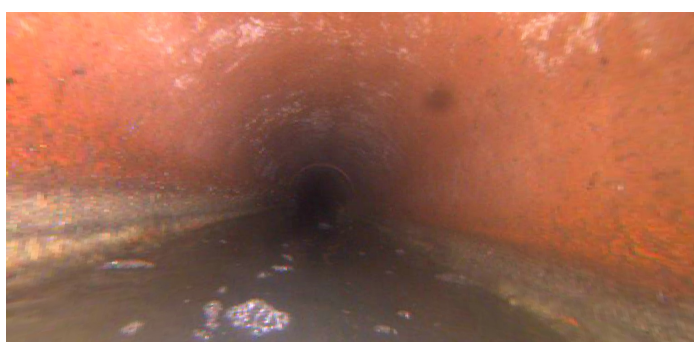
Code: **AMH**
Description: **Manhole**

Distance (ft): **.0**
Structural Grade: **0**
O&M Grade: **0**
Clock Start/From:
Clock To:
1st Value:
2nd Value:
Value Percent:
Continuous Index:
Within 8" of Joint: **NO**
Remarks: **M-904-021**

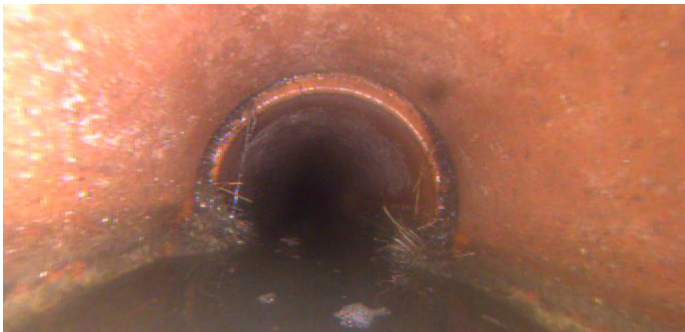
Code:	RFJ
Description:	Roots Fine Joint

Distance (ft):	3.5
Structural Grade:	0
O&M Grade:	1
Clock Start/From:	7
Clock To:	5
1st Value:	
2nd Value:	
Value Percent:	
Continuous Index:	S01
Within 8" of Joint:	YES
Remarks:

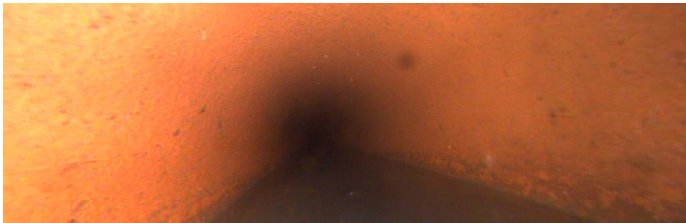
Code: **RFJ**
Description: **Roots Fine Joint**

Distance (ft): **20.4**
Structural Grade: **0**
O&M Grade: **1**
Clock Start/From: **7**
Clock To: **5**
1st Value:
2nd Value:
Value Percent:
Continuous Index: **F01**
Within 8" of Joint: **YES**
Remarks:

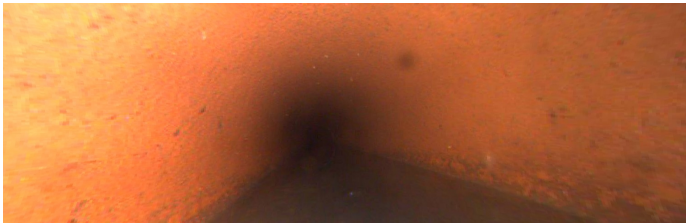
Code: **MSA**
Description: **Abandoned Survey**

Distance (ft): **20.4**
Structural Grade: **0**
O&M Grade: **0**
Clock Start/From:
Clock To:
1st Value:
2nd Value:
Value Percent:
Continuous Index:
Within 8" of Joint: **NO**
Remarks: **camera underwater**
