Profile/Photo Observation Report

Street:	CLEVELAND TERR	Flow Control:	Not Controlled
City:	Hobart, IN	Year Renewed:	
Location:	Other	Tape/Media #:	
Purpose:	Not Known	Dia/Height:	10"
Use:	Sanitary	Material:	VCP
Drain Area:	NA	Lining:	
Category:	NA		
Comment:

Location Details:		Direction of Survey:	Downstream
US MH:	M-904-025	DS MH:	M-904-024
		Total Length Surveyed (ft):	18.2

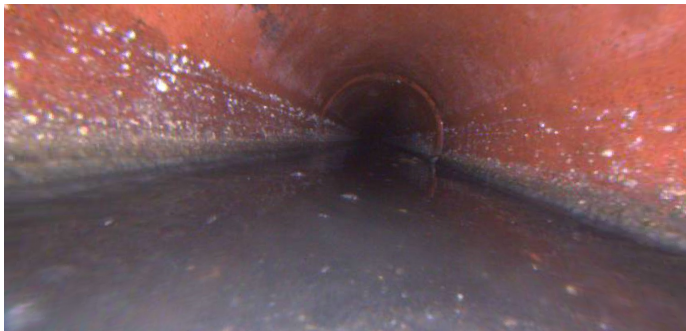
Code: **AMH**
Description: **Manhole**

Distance (ft): **.0**
Structural Grade: **0**
O&M Grade: **0**
Clock Start/From:
Clock To:
1st Value:
2nd Value:
Value Percent:
Continuous Index:
Within 8" of Joint: **NO**
Remarks: **M-904-025**

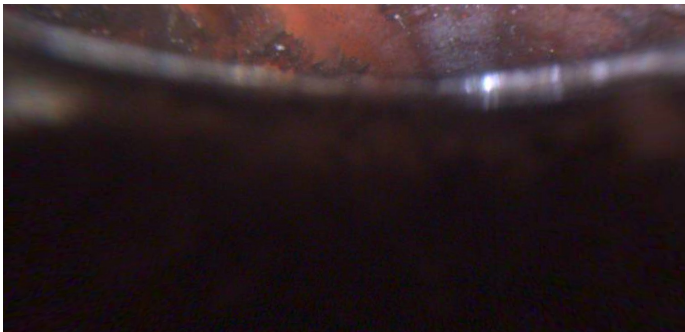
Code:	MSA
Description:	Abandoned Survey

Distance (ft):	18.2
Structural Grade:	0
O&M Grade:	0
Clock Start/From:	
Clock To:	
1st Value:	
2nd Value:	
Value Percent:	
Continuous Index:	
Within 8" of Joint:	NO
Remarks:	mcu

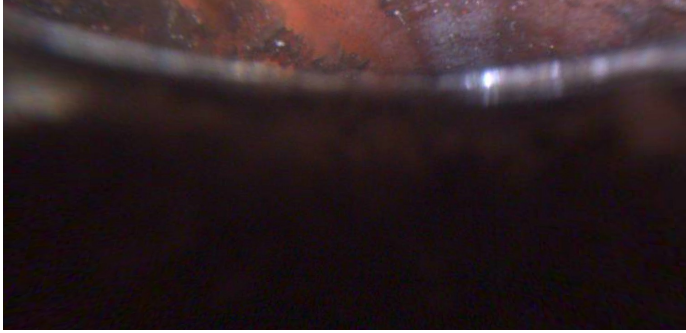
Code: **MCU**
Description: **Camera Underwater**

Distance (ft): **18.2**
Structural Grade: **0**
O&M Grade: **4**
Clock Start/From:
Clock To:
1st Value:
2nd Value:
Value Percent:
Continuous Index:
Within 8" of Joint: **NO**
Remarks:

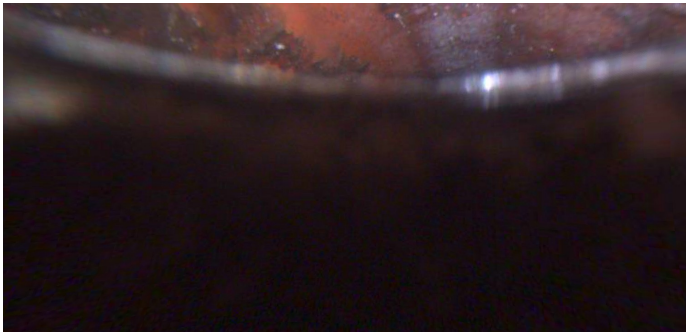
Code: **MWL**
Description: **Water Level**

Distance (ft): **18.2**
Structural Grade: **0**
O&M Grade: **0**
Clock Start/From:
Clock To:
1st Value:
2nd Value:
Value Percent: **60.000**
Continuous Index:
Within 8" of Joint: **NO**
Remarks:
