## Profile/Photo Observation Report

Street:	<b>CLEVELAND TERR</b>	Flow Control:	<b>Not Controlled</b>
City:	<b>Hobart, IN</b>	Year Renewed:	
Location:	<b>Other</b>	Tape/Media #:	
Purpose:	<b>Not Known</b>	Dia/Height:	<b>10"</b>
Use:	<b>Sanitary</b>	Material:	<b>VCP</b>
Drain Area:	<b>NA</b>	Lining:	
Category:	<b>NA</b>		
Comment:

Location Details:		Direction of Survey:	<b>Upstream</b>
US MH:	<b>M-904-026</b>	DS MH:	<b>M-904-025</b>
		Total Length Surveyed (ft):	<b>15.6</b>

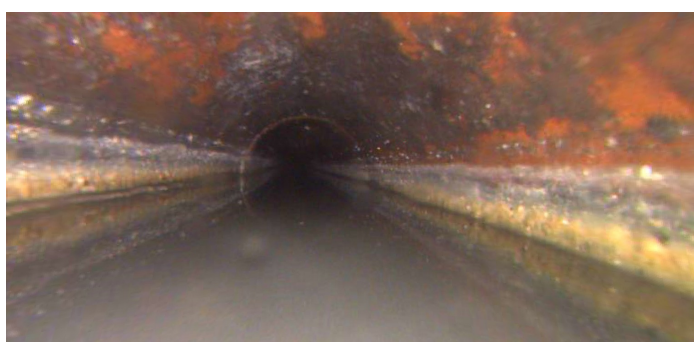
Code: **AMH**  
Description: **Manhole**

Distance (ft): **.0**  
Structural Grade: **0**  
O&M Grade: **0**  
Clock Start/From:  
Clock To:  
1st Value:  
2nd Value:  
Value Percent:  
Continuous Index:  
Within 8" of Joint: **NO**  
Remarks: **M-904-025**

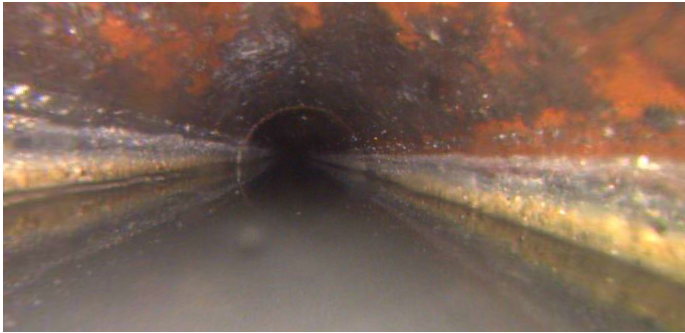
Code:	<b>MWL</b>
Description:	<b>Water Level</b>

Distance (ft):	<b>.0</b>
Structural Grade:	<b>0</b>
O&M Grade:	<b>0</b>
Clock Start/From:	
Clock To:	
1st Value:	
2nd Value:	
Value Percent:	<b>40.000</b>
Continuous Index:	
Within 8" of Joint:	<b>NO</b>
Remarks:

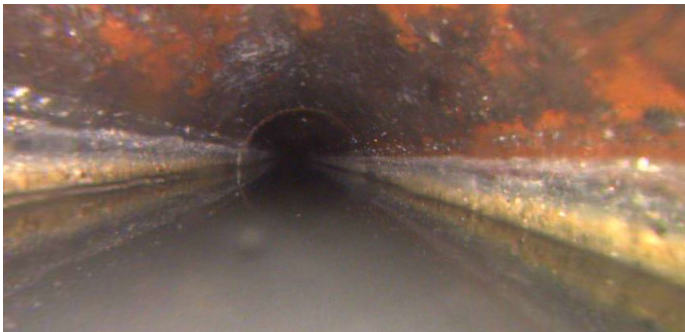
Code:	<b>DAGS</b>
Description:	<b>Deposits Attached Grease</b>

Distance (ft):	<b>.0</b>
Structural Grade:	<b>0</b>
O&M Grade:	<b>2</b>
Clock Start/From:	<b>8</b>
Clock To:	<b>4</b>
1st Value:	
2nd Value:	
Value Percent:	<b>5.000</b>
Continuous Index:	<b>S01</b>
Within 8" of Joint:	<b>NO</b>
Remarks:

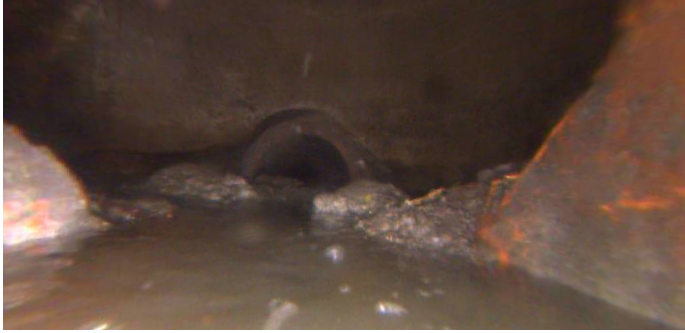
Code: **DAGS**  
Description: **Deposits Attached Grease**

Distance (ft): **14.0**  
Structural Grade: **0**  
O&M Grade: **2**  
Clock Start/From: **8**  
Clock To: **4**  
1st Value:  
2nd Value:  
Value Percent: **5.000**  
Continuous Index: **F01**  
Within 8" of Joint: **NO**  
Remarks:

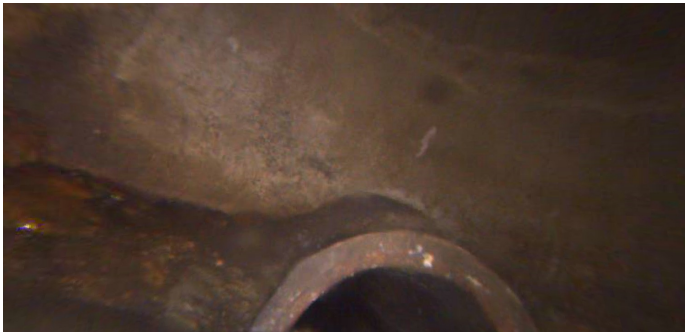
Code: **AMH**  
Description: **Manhole**

Distance (ft): **15.6**  
Structural Grade: **0**  
O&M Grade: **0**  
Clock Start/From:  
Clock To:  
1st Value:  
2nd Value:  
Value Percent:  
Continuous Index:  
Within 8" of Joint: **NO**  
Remarks: **M-904-026**
