Profile/Photo Observation Report

Street:	Cleveland Terr.	Flow Control:	Not Controlled
City:	Hobart, IN	Year Renewed:	
Location:	Other	Tape/Media #:	
Purpose:	Not Known	Dia/Height:	10"
Use:	Sanitary	Material:	VCP
Drain Area:	NA	Lining:	
Category:	NA		
Comment:

Location Details:		Direction of Survey:	Upstream
US MH:	M-904-026	DS MH:	M-904-025
		Total Length Surveyed (ft):	15.6

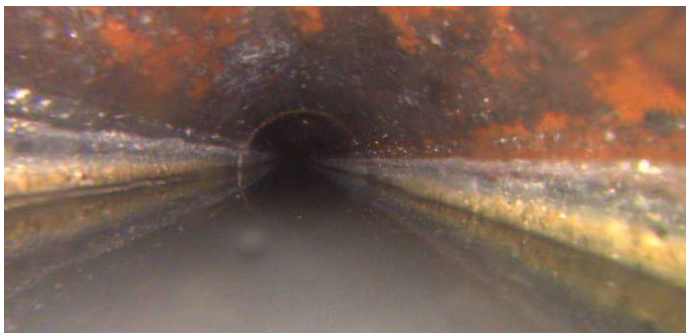
Code: **AMH**
Description: **Manhole**

Distance (ft): **.0**
Structural Grade: **0**
O&M Grade: **0**
Clock Start/From:
Clock To:
1st Value:
2nd Value:
Value Percent:
Continuous Index:
Within 8" of Joint: **NO**
Remarks: **M-904-025**

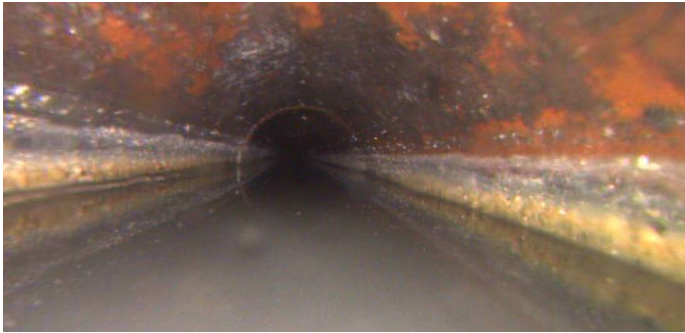
Code:	MWL
Description:	Water Level

Distance (ft):	.0
Structural Grade:	0
O&M Grade:	0
Clock Start/From:	
Clock To:	
1st Value:	
2nd Value:	
Value Percent:	40.000
Continuous Index:	
Within 8" of Joint:	NO
Remarks:

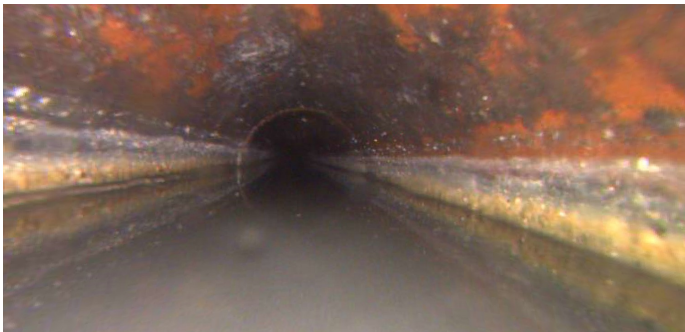
Code:	DAGS
Description:	Deposits Attached Grease

Distance (ft):	.0
Structural Grade:	0
O&M Grade:	2
Clock Start/From:	8
Clock To:	4
1st Value:	
2nd Value:	
Value Percent:	5.000
Continuous Index:	S01
Within 8" of Joint:	NO
Remarks:

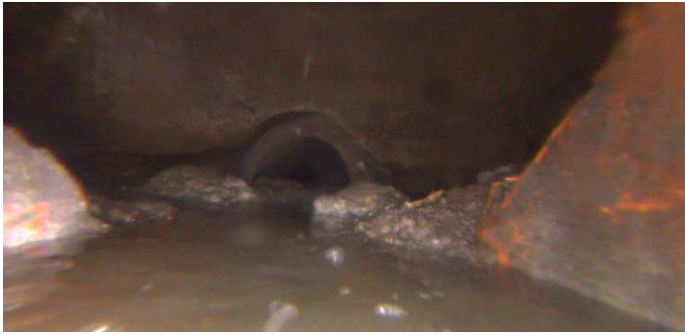
Code: **DAGS**
Description: **Deposits Attached Grease**

Distance (ft): **14.0**
Structural Grade: **0**
O&M Grade: **2**
Clock Start/From: **8**
Clock To: **4**
1st Value:
2nd Value:
Value Percent: **5.000**
Continuous Index: **F01**
Within 8" of Joint: **NO**
Remarks:

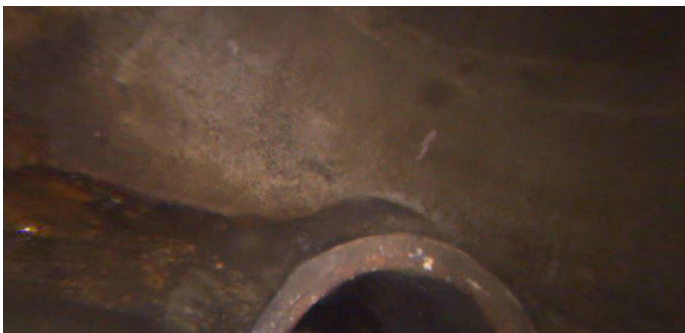
Code: **AMH**
Description: **Manhole**

Distance (ft): **15.6**
Structural Grade: **0**
O&M Grade: **0**
Clock Start/From:
Clock To:
1st Value:
2nd Value:
Value Percent:
Continuous Index:
Within 8" of Joint: **NO**
Remarks: **M-904-026**
