Profile/Photo Observation Report

Street:	CLEVELAND TERR	Flow Control:	Not Controlled
City:	Hobart, IN	Year Renewed:	
Location:	Other	Tape/Media #:	
Purpose:	Not Known	Dia/Height:	10"
Use:	Sanitary	Material:	VCP
Drain Area:	NA	Lining:	
Category:	NA		
Comment:

Location Details:		Direction of Survey:	Downstream
US MH:	M-904-029	DS MH:	M-904-028
		Total Length Surveyed (ft):	5.2

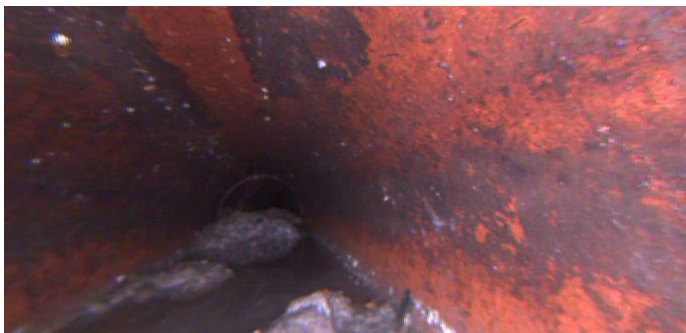
Code: **AMH**
Description: **Manhole**

Distance (ft): **.0**
Structural Grade: **0**
O&M Grade: **0**
Clock Start/From:
Clock To:
1st Value:
2nd Value:
Value Percent:
Continuous Index:
Within 8" of Joint: **NO**
Remarks: **M-904-029**

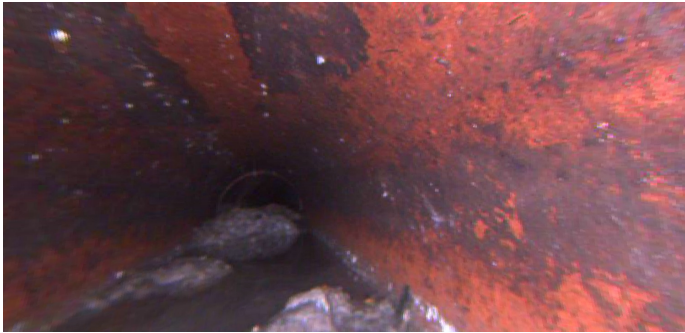
Code:	MWL
Description:	Water Level

Distance (ft):	.0
Structural Grade:	0
O&M Grade:	0
Clock Start/From:	
Clock To:	
1st Value:	
2nd Value:	
Value Percent:	5.000
Continuous Index:	
Within 8" of Joint:	NO
Remarks:

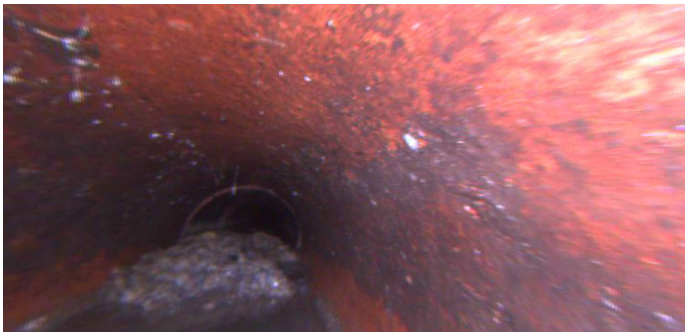
Code:	DSZ
Description:	Deposits Settled Other

Distance (ft):	2.2
Structural Grade:	0
O&M Grade:	2
Clock Start/From:	6
Clock To:	
1st Value:	
2nd Value:	
Value Percent:	10.000
Continuous Index:	
Within 8" of Joint:	NO
Remarks:	mixed material
