Profile/Photo Observation Report

Street:	CLEVELAND TERR	Flow Control:	Not Controlled
City:	Hobart, IN	Year Renewed:	
Location:	Other	Tape/Media #:	
Purpose:	Not Known	Dia/Height:	10"
Use:	Sanitary	Material:	VCP
Drain Area:	NA	Lining:	
Category:	NA		
Comment:

Location Details:		Direction of Survey:	Upstream
US MH:	M-904-030	DS MH:	M-904-029
		Total Length Surveyed (ft):	31.3

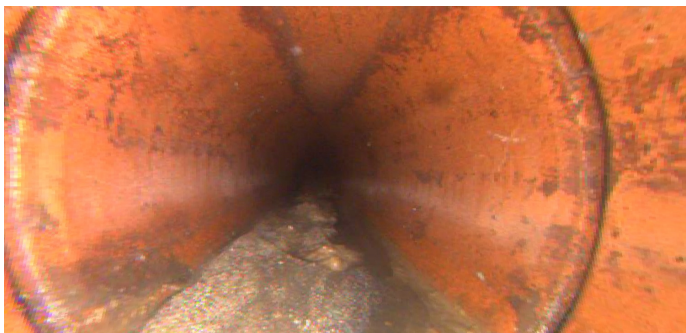
Code: **AMH**
Description: **Manhole**

Distance (ft): **.0**
Structural Grade: **0**
O&M Grade: **0**
Clock Start/From:
Clock To:
1st Value:
2nd Value:
Value Percent:
Continuous Index:
Within 8" of Joint: **NO**
Remarks: **M-904-029**

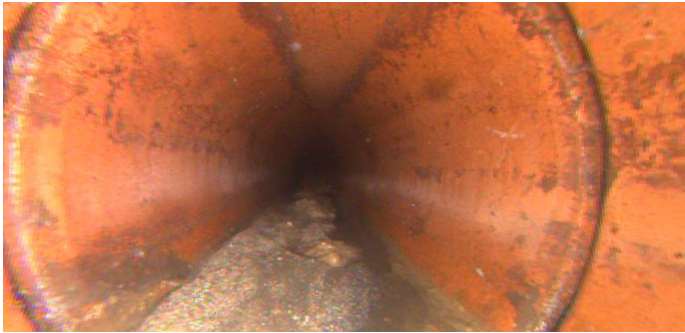
Code:	MWL
Description:	Water Level

Distance (ft):	.0
Structural Grade:	0
O&M Grade:	0
Clock Start/From:	
Clock To:	
1st Value:	
2nd Value:	
Value Percent:	5.000
Continuous Index:	
Within 8" of Joint:	NO
Remarks:

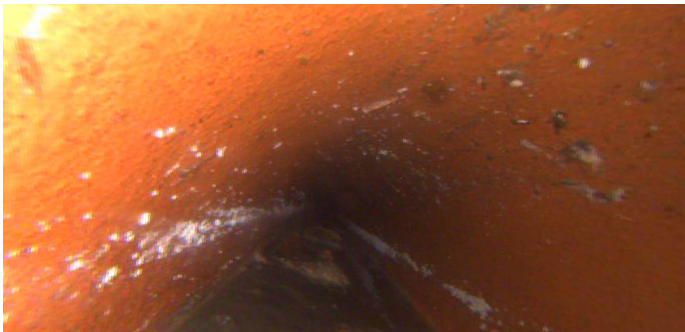
Code:	MSA
Description:	Abandoned Survey

Distance (ft):	31.3
Structural Grade:	0
O&M Grade:	0
Clock Start/From:	
Clock To:	
1st Value:	
2nd Value:	
Value Percent:	
Continuous Index:	
Within 8" of Joint:	NO
Remarks:	debris
