## Profile/Photo Observation Report

Street:	<b>CLEVELAND TERR</b>	Flow Control:	<b>Not Controlled</b>
City:	<b>Hobart, IN</b>	Year Renewed:	
Location:	<b>Other</b>	Tape/Media #:	
Purpose:	<b>Not Known</b>	Dia/Height:	<b>10"</b>
Use:	<b>Sanitary</b>	Material:	<b>VCP</b>
Drain Area:	<b>NA</b>	Lining:	
Category:	<b>NA</b>		
Comment:

Location Details:		Direction of Survey:	<b>Upstream</b>
US MH:	<b>M-904-031</b>	DS MH:	<b>M-904-030</b>
		Total Length Surveyed (ft):	<b>126.5</b>

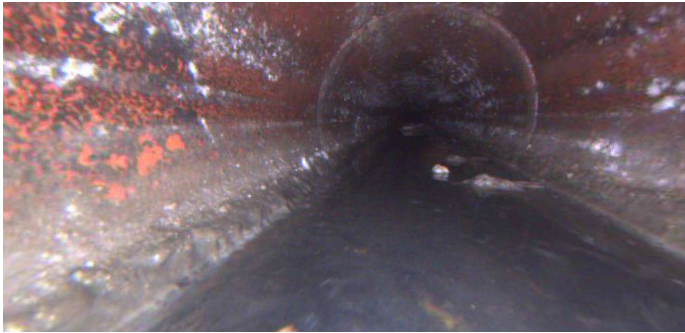
Code:	<b>MWL</b>
Description:	<b>Water Level</b>

Distance (ft):	<b>.0</b>
Structural Grade:	<b>0</b>
O&M Grade:	<b>0</b>
Clock Start/From:	
Clock To:	
1st Value:	
2nd Value:	
Value Percent:	<b>10.000</b>
Continuous Index:	
Within 8" of Joint:	<b>NO</b>
Remarks:

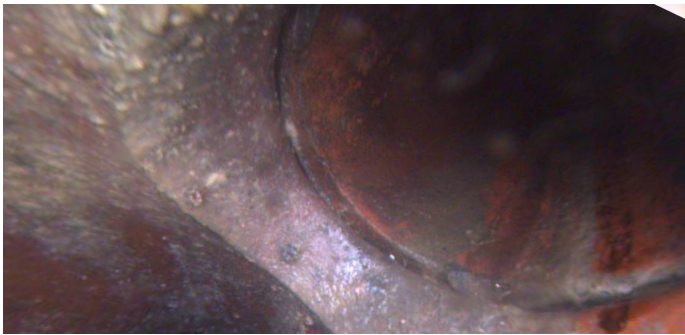
Code:	<b>TF</b>
Description:	<b>Tap Factory</b>

Distance (ft):	<b>37.6</b>
Structural Grade:	<b>0</b>
O&M Grade:	<b>0</b>
Clock Start/From:	<b>2</b>
Clock To:	
1st Value:	<b>4.000</b>
2nd Value:	
Value Percent:	
Continuous Index:	
Within 8" of Joint:	
Remarks:

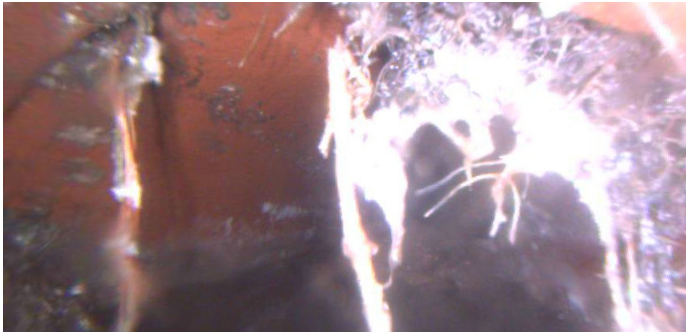
Code: **RFJ**  
Description: **Roots Fine Joint**

Distance (ft): **39.0**  
Structural Grade: **0**  
O&M Grade: **1**  
Clock Start/From: **10**  
Clock To: **4**  
1st Value:  
2nd Value:  
Value Percent:  
Continuous Index:  
Within 8" of Joint: **YES**  
Remarks:

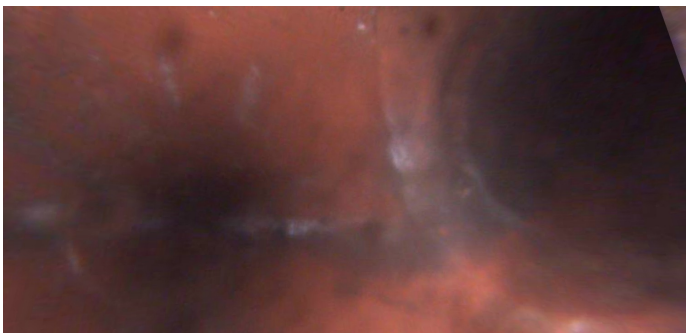
Code: **TF**  
Description: **Tap Factory**

Distance (ft): **84.4**  
Structural Grade: **0**  
O&M Grade: **0**  
Clock Start/From: **4**  
Clock To:  
1st Value: **4.000**  
2nd Value:  
Value Percent:  
Continuous Index:  
Within 8" of Joint:  
Remarks:

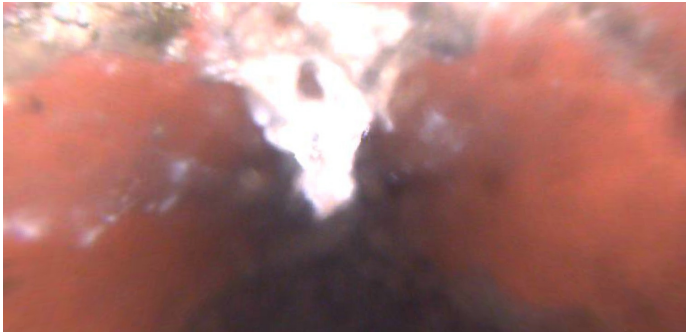
Code: **DAGS**  
Description: **Deposits Attached Grease**

Distance (ft): **110.7**  
Structural Grade: **0**  
O&M Grade: **2**  
Clock Start/From: **12**  
Clock To:  
1st Value:  
2nd Value:  
Value Percent: **10.000**  
Continuous Index:  
Within 8" of Joint: **YES**  
Remarks:

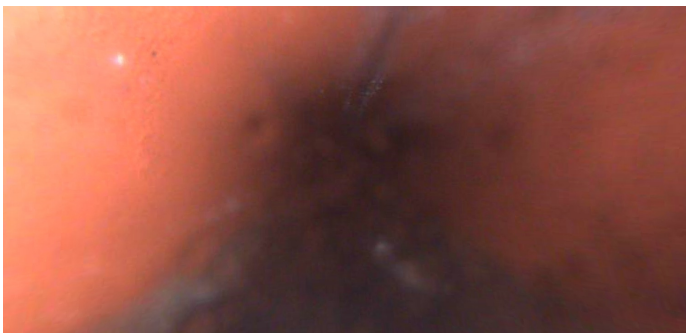
Code: **MSA**  
Description: **Abandoned Survey**

Distance (ft): **126.5**  
Structural Grade: **0**  
O&M Grade: **0**  
Clock Start/From:  
Clock To:  
1st Value:  
2nd Value:  
Value Percent:  
Continuous Index:  
Within 8" of Joint: **NO**  
Remarks: **No blockage**
