Profile/Photo Observation Report

Street:	Cleveland Terr.	Flow Control:	Not Controlled
City:	Hobart, IN	Year Renewed:	
Location:	Other	Tape/Media #:	
Purpose:	Not Known	Dia/Height:	10"
Use:	Sanitary	Material:	VCP
Drain Area:	NA	Lining:	
Category:	NA		
Comment:

Location Details:		Direction of Survey:	Upstream
US MH:	M-904-031	DS MH:	M-904-030
		Total Length Surveyed (ft):	126.5

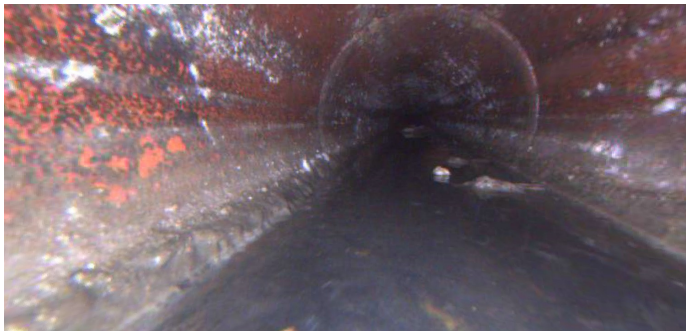
Code: **AMH**
Description: **Manhole**

Distance (ft): **.0**
Structural Grade: **0**
O&M Grade: **0**
Clock Start/From:
Clock To:
1st Value:
2nd Value:
Value Percent:
Continuous Index:
Within 8" of Joint: **NO**
Remarks: **M-904-030**

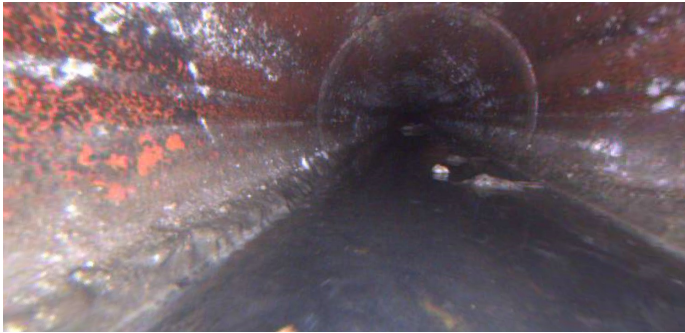
Code:	MWL
Description:	Water Level

Distance (ft):	.0
Structural Grade:	0
O&M Grade:	0
Clock Start/From:	
Clock To:	
1st Value:	
2nd Value:	
Value Percent:	10.000
Continuous Index:	
Within 8" of Joint:	NO
Remarks:

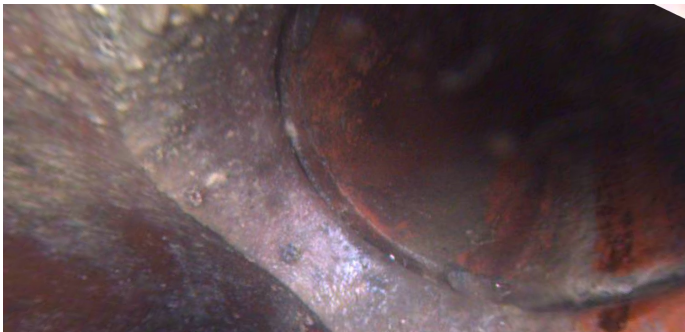
Code:	TF
Description:	Tap Factory

Distance (ft):	37.6
Structural Grade:	0
O&M Grade:	0
Clock Start/From:	2
Clock To:	
1st Value:	4.000
2nd Value:	
Value Percent:	
Continuous Index:	
Within 8" of Joint:	
Remarks:

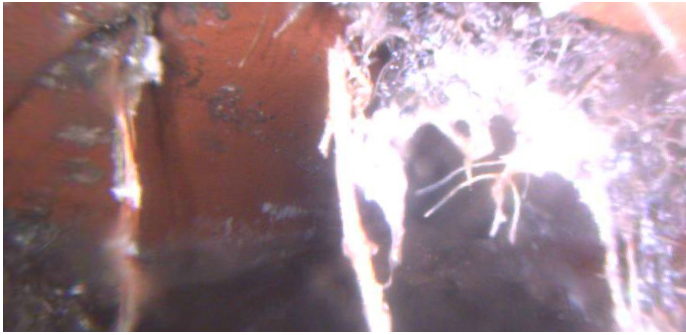
Code: **RFJ**
Description: **Roots Fine Joint**

Distance (ft): **39.0**
Structural Grade: **0**
O&M Grade: **1**
Clock Start/From: **10**
Clock To: **4**
1st Value:
2nd Value:
Value Percent:
Continuous Index:
Within 8" of Joint: **YES**
Remarks:

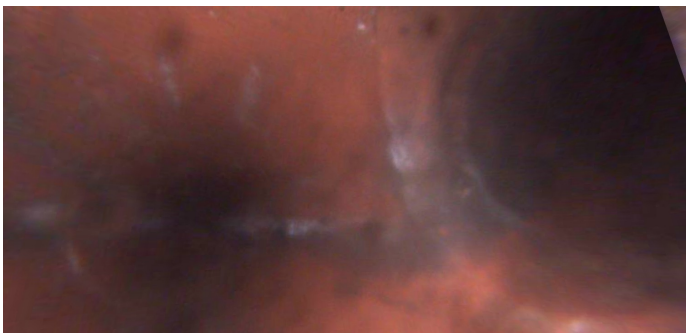
Code: **TF**
Description: **Tap Factory**

Distance (ft): **84.4**
Structural Grade: **0**
O&M Grade: **0**
Clock Start/From: **4**
Clock To:
1st Value: **4.000**
2nd Value:
Value Percent:
Continuous Index:
Within 8" of Joint:
Remarks:

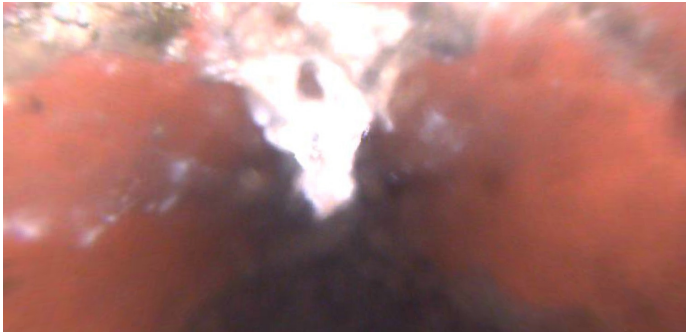
Code: **DAGS**
Description: **Deposits Attached Grease**

Distance (ft): **110.7**
Structural Grade: **0**
O&M Grade: **2**
Clock Start/From: **12**
Clock To:
1st Value:
2nd Value:
Value Percent: **10.000**
Continuous Index:
Within 8" of Joint: **YES**
Remarks:

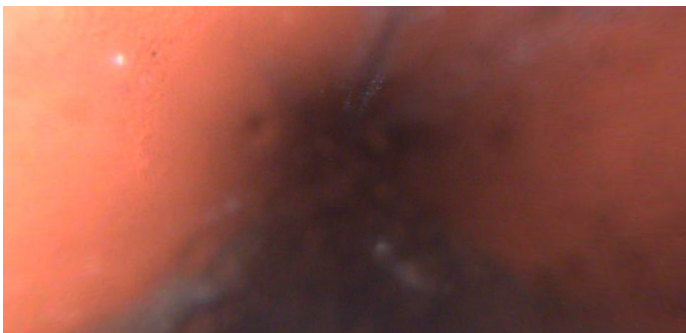
Code: **MSA**
Description: **Abandoned Survey**

Distance (ft): **126.5**
Structural Grade: **0**
O&M Grade: **0**
Clock Start/From:
Clock To:
1st Value:
2nd Value:
Value Percent:
Continuous Index:
Within 8" of Joint: **NO**
Remarks: **No blockage**
