Profile/Photo Observation Report

Date:	04/17/2018	Weather:		Coding:	PACP 6.0
Pipe Length (ft):	258.0	Owner:	NA	Pre Clean:	Not Known
P.O.#:		Surveyor:	Justin Gonzales	PSR:	P-904-033-032
Customer:		Clean Date:	01/01/1900	Shape:	C

Location Details:		Direction of Survey:	Upstream
US MH:	M-904-033	DS MH:	M-904-032
		Total Length Surveyed (ft):	243.9

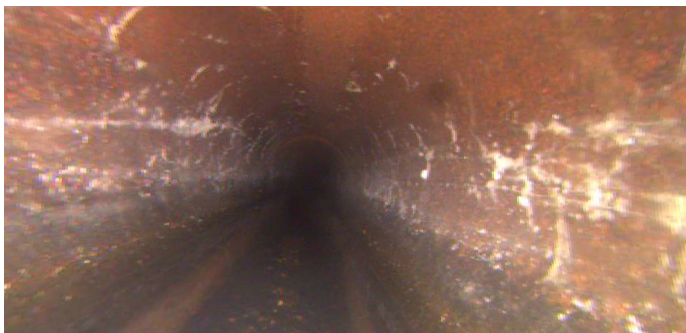
Code: **AMH**
Description: **Manhole**

Distance (ft): **.0**
Structural Grade: **0**
O&M Grade: **0**
Clock Start/From:
Clock To:
1st Value:
2nd Value:
Value Percent:
Continuous Index:
Within 8" of Joint: **NO**
Remarks: **M-904-032**

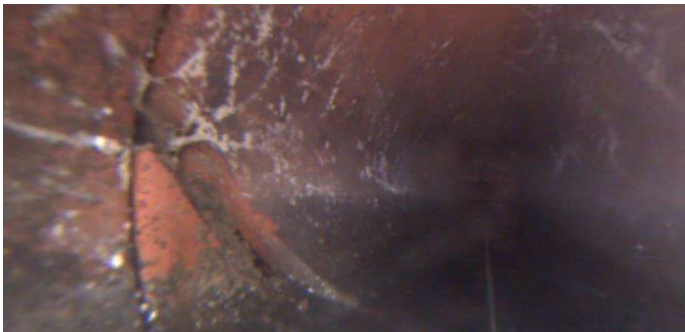
Code:	BSV
Description:	Broken Soil Visible

Distance (ft):	4.2
Structural Grade:	5
O&M Grade:	0
Clock Start/From:	3
Clock To:	5
1st Value:	
2nd Value:	
Value Percent:	
Continuous Index:	
Within 8" of Joint:	YES
Remarks:

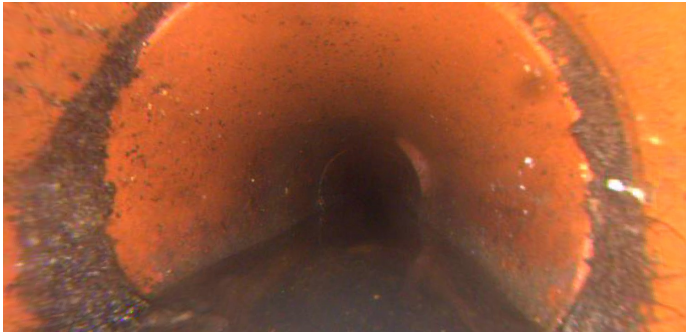
Code: **RFJ**
Description: **Roots Fine Joint**

Distance (ft): **62.9**
Structural Grade: **0**
O&M Grade: **1**
Clock Start/From: **8**
Clock To: **4**
1st Value:
2nd Value:
Value Percent:
Continuous Index:
Within 8" of Joint: **YES**
Remarks:

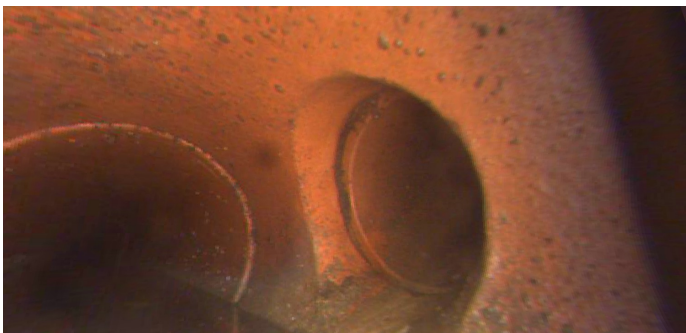
Code: **TF**
Description: **Tap Factory**

Distance (ft): **64.1**
Structural Grade: **0**
O&M Grade: **0**
Clock Start/From: **3**
Clock To:
1st Value: **4.000**
2nd Value:
Value Percent:
Continuous Index:
Within 8" of Joint:
Remarks:

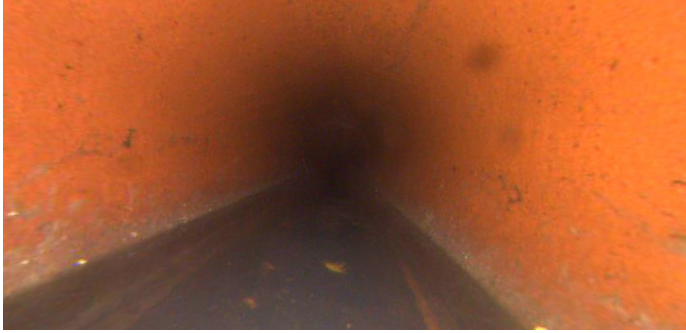
Code: **MWL**
Description: **Water Level**

Distance (ft): **71.8**
Structural Grade: **0**
O&M Grade: **0**
Clock Start/From:
Clock To:
1st Value:
2nd Value:
Value Percent: **20.000**
Continuous Index:
Within 8" of Joint: **NO**
Remarks:

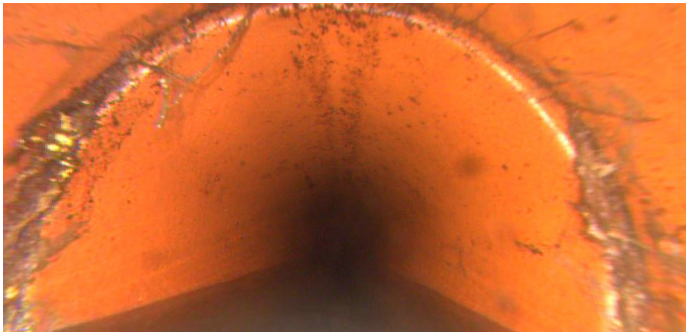
Code: **RFJ**
Description: **Roots Fine Joint**

Distance (ft): **95.1**
Structural Grade: **0**
O&M Grade: **1**
Clock Start/From: **8**
Clock To: **4**
1st Value:
2nd Value:
Value Percent:
Continuous Index:
Within 8" of Joint: **YES**
Remarks:

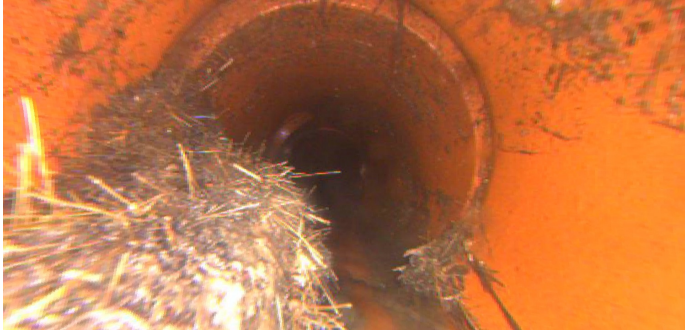
Code: **RMJ**
Description: **Roots Medium Joint**

Distance (ft): **104.4**
Structural Grade: **0**
O&M Grade: **3**
Clock Start/From: **7**
Clock To: **5**
1st Value:
2nd Value:
Value Percent: **20.000**
Continuous Index:
Within 8" of Joint: **YES**
Remarks:

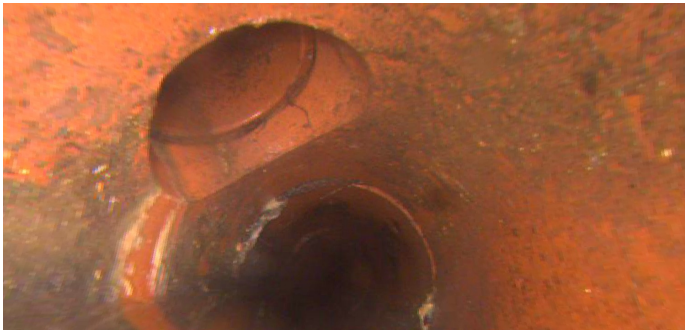
Code: **TF**
Description: **Tap Factory**

Distance (ft): **106.3**
Structural Grade: **0**
O&M Grade: **0**
Clock Start/From: **9**
Clock To:
1st Value: **4.000**
2nd Value:
Value Percent:
Continuous Index:
Within 8" of Joint:
Remarks:

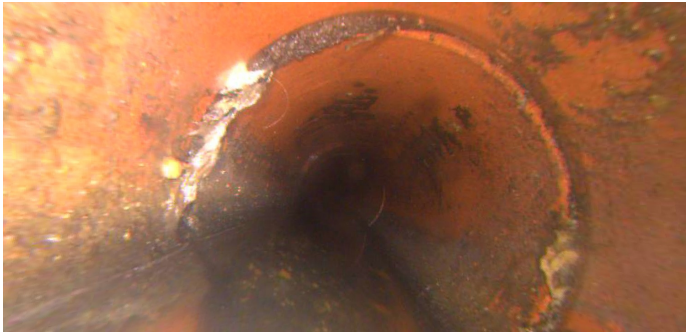
Code: **RFJ**
Description: **Roots Fine Joint**

Distance (ft): **106.8**
Structural Grade: **0**
O&M Grade: **1**
Clock Start/From: **8**
Clock To: **4**
1st Value:
2nd Value:
Value Percent:
Continuous Index:
Within 8" of Joint: **YES**
Remarks:

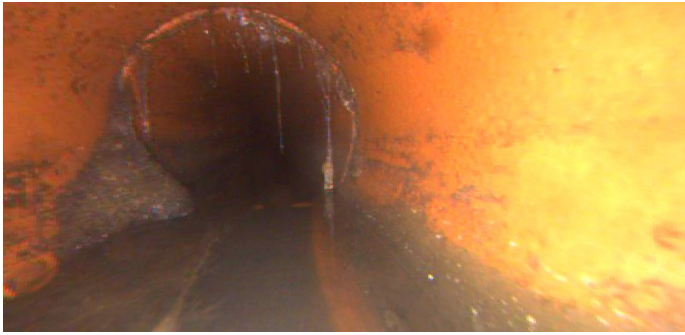
Code: **RMJ**
Description: **Roots Medium Joint**

Distance (ft): **112.9**
Structural Grade: **0**
O&M Grade: **3**
Clock Start/From: **7**
Clock To: **5**
1st Value:
2nd Value:
Value Percent: **20.000**
Continuous Index:
Within 8" of Joint: **YES**
Remarks:

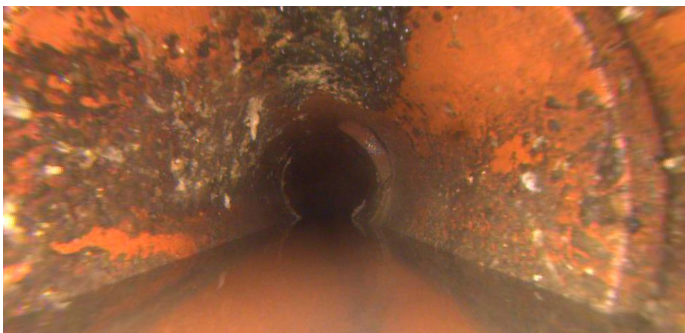
Code: **DAGS**
Description: **Deposits Attached Grease**

Distance (ft): **143.5**
Structural Grade: **0**
O&M Grade: **2**
Clock Start/From: **8**
Clock To: **4**
1st Value:
2nd Value:
Value Percent: **5.000**
Continuous Index:
Within 8" of Joint: **NO**
Remarks:

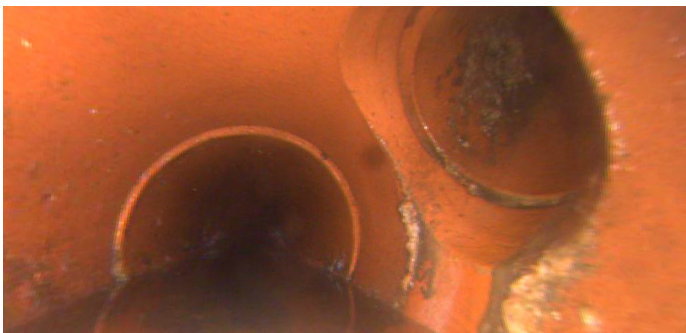
Code: **TF**
Description: **Tap Factory**

Distance (ft): **156.7**
Structural Grade: **0**
O&M Grade: **0**
Clock Start/From: **2**
Clock To:
1st Value: **4.000**
2nd Value:
Value Percent:
Continuous Index:
Within 8" of Joint:
Remarks:

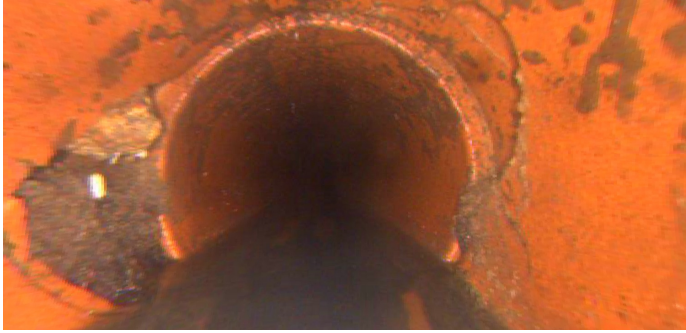
Code: **FM**
Description: **Fracture Multiple**

Distance (ft): **176.9**
Structural Grade: **4**
O&M Grade: **0**
Clock Start/From: **7**
Clock To: **3**
1st Value:
2nd Value:
Value Percent:
Continuous Index:
Within 8" of Joint: **YES**
Remarks:

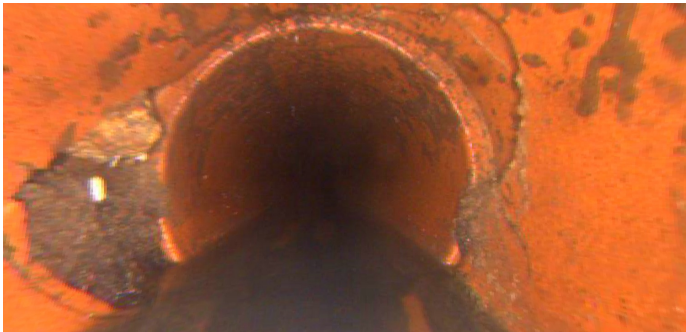
Code: **HSV**
Description: **Hole Soil Visible**

Distance (ft): **176.9**
Structural Grade: **5**
O&M Grade: **0**
Clock Start/From: **7**
Clock To: **9**
1st Value:
2nd Value:
Value Percent:
Continuous Index:
Within 8" of Joint: **YES**
Remarks:

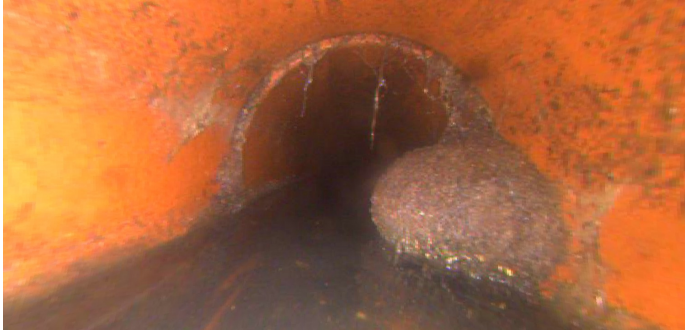
Code: **RMJ**
Description: **Roots Medium Joint**

Distance (ft): **216.5**
Structural Grade: **0**
O&M Grade: **3**
Clock Start/From: **7**
Clock To: **5**
1st Value:
2nd Value:
Value Percent: **20.000**
Continuous Index:
Within 8" of Joint: **YES**
Remarks:
