Profile/Photo Observation Report

Street:	CLEVELAND TERR	Flow Control:	Not Controlled
City:	Hobart, IN	Year Renewed:	
Location:	Other	Tape/Media #:	
Purpose:	Not Known	Dia/Height:	8"
Use:	Sanitary	Material:	VCP
Drain Area:	NA	Lining:	
Category:	NA		
Comment:

Location Details:		Direction of Survey:	Upstream
US MH:	M-904-034	DS MH:	M-904-033
		Total Length Surveyed (ft):	2.5

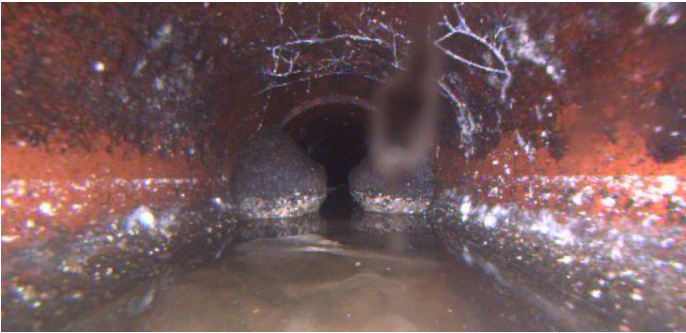
Code: **AMH**
Description: **Manhole**

Distance (ft): **.0**
Structural Grade: **0**
O&M Grade: **0**
Clock Start/From:
Clock To:
1st Value:
2nd Value:
Value Percent:
Continuous Index:
Within 8" of Joint: **NO**
Remarks: **M-904-033**

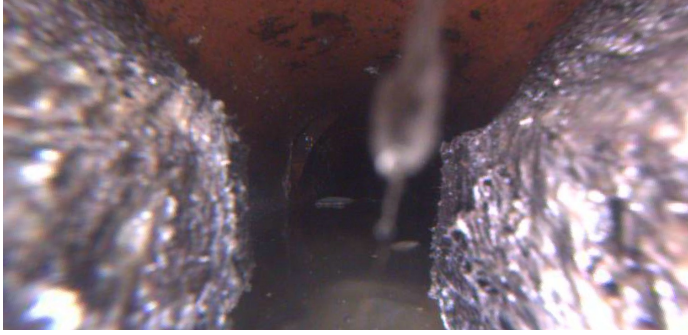
Code:	MSA
Description:	Abandoned Survey
Distance (ft):	2.5
Structural Grade:	0
O&M Grade:	0
Clock Start/From:	
Clock To:	
1st Value:	
2nd Value:	
Value Percent:	
Continuous Index:	
Within 8" of Joint:	NO
Remarks:	roots
