Profile/Photo Observation Report

Street:	Cleveland Terr.	Flow Control:	Not Controlled
City:	Hobart, IN	Year Renewed:	
Location:	Other	Tape/Media #:	
Purpose:	Not Known	Dia/Height:	8"
Use:	Sanitary	Material:	VCP
Drain Area:	NA	Lining:	
Category:	NA		
Comment:

Location Details:		Direction of Survey:	Upstream
US MH:	M-904-034	DS MH:	M-904-033
		Total Length Surveyed (ft):	2.5

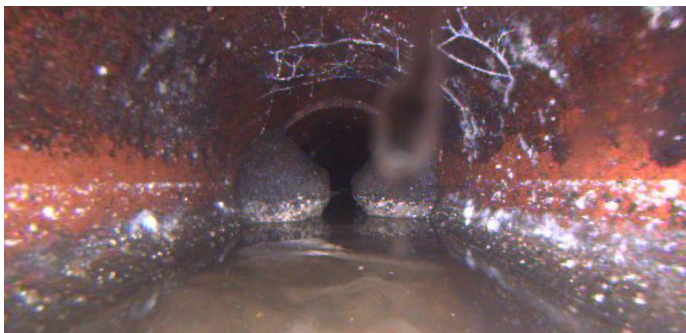
Code: **AMH**
Description: **Manhole**

Distance (ft): **.0**
Structural Grade: **0**
O&M Grade: **0**
Clock Start/From:
Clock To:
1st Value:
2nd Value:
Value Percent:
Continuous Index:
Within 8" of Joint: **NO**
Remarks: **M-904-033**

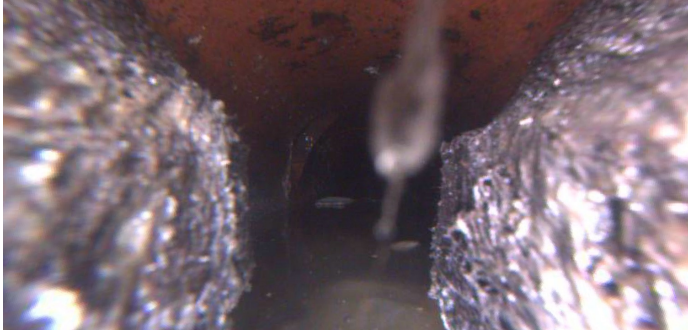
Code:	MSA
Description:	Abandoned Survey
Distance (ft):	2.5
Structural Grade:	0
O&M Grade:	0
Clock Start/From:	
Clock To:	
1st Value:	
2nd Value:	
Value Percent:	
Continuous Index:	
Within 8" of Joint:	NO
Remarks:	roots
