Profile/Photo Observation Report

Street:	CLEVELAND TERR	Flow Control:	Not Controlled
City:	Hobart, IN	Year Renewed:	
Location:	Other	Tape/Media #:	
Purpose:	Not Known	Dia/Height:	8"
Use:	Sanitary	Material:	VCP
Drain Area:	NA	Lining:	
Category:	NA		
Comment:

Location Details:		Direction of Survey:	Downstream
US MH:	M-904-034	DS MH:	M-904-033
		Total Length Surveyed (ft):	293.3

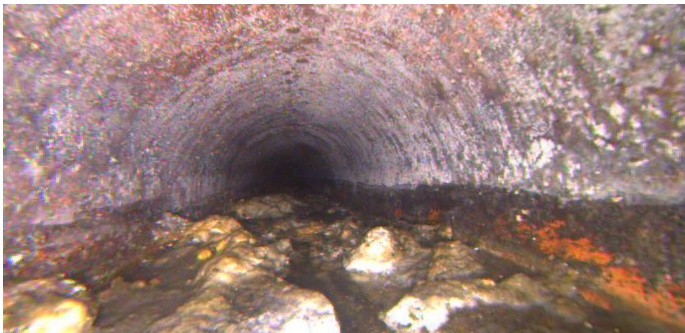
Code: **AMH**
Description: **Manhole**

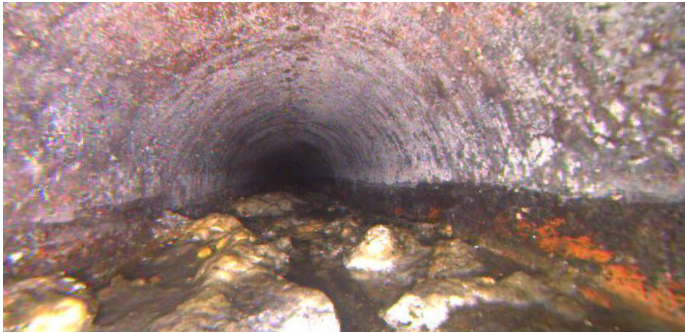
Code:	MWL
Description:	Water Level

Distance (ft):	.0
Structural Grade:	0
O&M Grade:	0
Clock Start/From:	
Clock To:	
1st Value:	
2nd Value:	
Value Percent:	30.000
Continuous Index:	
Within 8" of Joint:	NO
Remarks:

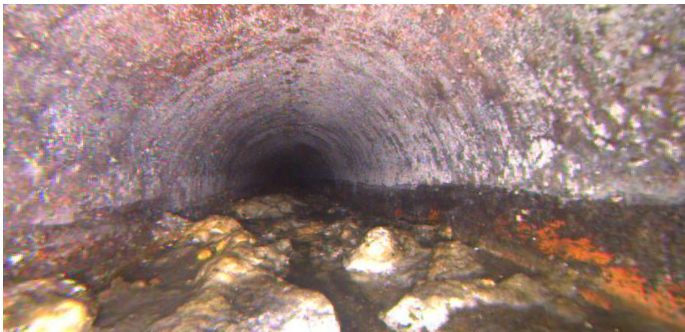
Code:	OBZ
Description:	Obstacle Other

Distance (ft):	.0
Structural Grade:	0
O&M Grade:	5
Clock Start/From:	3
Clock To:	9
1st Value:	
2nd Value:	
Value Percent:	40.000
Continuous Index:	S01
Within 8" of Joint:	NO
Remarks:	misc

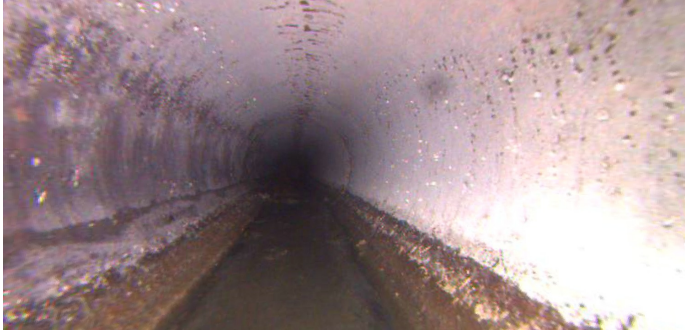
Code: **OBZ**
Description: **Obstacle Other**

Distance (ft): **15.8**
Structural Grade: **0**
O&M Grade: **5**
Clock Start/From: **3**
Clock To: **9**
1st Value:
2nd Value:
Value Percent: **40.000**
Continuous Index: **F01**
Within 8" of Joint: **NO**
Remarks: **misc**

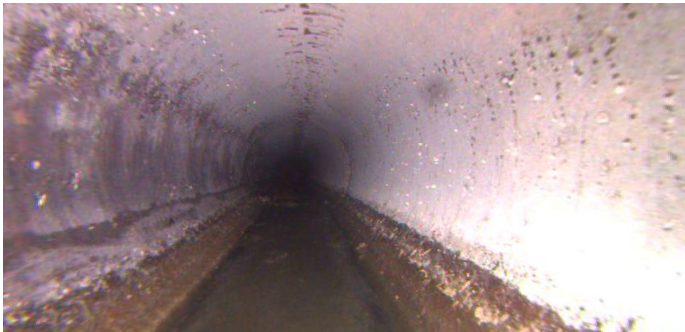
Code: **MWL**
Description: **Water Level**

Distance (ft): **15.8**
Structural Grade: **0**
O&M Grade: **0**
Clock Start/From:
Clock To:
1st Value:
2nd Value:
Value Percent: **5.000**
Continuous Index:
Within 8" of Joint: **NO**
Remarks:

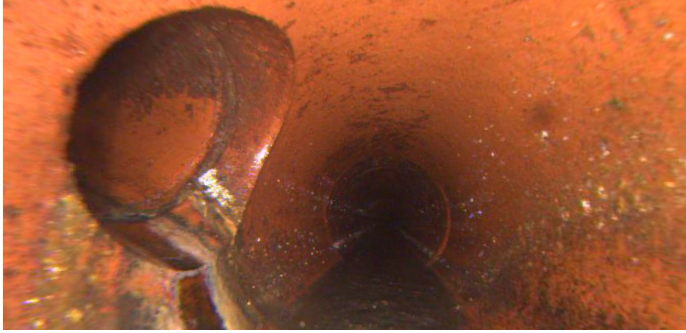
Code: **TFA**
Description: **Tap Factory Active**

Distance (ft): **108.1**
Structural Grade: **0**
O&M Grade: **0**
Clock Start/From: **9**
Clock To:
1st Value: **4.000**
2nd Value:
Value Percent:
Continuous Index:
Within 8" of Joint:
Remarks:

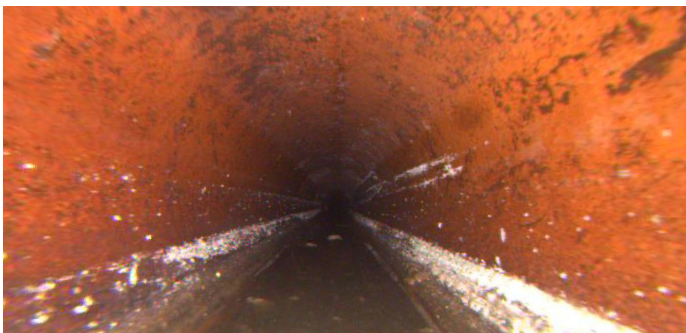
Code: **DAGS**
Description: **Deposits Attached Grease**

Distance (ft): **136.6**
Structural Grade: **0**
O&M Grade: **2**
Clock Start/From: **8**
Clock To: **4**
1st Value:
2nd Value:
Value Percent: **5.000**
Continuous Index: **S02**
Within 8" of Joint: **NO**
Remarks:

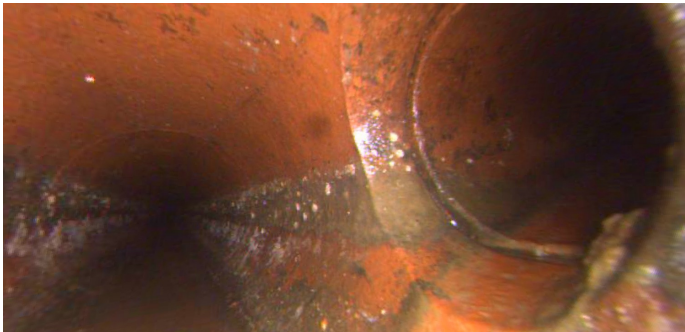
Code: **TF**
Description: **Tap Factory**

Distance (ft): **217.3**
Structural Grade: **0**
O&M Grade: **0**
Clock Start/From: **3**
Clock To:
1st Value: **4.000**
2nd Value:
Value Percent:
Continuous Index:
Within 8" of Joint:
Remarks:

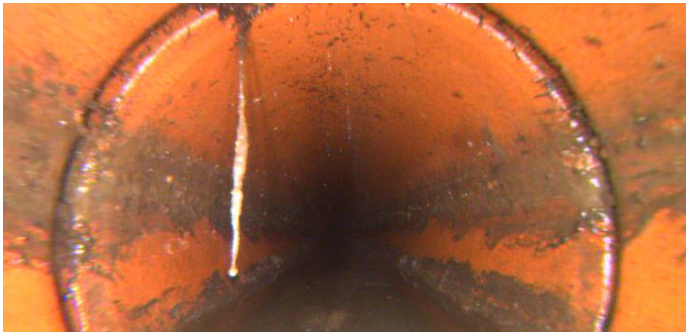
Code: **RFJ**
Description: **Roots Fine Joint**

Distance (ft): **275.2**
Structural Grade: **0**
O&M Grade: **1**
Clock Start/From: **11**
Clock To:
1st Value:
2nd Value:
Value Percent:
Continuous Index:
Within 8" of Joint: **YES**
Remarks:

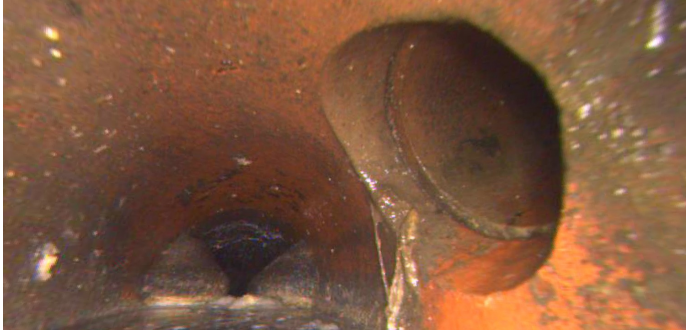
Code: **TF**
Description: **Tap Factory**

Distance (ft): **290.9**
Structural Grade: **0**
O&M Grade: **0**
Clock Start/From: **2**
Clock To:
1st Value: **4.000**
2nd Value:
Value Percent:
Continuous Index:
Within 8" of Joint:
Remarks:

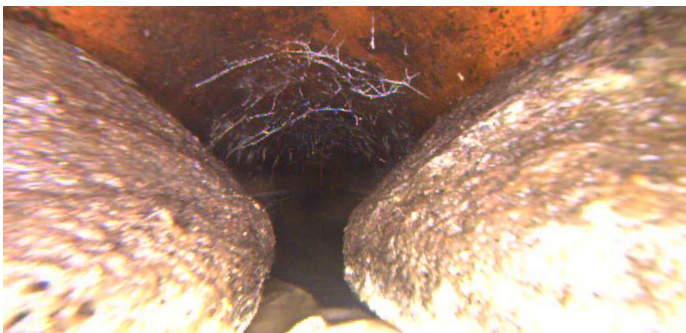
Code: **DAE**
Description: **Deposits Attached Encrustation**

Distance (ft): **292.5**
Structural Grade: **0**
O&M Grade: **5**
Clock Start/From: **7**
Clock To: **5**
1st Value:
2nd Value:
Value Percent: **60.000**
Continuous Index:
Within 8" of Joint: **YES**
Remarks:

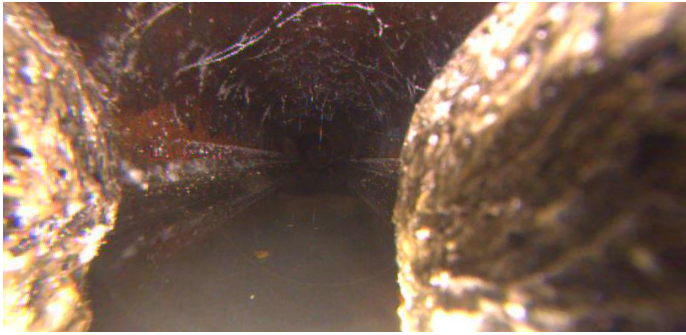
Code: **MSA**
Description: **Abandoned Survey**

Distance (ft): **293.3**
Structural Grade: **0**
O&M Grade: **0**
Clock Start/From:
Clock To:
1st Value:
2nd Value:
Value Percent:
Continuous Index:
Within 8" of Joint: **NO**
Remarks: **dae**

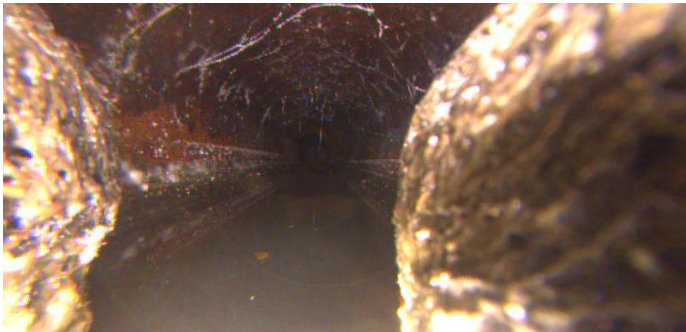
Code: **DAGS**
Description: **Deposits Attached Grease**

Distance (ft): **293.3**
Structural Grade: **0**
O&M Grade: **2**
Clock Start/From: **8**
Clock To: **4**
1st Value:
2nd Value:
Value Percent: **5.000**
Continuous Index: **F02**
Within 8" of Joint: **NO**
Remarks:
