Profile/Photo Observation Report

Street:	Cleveland Terr.	Flow Control:	Not Controlled
City:	Hobart, IN	Year Renewed:	
Location:	Other	Tape/Media #:	
Purpose:	Not Known	Dia/Height:	8"
Use:	Sanitary	Material:	VCP
Drain Area:	NA	Lining:	
Category:	NA		
Comment:

Location Details:		Direction of Survey:	Downstream
US MH:	M-904-034	DS MH:	M-904-033
		Total Length Surveyed (ft):	293.3

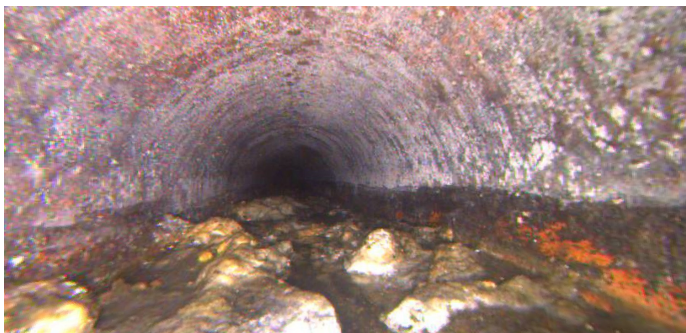
Code: **AMH**
Description: **Manhole**

Distance (ft): **.0**
Structural Grade: **0**
O&M Grade: **0**
Clock Start/From:
Clock To:
1st Value:
2nd Value:
Value Percent:
Continuous Index:
Within 8" of Joint: **NO**
Remarks: **M-904-034**

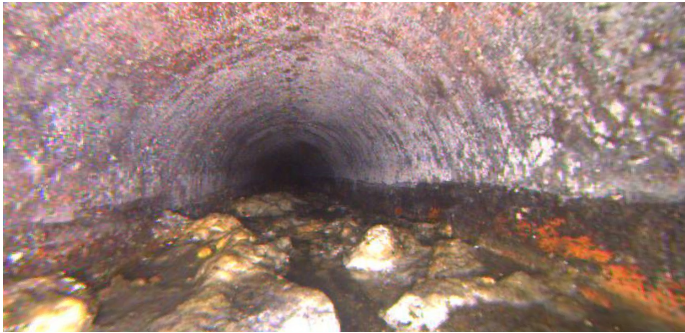
Code:	MWL
Description:	Water Level

Distance (ft):	.0
Structural Grade:	0
O&M Grade:	0
Clock Start/From:	
Clock To:	
1st Value:	
2nd Value:	
Value Percent:	30.000
Continuous Index:	
Within 8" of Joint:	NO
Remarks:

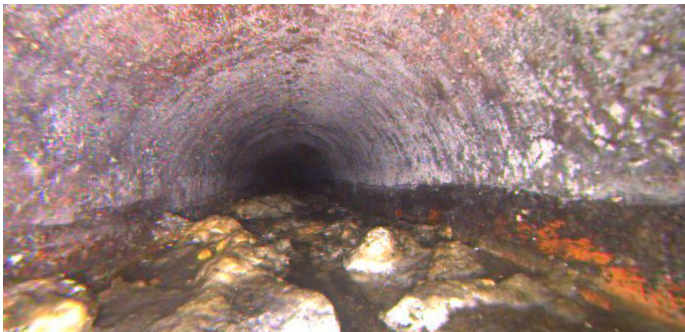
Code:	OBZ
Description:	Obstacle Other

Distance (ft):	.0
Structural Grade:	0
O&M Grade:	5
Clock Start/From:	3
Clock To:	9
1st Value:	
2nd Value:	
Value Percent:	40.000
Continuous Index:	S01
Within 8" of Joint:	NO
Remarks:	misc

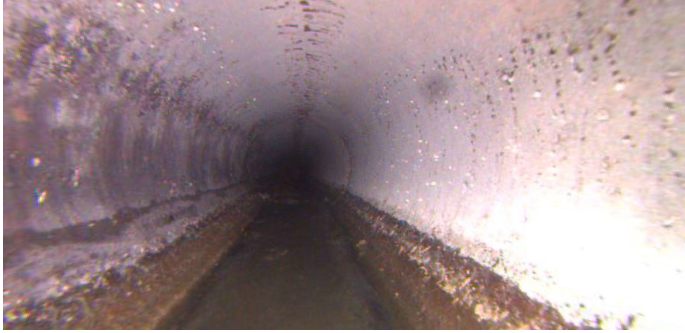
Code: **OBZ**
Description: **Obstacle Other**

Distance (ft): **15.8**
Structural Grade: **0**
O&M Grade: **5**
Clock Start/From: **3**
Clock To: **9**
1st Value:
2nd Value:
Value Percent: **40.000**
Continuous Index: **F01**
Within 8" of Joint: **NO**
Remarks: **misc**

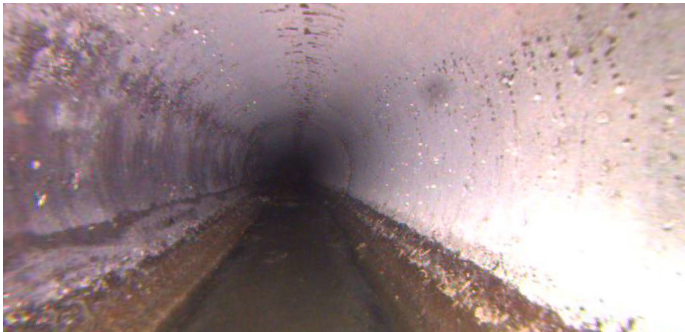
Code: **MWL**
Description: **Water Level**

Distance (ft): **15.8**
Structural Grade: **0**
O&M Grade: **0**
Clock Start/From:
Clock To:
1st Value:
2nd Value:
Value Percent: **5.000**
Continuous Index:
Within 8" of Joint: **NO**
Remarks:

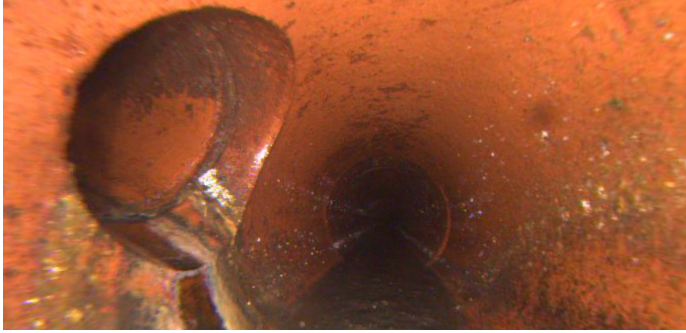
Code: **TFA**
Description: **Tap Factory Active**

Distance (ft): **108.1**
Structural Grade: **0**
O&M Grade: **0**
Clock Start/From: **9**
Clock To:
1st Value: **4.000**
2nd Value:
Value Percent:
Continuous Index:
Within 8" of Joint:
Remarks:

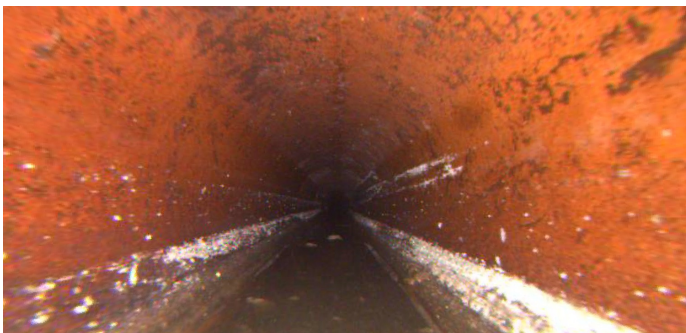
Code: **DAGS**
Description: **Deposits Attached Grease**

Distance (ft): **136.6**
Structural Grade: **0**
O&M Grade: **2**
Clock Start/From: **8**
Clock To: **4**
1st Value:
2nd Value:
Value Percent: **5.000**
Continuous Index: **S02**
Within 8" of Joint: **NO**
Remarks:

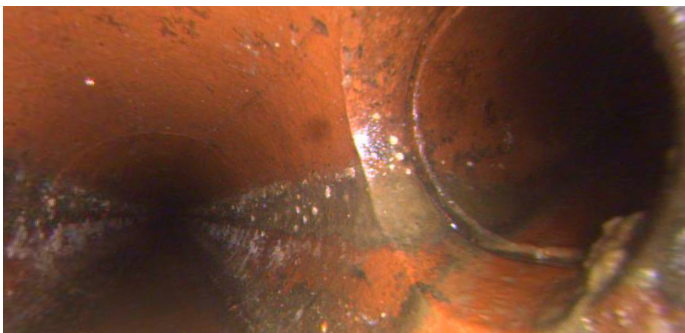
Code: **TF**
Description: **Tap Factory**

Distance (ft): **217.3**
Structural Grade: **0**
O&M Grade: **0**
Clock Start/From: **3**
Clock To:
1st Value: **4.000**
2nd Value:
Value Percent:
Continuous Index:
Within 8" of Joint:
Remarks:

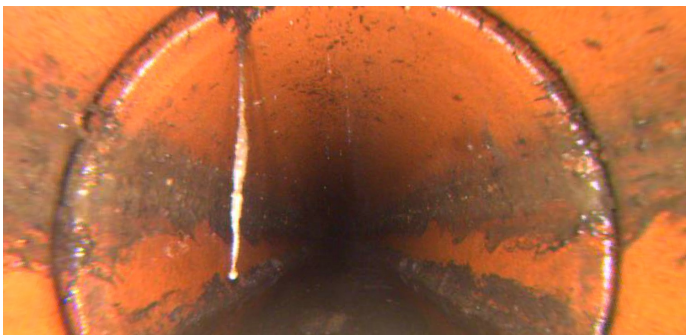
Code: **RFJ**
Description: **Roots Fine Joint**

Distance (ft): **275.2**
Structural Grade: **0**
O&M Grade: **1**
Clock Start/From: **11**
Clock To:
1st Value:
2nd Value:
Value Percent:
Continuous Index:
Within 8" of Joint: **YES**
Remarks:

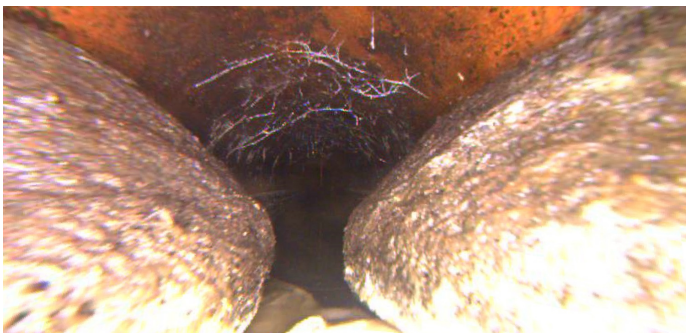
Code: **DAE**
Description: **Deposits Attached Encrustation**

Distance (ft): **292.5**
Structural Grade: **0**
O&M Grade: **5**
Clock Start/From: **7**
Clock To: **5**
1st Value:
2nd Value:
Value Percent: **60.000**
Continuous Index:
Within 8" of Joint: **YES**
Remarks:

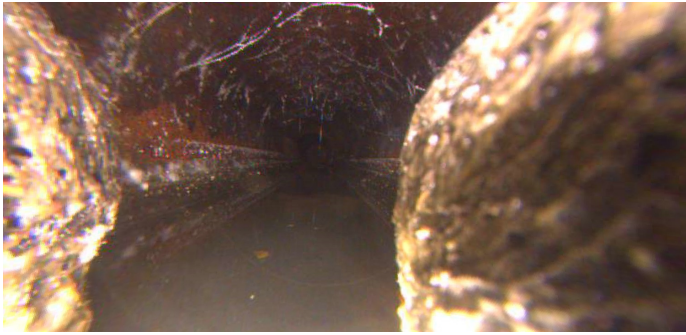
Code: **MSA**
Description: **Abandoned Survey**

Distance (ft): **293.3**
Structural Grade: **0**
O&M Grade: **0**
Clock Start/From:
Clock To:
1st Value:
2nd Value:
Value Percent:
Continuous Index:
Within 8" of Joint: **NO**
Remarks: **dae**

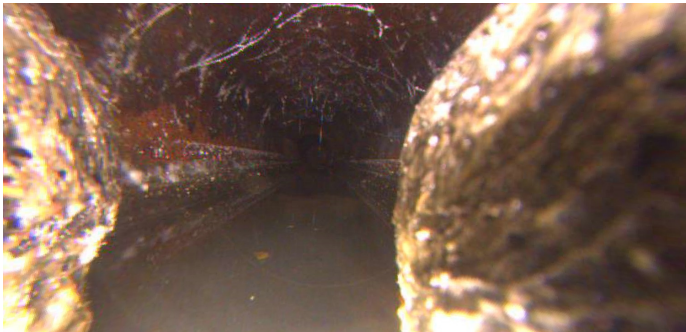
Code: **DAGS**
Description: **Deposits Attached Grease**

Distance (ft): **293.3**
Structural Grade: **0**
O&M Grade: **2**
Clock Start/From: **8**
Clock To: **4**
1st Value:
2nd Value:
Value Percent: **5.000**
Continuous Index: **F02**
Within 8" of Joint: **NO**
Remarks:
