Profile/Photo Observation Report

Street:	CLEVELAND TERR	Flow Control:	Not Controlled
City:	Hobart, IN	Year Renewed:	
Location:	Other	Tape/Media #:	
Purpose:	Not Known	Dia/Height:	10"
Use:	Sanitary	Material:	VCP
Drain Area:	NA	Lining:	
Category:	NA		
Comment:

Location Details:		Direction of Survey:	Downstream
US MH:	M-904-034	DS MH:	M-904-035
		Total Length Surveyed (ft):	79.6

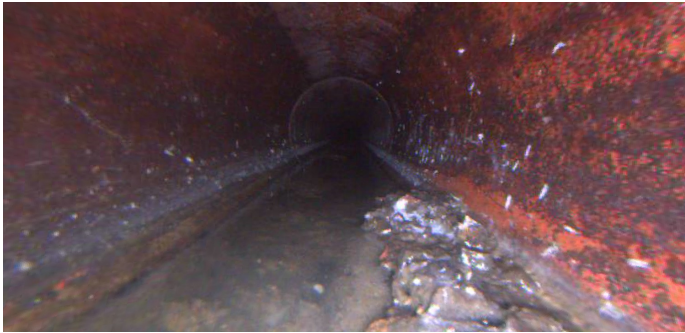
Code:	MWL
Description:	Water Level

Distance (ft):	.0
Structural Grade:	0
O&M Grade:	0
Clock Start/From:	
Clock To:	
1st Value:	
2nd Value:	
Value Percent:	10.000
Continuous Index:	
Within 8" of Joint:	NO
Remarks:

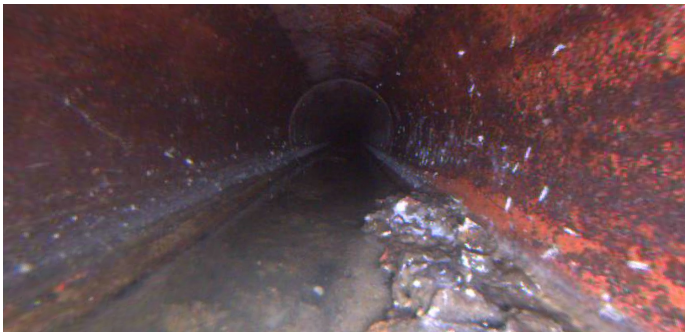
Code:	DSZ
Description:	Deposits Settled Other

Distance (ft):	.0
Structural Grade:	0
O&M Grade:	2
Clock Start/From:	4
Clock To:	5
1st Value:	
2nd Value:	
Value Percent:	10.000
Continuous Index:	
Within 8" of Joint:	NO
Remarks:	MISC

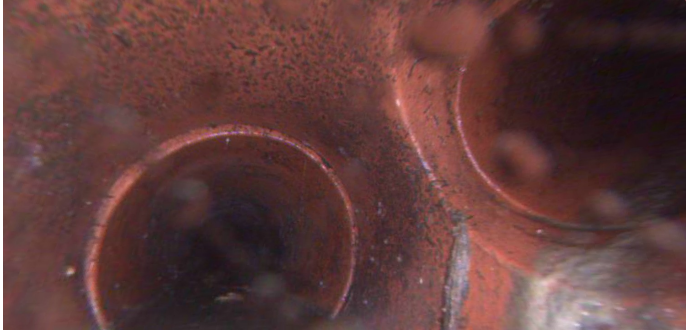
Code: **TF**
Description: **Tap Factory**

Distance (ft): **68.8**
Structural Grade: **0**
O&M Grade: **0**
Clock Start/From: **2**
Clock To:
1st Value: **4.000**
2nd Value:
Value Percent:
Continuous Index:
Within 8" of Joint:
Remarks:

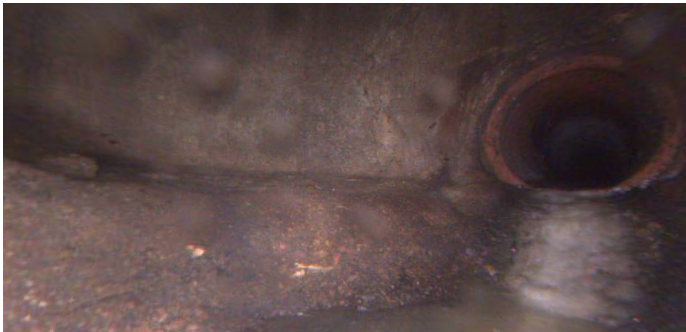
Code: **AMH**
Description: **Manhole**

Distance (ft): **79.6**
Structural Grade: **0**
O&M Grade: **0**
Clock Start/From:
Clock To:
1st Value:
2nd Value:
Value Percent:
Continuous Index:
Within 8" of Joint: **NO**
Remarks: **M-904-035**
