Profile/Photo Observation Report

Street:	Cleveland Terr.	Flow Control:	Not Controlled
City:	Hobart, IN	Year Renewed:	
Location:	Other	Tape/Media #:	
Purpose:	Not Known	Dia/Height:	10"
Use:	Sanitary	Material:	VCP
Drain Area:	NA	Lining:	
Category:	NA		
Comment:

Location Details:		Direction of Survey:	Downstream
US MH:	M-904-034	DS MH:	M-904-035
		Total Length Surveyed (ft):	79.6

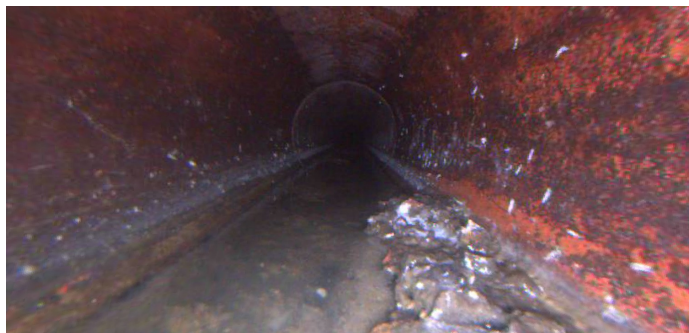
Code: **AMH**
Description: **Manhole**

Distance (ft): **.0**
Structural Grade: **0**
O&M Grade: **0**
Clock Start/From:
Clock To:
1st Value:
2nd Value:
Value Percent:
Continuous Index:
Within 8" of Joint: **NO**
Remarks: **M-904-034**

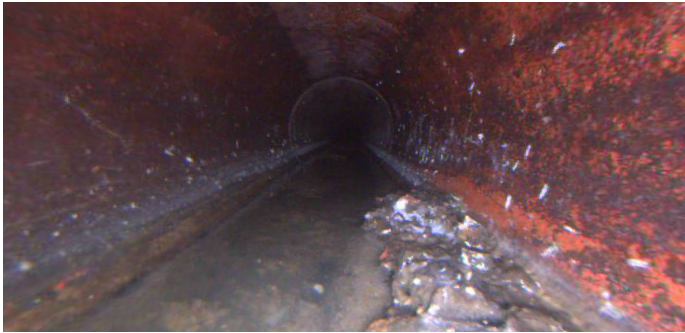
Code:	MWL
Description:	Water Level

Distance (ft):	.0
Structural Grade:	0
O&M Grade:	0
Clock Start/From:	
Clock To:	
1st Value:	
2nd Value:	
Value Percent:	10.000
Continuous Index:	
Within 8" of Joint:	NO
Remarks:

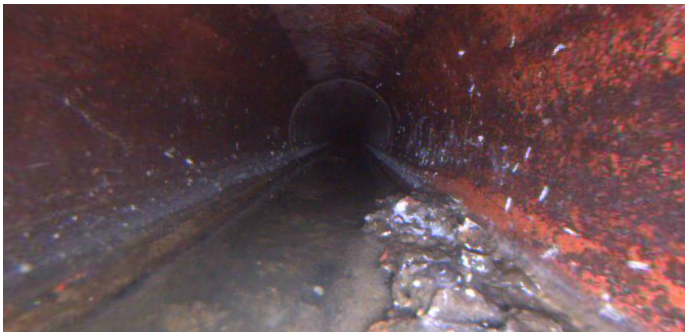
Code:	DSZ
Description:	Deposits Settled Other

Distance (ft):	.0
Structural Grade:	0
O&M Grade:	2
Clock Start/From:	4
Clock To:	5
1st Value:	
2nd Value:	
Value Percent:	10.000
Continuous Index:	
Within 8" of Joint:	NO
Remarks:	MISC

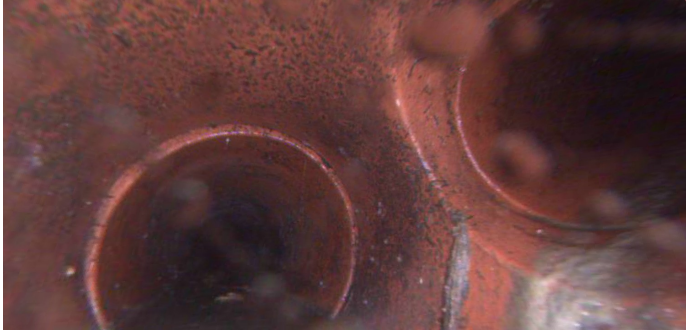
Code: **TF**
Description: **Tap Factory**

Distance (ft): **68.8**
Structural Grade: **0**
O&M Grade: **0**
Clock Start/From: **2**
Clock To:
1st Value: **4.000**
2nd Value:
Value Percent:
Continuous Index:
Within 8" of Joint:
Remarks:

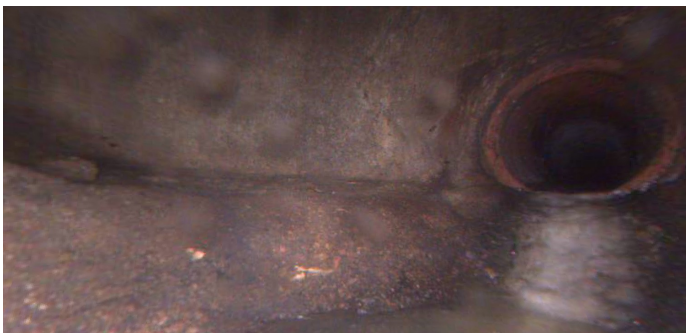
Code: **AMH**
Description: **Manhole**

Distance (ft): **79.6**
Structural Grade: **0**
O&M Grade: **0**
Clock Start/From:
Clock To:
1st Value:
2nd Value:
Value Percent:
Continuous Index:
Within 8" of Joint: **NO**
Remarks: **M-904-035**
