Profile/Photo Observation Report

Date:	04/11/2018	Weather:		Coding:	PACP 6.0
Pipe Length (ft):	175.6	Owner:	NA	Pre Clean:	Not Known
P.O.#:		Surveyor:	Jen Costello	PSR:	P-904-036-034
Customer:		Clean Date:	01/01/1900	Shape:	C

Street:	CLEVELAND TERR	Flow Control:	Not Controlled
City:	Hobart, IN	Year Renewed:	
Location:	Other	Tape/Media #:	
Purpose:	Not Known	Dia/Height:	10"
Use:	Sanitary	Material:	VCP
Drain Area:	NA	Lining:	
Category:	NA		
Comment:	NULL - MH-M-704-063 Debris at entrance		
Location Details:		Direction of Survey:	Downstream
US MH:	M-904-034	DS MH:	M-904-036
		Total Length Surveyed (ft):	41.0

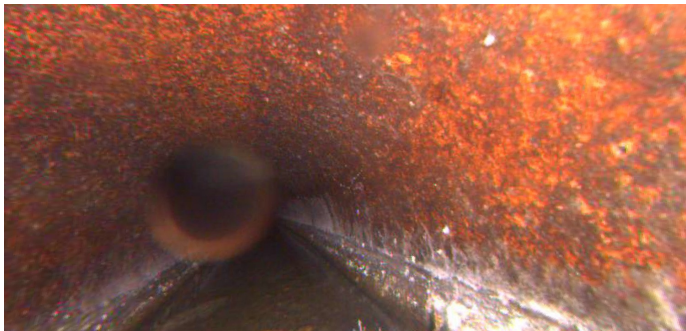
Code: **AMH**
Description: **Manhole**

Distance (ft): **.0**
Structural Grade: **0**
O&M Grade: **0**
Clock Start/From:
Clock To:
1st Value:
2nd Value:
Value Percent:
Continuous Index:
Within 8" of Joint: **NO**
Remarks: **M-904-034**

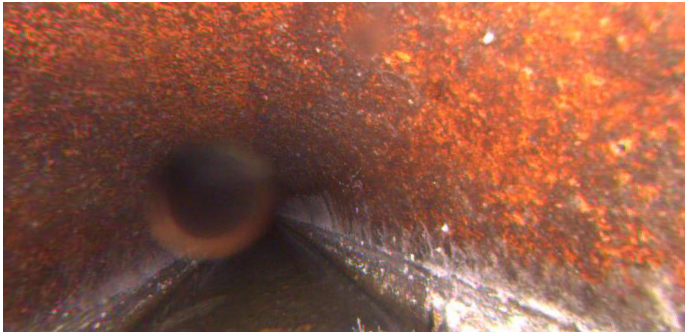
Code:	MWL
Description:	Water Level

Distance (ft):	.0
Structural Grade:	0
O&M Grade:	0
Clock Start/From:	
Clock To:	
1st Value:	
2nd Value:	
Value Percent:	10.000
Continuous Index:	
Within 8" of Joint:	NO
Remarks:

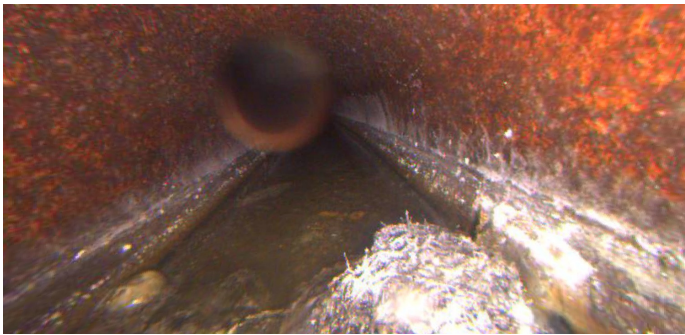
Code:	OBZ
Description:	Obstacle Other

Distance (ft):	.0
Structural Grade:	0
O&M Grade:	2
Clock Start/From:	4
Clock To:	6
1st Value:	
2nd Value:	
Value Percent:	10.000
Continuous Index:	
Within 8" of Joint:	NO
Remarks:	UNKNWON

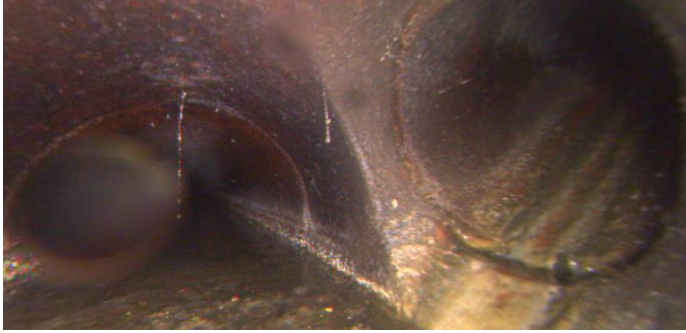
Code: **TF**
Description: **Tap Factory**

Distance (ft): **9.2**
Structural Grade: **0**
O&M Grade: **0**
Clock Start/From: **3**
Clock To:
1st Value: **4.000**
2nd Value:
Value Percent:
Continuous Index:
Within 8" of Joint:
Remarks:

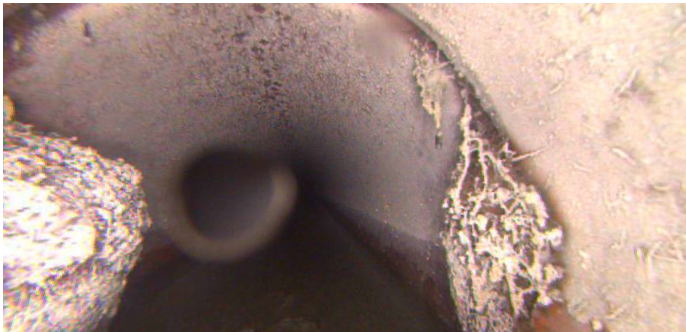
Code: **RMJ**
Description: **Roots Medium Joint**

Distance (ft): **29.7**
Structural Grade: **0**
O&M Grade: **3**
Clock Start/From: **8**
Clock To: **4**
1st Value:
2nd Value:
Value Percent: **10.000**
Continuous Index:
Within 8" of Joint: **YES**
Remarks:

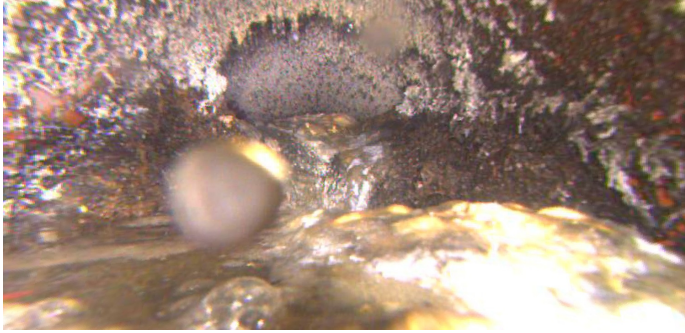
Code: **RBJ**
Description: **Roots Ball Joint**

Distance (ft): **39.5**
Structural Grade: **0**
O&M Grade: **4**
Clock Start/From: **8**
Clock To: **4**
1st Value:
2nd Value:
Value Percent: **60.000**
Continuous Index:
Within 8" of Joint: **YES**
Remarks:

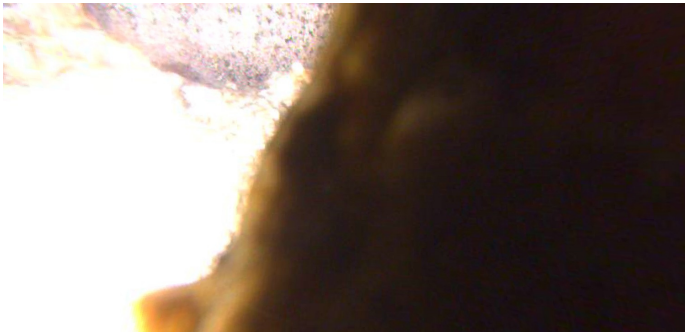
Code: **MSA**
Description: **Abandoned Survey**

Distance (ft): **41.0**
Structural Grade: **0**
O&M Grade: **0**
Clock Start/From:
Clock To:
1st Value:
2nd Value:
Value Percent:
Continuous Index:
Within 8" of Joint: **NO**
Remarks: **ROOTS**
