Profile/Photo Observation Report

Date:	04/11/2018	Weather:		Coding:	PACP 6.0
Pipe Length (ft):	175.6	Owner:	NA	Pre Clean:	Not Known
P.O.#:		Surveyor:	Jen Costello	PSR:	P-904-036-034
Customer:		Clean Date:	01/01/1900	Shape:	C

Street:	Cleveland Terr.	Flow Control:	Not Controlled
City:	Hobart, IN	Year Renewed:	
Location:	Other	Tape/Media #:	
Purpose:	Not Known	Dia/Height:	10"
Use:	Sanitary	Material:	VCP
Drain Area:	NA	Lining:	
Category:	NA		
Comment:	NULL - MH-M-704-063 Debris at entrance		
Location Details:		Direction of Survey:	Downstream
US MH:	M-904-034	DS MH:	M-904-036
		Total Length Surveyed (ft):	41.0

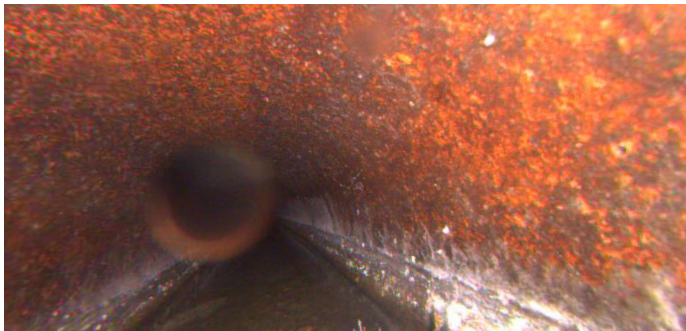
Code: **AMH**
Description: **Manhole**

Distance (ft): **.0**
Structural Grade: **0**
O&M Grade: **0**
Clock Start/From:
Clock To:
1st Value:
2nd Value:
Value Percent:
Continuous Index:
Within 8" of Joint: **NO**
Remarks: **M-904-034**

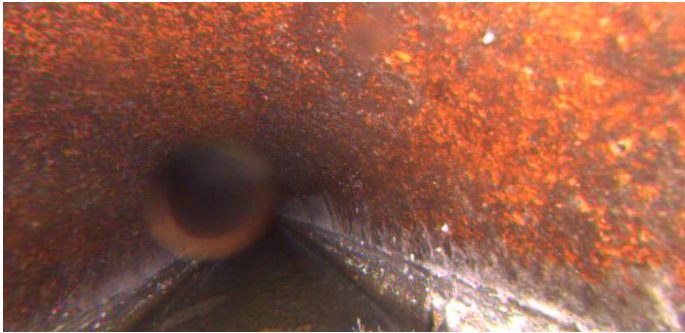
Code:	MWL
Description:	Water Level

Distance (ft):	.0
Structural Grade:	0
O&M Grade:	0
Clock Start/From:	
Clock To:	
1st Value:	
2nd Value:	
Value Percent:	10.000
Continuous Index:	
Within 8" of Joint:	NO
Remarks:

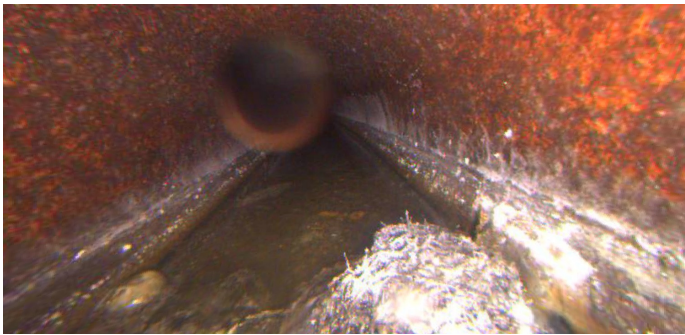
Code:	OBZ
Description:	Obstacle Other

Distance (ft):	.0
Structural Grade:	0
O&M Grade:	2
Clock Start/From:	4
Clock To:	6
1st Value:	
2nd Value:	
Value Percent:	10.000
Continuous Index:	
Within 8" of Joint:	NO
Remarks:	UNKNWON

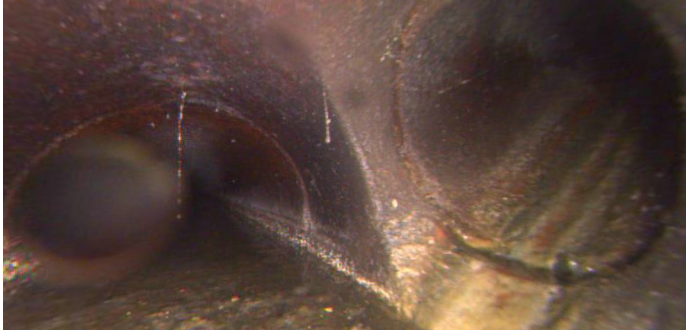
Code: **TF**
Description: **Tap Factory**

Distance (ft): **9.2**
Structural Grade: **0**
O&M Grade: **0**
Clock Start/From: **3**
Clock To:
1st Value: **4.000**
2nd Value:
Value Percent:
Continuous Index:
Within 8" of Joint:
Remarks:

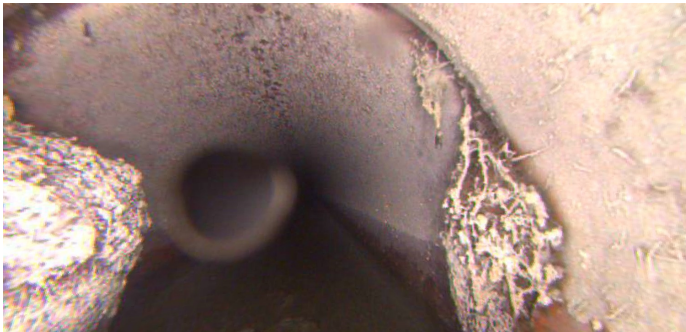
Code: **RMJ**
Description: **Roots Medium Joint**

Distance (ft): **29.7**
Structural Grade: **0**
O&M Grade: **3**
Clock Start/From: **8**
Clock To: **4**
1st Value:
2nd Value:
Value Percent: **10.000**
Continuous Index:
Within 8" of Joint: **YES**
Remarks:

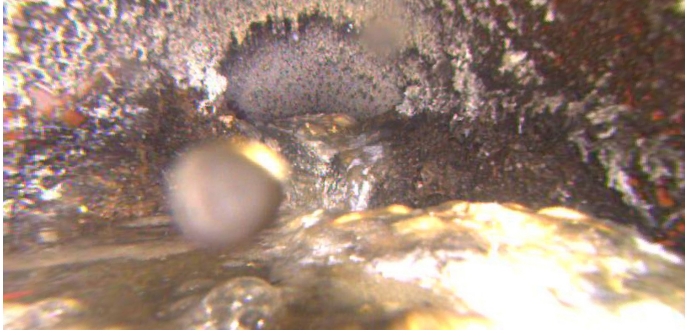
Code: **RBJ**
Description: **Roots Ball Joint**

Distance (ft): **39.5**
Structural Grade: **0**
O&M Grade: **4**
Clock Start/From: **8**
Clock To: **4**
1st Value:
2nd Value:
Value Percent: **60.000**
Continuous Index:
Within 8" of Joint: **YES**
Remarks:

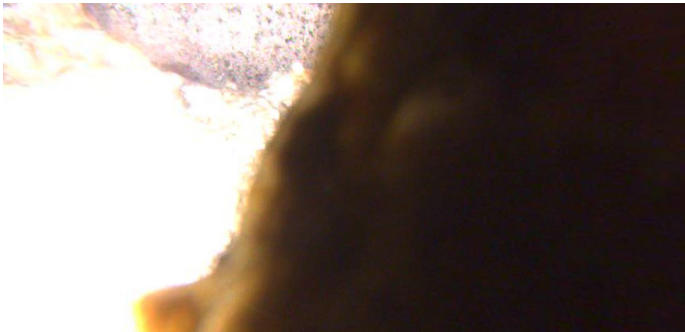
Code: **MSA**
Description: **Abandoned Survey**

Distance (ft): **41.0**
Structural Grade: **0**
O&M Grade: **0**
Clock Start/From:
Clock To:
1st Value:
2nd Value:
Value Percent:
Continuous Index:
Within 8" of Joint: **NO**
Remarks: **ROOTS**
