Profile/Photo Observation Report

Street:	Brandt Pl.	Flow Control:	Not Controlled
City:	Hobart, IN	Year Renewed:	
Location:	Light Highway	Tape/Media #:	
Purpose:	Routine Assessment	Dia/Height:	10"
Use:	Sanitary	Material:	VCP
Drain Area:	NA	Lining:	
Category:	NA		
Comment:

Location Details:		Direction of Survey:	Upstream
US MH:	M-904-038	DS MH:	M-904-037
		Total Length Surveyed (ft):	211.5

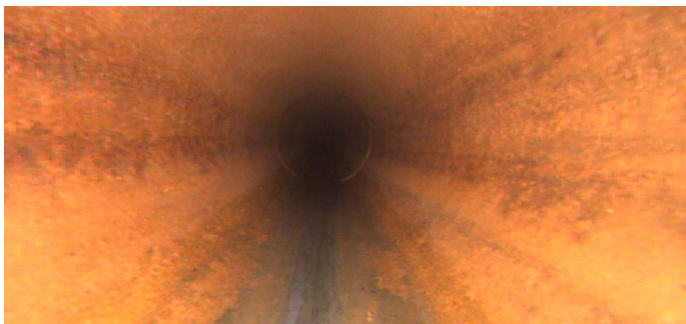
Code: **AMH**
Description: **Manhole**

Distance (ft): **.0**
Structural Grade: **0**
O&M Grade: **0**
Clock Start/From:
Clock To:
1st Value:
2nd Value:
Value Percent:
Continuous Index:
Within 8" of Joint: **NO**
Remarks: **M-904-037**

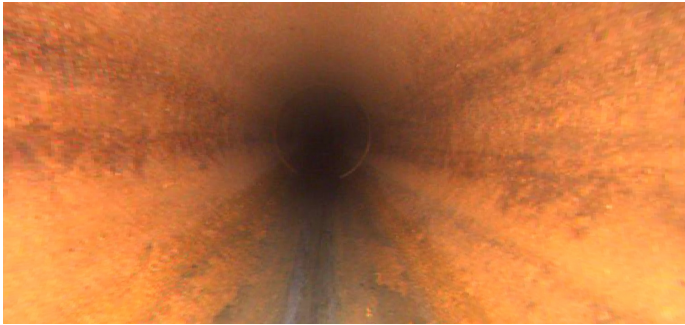
Code:	MWL
Description:	Water Level

Distance (ft):	.0
Structural Grade:	0
O&M Grade:	0
Clock Start/From:	
Clock To:	
1st Value:	
2nd Value:	
Value Percent:	5.000
Continuous Index:	
Within 8" of Joint:	NO
Remarks:

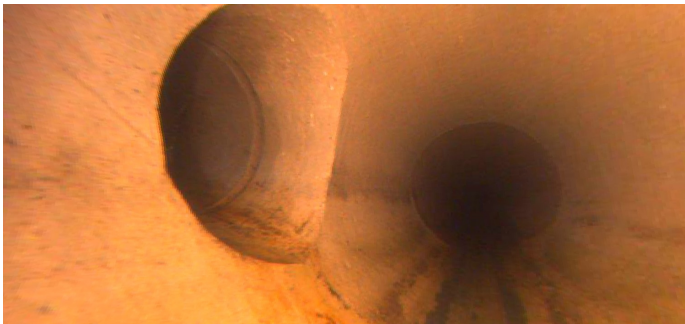
Code:	TF
Description:	Tap Factory

Distance (ft):	23.6
Structural Grade:	0
O&M Grade:	0
Clock Start/From:	9
Clock To:	
1st Value:	4.000
2nd Value:	
Value Percent:	
Continuous Index:	
Within 8" of Joint:	
Remarks:

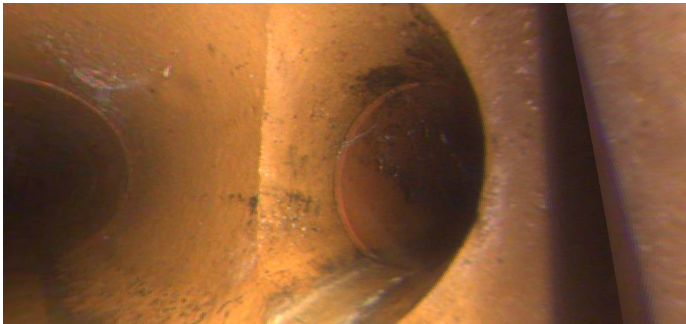
Code: **TF**
Description: **Tap Factory**

Distance (ft): **102.4**
Structural Grade: **0**
O&M Grade: **0**
Clock Start/From: **3**
Clock To:
1st Value: **4.000**
2nd Value:
Value Percent:
Continuous Index:
Within 8" of Joint:
Remarks:

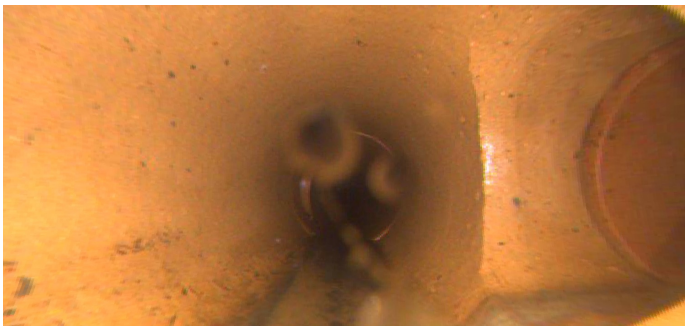
Code: **TF**
Description: **Tap Factory**

Distance (ft): **161.1**
Structural Grade: **0**
O&M Grade: **0**
Clock Start/From: **3**
Clock To:
1st Value: **4.000**
2nd Value:
Value Percent:
Continuous Index:
Within 8" of Joint: **NO**
Remarks:

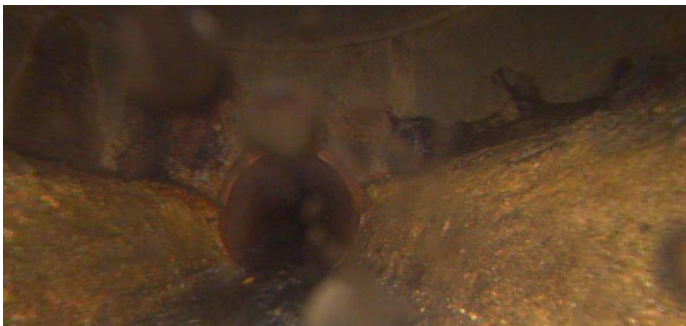
Code: **AMH**
Description: **Manhole**

Distance (ft): **211.5**
Structural Grade: **0**
O&M Grade: **0**
Clock Start/From:
Clock To:
1st Value:
2nd Value:
Value Percent:
Continuous Index:
Within 8" of Joint: **NO**
Remarks: **M-904-038**
