Profile/Photo Observation Report

Date:	04/05/2018	Weather:		Coding:	PACP 6.0
Pipe Length (ft):	230.3	Owner:	NA	Pre Clean:	Not Known
P.O.#:		Surveyor:	Jen Costello	PSR:	P-904-038-039
Customer:		Clean Date:	01/01/1900	Shape:	C

Street:	BRANDT PL	Flow Control:	Not Controlled
City:	Hobart, IN	Year Renewed:	
Location:	Other	Tape/Media #:	
Purpose:	Not Known	Dia/Height:	10"
Use:	Sanitary	Material:	PVC
Drain Area:	NA	Lining:	
Category:	NA		
Comment:			
Location Details:		Direction of Survey:	Upstream
US MH:	M-904-039	DS MH:	M-904-038
		Total Length Surveyed (ft):	215.4

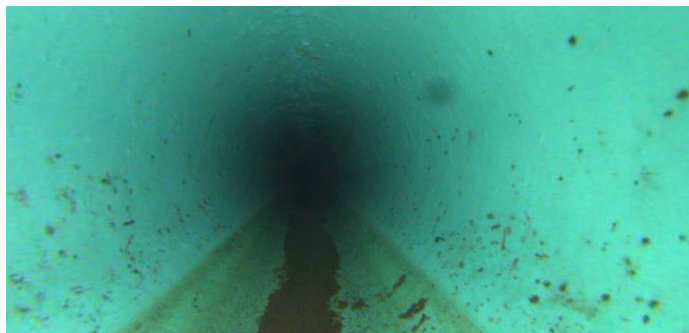
Code: **AMH**
Description: **Manhole**

Distance (ft): **.0**
Structural Grade: **0**
O&M Grade: **0**
Clock Start/From:
Clock To:
1st Value:
2nd Value:
Value Percent:
Continuous Index:
Within 8" of Joint: **NO**
Remarks: **M-904-038**

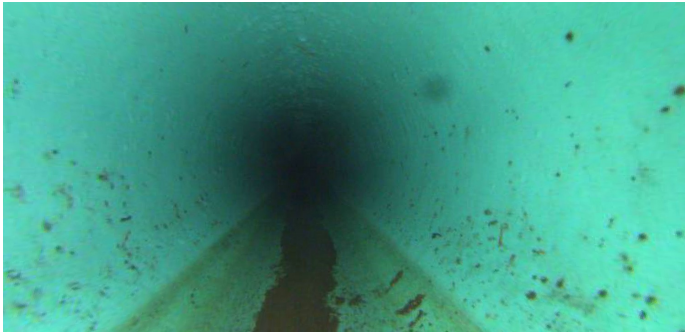
Code:	MWL
Description:	Water Level

Distance (ft):	.0
Structural Grade:	0
O&M Grade:	0
Clock Start/From:	
Clock To:	
1st Value:	
2nd Value:	
Value Percent:	5.000
Continuous Index:	
Within 8" of Joint:	NO
Remarks:

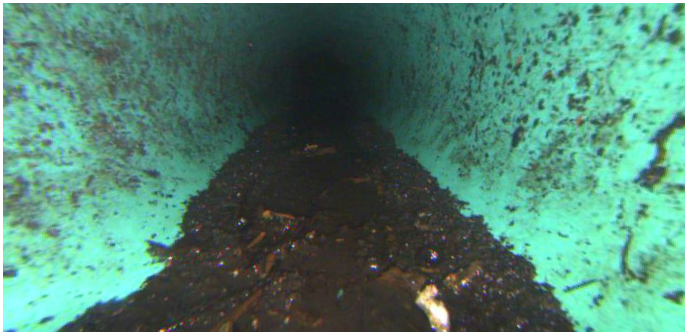
Code: **DSF**
Description: **Deposits Settled Fine**

Distance (ft): **58.3**
Structural Grade: **0**
O&M Grade: **2**
Clock Start/From: **5**
Clock To: **7**
1st Value:
2nd Value:
Value Percent: **10.000**
Continuous Index: **S01**
Within 8" of Joint: **NO**
Remarks:

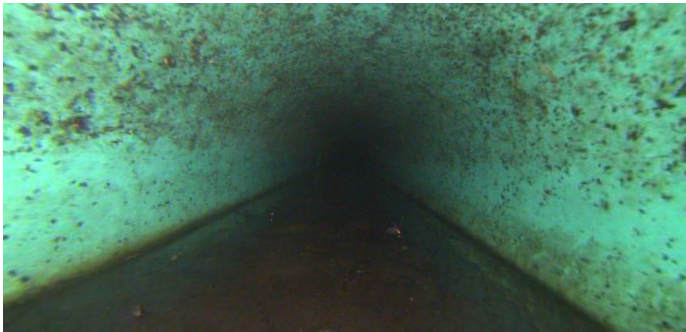
Code: **MWL**
Description: **Water Level**

Distance (ft): **113.4**
Structural Grade: **0**
O&M Grade: **0**
Clock Start/From:
Clock To:
1st Value:
2nd Value:
Value Percent: **30.000**
Continuous Index:
Within 8" of Joint: **NO**
Remarks:

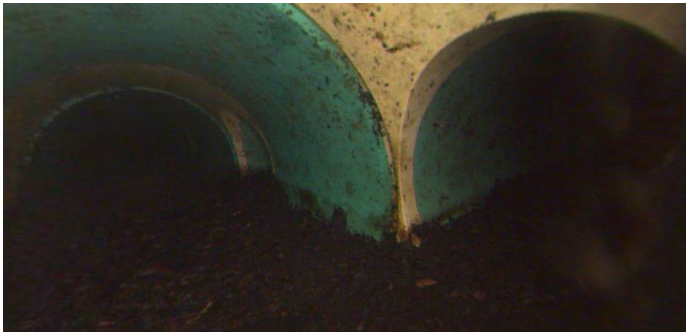
Code: **TFD**
Description: **Tap Factory Defective**

Distance (ft): **143.1**
Structural Grade: **0**
O&M Grade: **2**
Clock Start/From: **3**
Clock To:
1st Value: **4.000**
2nd Value:
Value Percent:
Continuous Index:
Within 8" of Joint:
Remarks: **dsf**

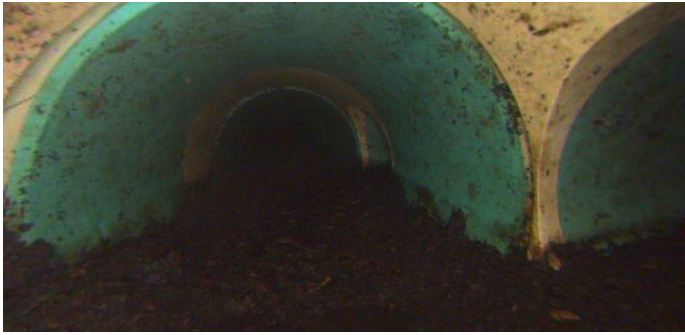
Code: **DSF**
Description: **Deposits Settled Fine**

Distance (ft): **143.1**
Structural Grade: **0**
O&M Grade: **5**
Clock Start/From: **3**
Clock To: **9**
1st Value:
2nd Value:
Value Percent: **40.000**
Continuous Index: **S02**
Within 8" of Joint: **NO**
Remarks:

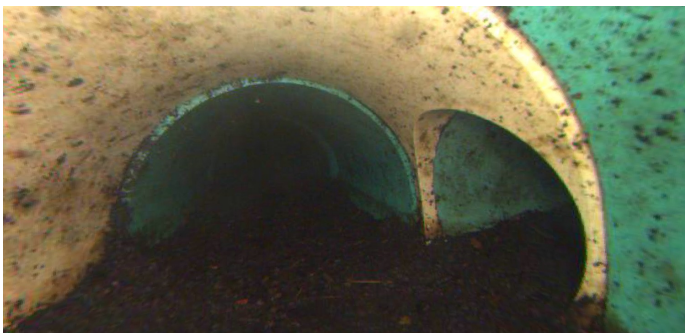
Code: **TFD**
Description: **Tap Factory Defective**

Distance (ft): **143.9**
Structural Grade: **0**
O&M Grade: **2**
Clock Start/From: **3**
Clock To:
1st Value: **4.000**
2nd Value:
Value Percent:
Continuous Index:
Within 8" of Joint:
Remarks: **dsf**

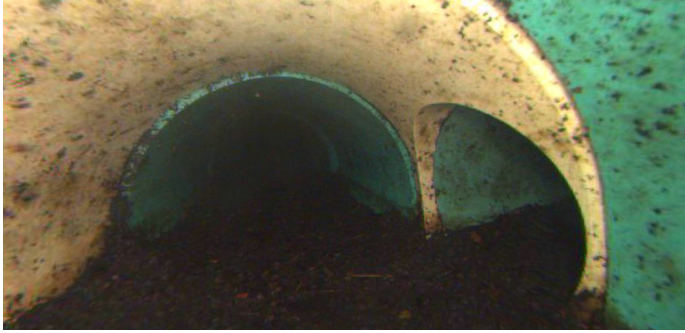
Code: **MWL**
Description: **Water Level**

Distance (ft): **143.9**
Structural Grade: **0**
O&M Grade: **0**
Clock Start/From:
Clock To:
1st Value:
2nd Value:
Value Percent: **0.000**
Continuous Index:
Within 8" of Joint: **NO**
Remarks:

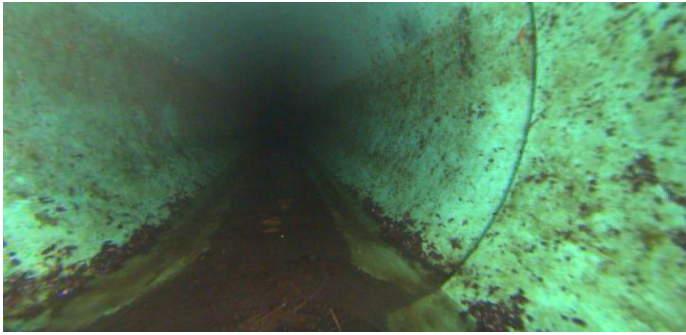
Code: **MWL**
Description: **Water Level**

Distance (ft): **173.0**
Structural Grade: **0**
O&M Grade: **0**
Clock Start/From:
Clock To:
1st Value:
2nd Value:
Value Percent: **5.000**
Continuous Index:
Within 8" of Joint: **NO**
Remarks:

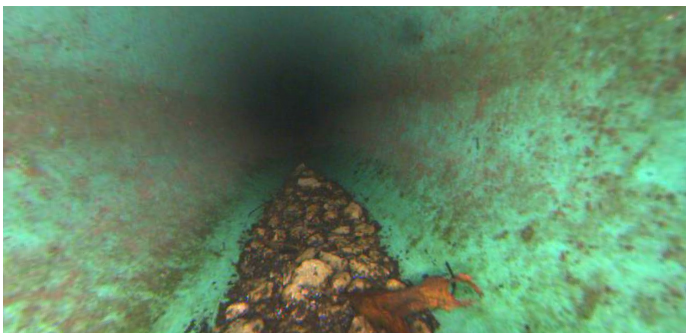
Code: **DSGV**
Description: **Deposits Settled Gravel**

Distance (ft): **181.2**
Structural Grade: **0**
O&M Grade: **2**
Clock Start/From: **6**
Clock To:
1st Value:
2nd Value:
Value Percent: **5.000**
Continuous Index:
Within 8" of Joint: **NO**
Remarks:

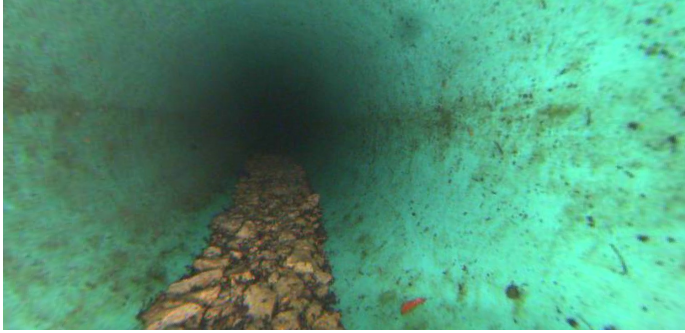
Code: **DSGV**
Description: **Deposits Settled Gravel**

Distance (ft): **187.0**
Structural Grade: **0**
O&M Grade: **2**
Clock Start/From: **6**
Clock To:
1st Value:
2nd Value:
Value Percent: **5.000**
Continuous Index:
Within 8" of Joint: **NO**
Remarks:

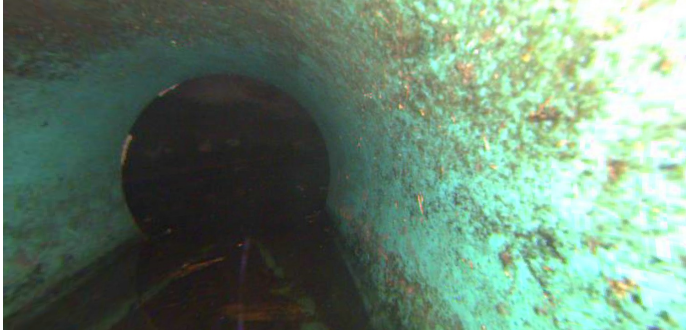
Code:	DSF
Description:	Deposits Settled Fine
Distance (ft):	213.3
Structural Grade:	0
O&M Grade:	2
Clock Start/From:	5
Clock To:	7
1st Value:	
2nd Value:	
Value Percent:	10.000
Continuous Index:	F03
Within 8" of Joint:	NO
Remarks:

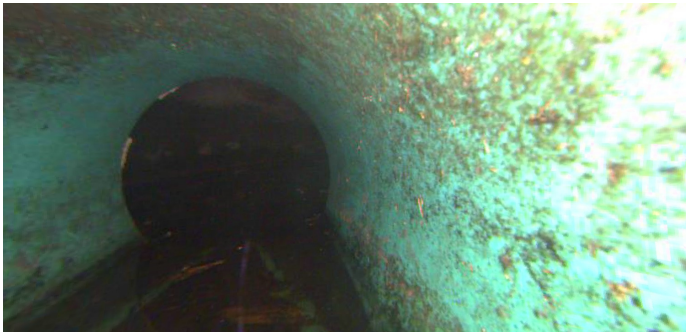
Code:	MWL
Description:	Water Level
Distance (ft):	213.3
Structural Grade:	0
O&M Grade:	0
Clock Start/From:	
Clock To:	
1st Value:	
2nd Value:	
Value Percent:	20.000
Continuous Index:	
Within 8" of Joint:	NO
Remarks:
