Profile/Photo Observation Report

Street:	Brandt Pl.	Flow Control:	Not Controlled
City:	Hobart, IN	Year Renewed:	
Location:	Other	Tape/Media #:	
Purpose:	Not Known	Dia/Height:	10"
Use:	Sanitary	Material:	PVC
Drain Area:	NA	Lining:	
Category:	NA		
Comment:

Location Details:		Direction of Survey:	Upstream
US MH:	M-904-039	DS MH:	M-904-038
		Total Length Surveyed (ft):	215.4

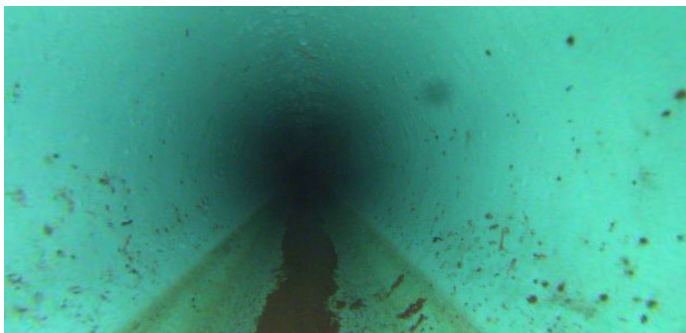
Code: **AMH**
Description: **Manhole**

Distance (ft): **.0**
Structural Grade: **0**
O&M Grade: **0**
Clock Start/From:
Clock To:
1st Value:
2nd Value:
Value Percent:
Continuous Index:
Within 8" of Joint: **NO**
Remarks: **M-904-038**

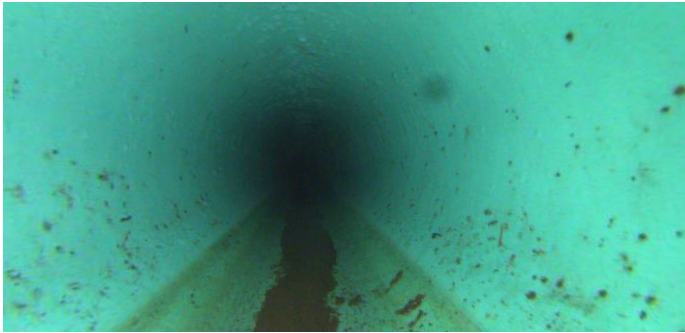
Code: **MWL**
Description: **Water Level**

Distance (ft): **.0**
Structural Grade: **0**
O&M Grade: **0**
Clock Start/From:
Clock To:
1st Value:
2nd Value:
Value Percent: **5.000**
Continuous Index:
Within 8" of Joint: **NO**
Remarks:

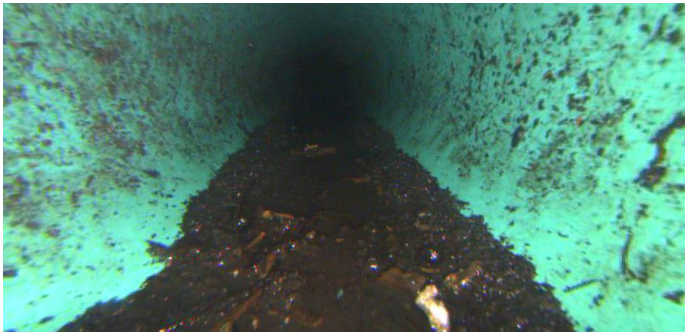
Code: **DSF**
Description: **Deposits Settled Fine**

Distance (ft): **58.3**
Structural Grade: **0**
O&M Grade: **2**
Clock Start/From: **5**
Clock To: **7**
1st Value:
2nd Value:
Value Percent: **10.000**
Continuous Index: **S01**
Within 8" of Joint: **NO**
Remarks:

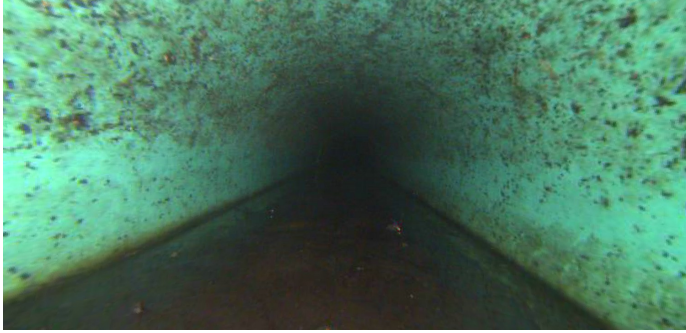
Code: **DSF**
Description: **Deposits Settled Fine**

Distance (ft): **113.4**
Structural Grade: **0**
O&M Grade: **2**
Clock Start/From: **5**
Clock To: **7**
1st Value:
2nd Value:
Value Percent: **10.000**
Continuous Index: **F01**
Within 8" of Joint: **NO**
Remarks:

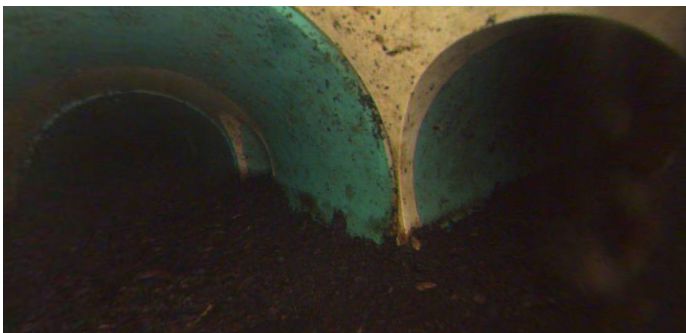
Code: **TFD**
Description: **Tap Factory Defective**

Distance (ft): **143.1**
Structural Grade: **0**
O&M Grade: **2**
Clock Start/From: **3**
Clock To:
1st Value: **4.000**
2nd Value:
Value Percent:
Continuous Index:
Within 8" of Joint:
Remarks: **dsf**

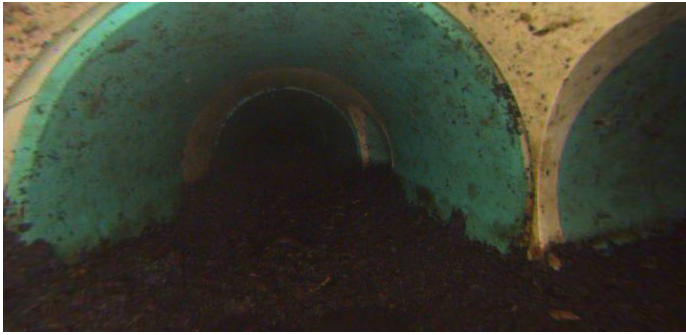
Code: **DSF**
Description: **Deposits Settled Fine**

Distance (ft): **143.1**
Structural Grade: **0**
O&M Grade: **5**
Clock Start/From: **3**
Clock To: **9**
1st Value:
2nd Value:
Value Percent: **40.000**
Continuous Index: **S02**
Within 8" of Joint: **NO**
Remarks:

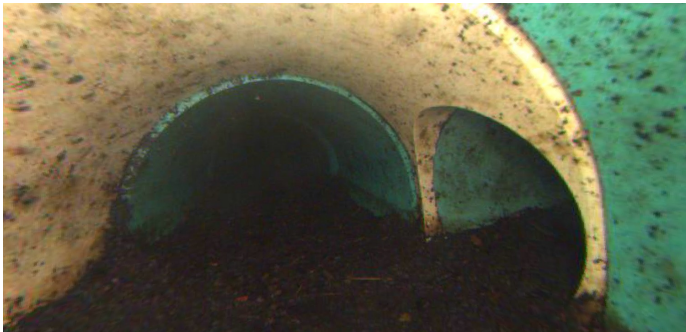
Code: **TFD**
Description: **Tap Factory Defective**

Distance (ft): **143.9**
Structural Grade: **0**
O&M Grade: **2**
Clock Start/From: **3**
Clock To:
1st Value: **4.000**
2nd Value:
Value Percent:
Continuous Index:
Within 8" of Joint:
Remarks: **dsf**

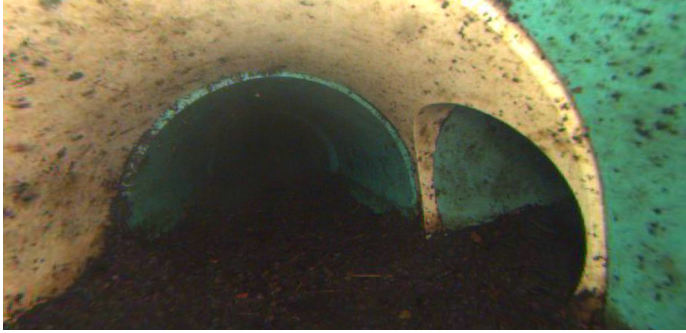
Code: **MWL**
Description: **Water Level**

Distance (ft): **143.9**
Structural Grade: **0**
O&M Grade: **0**
Clock Start/From:
Clock To:
1st Value:
2nd Value:
Value Percent: **0.000**
Continuous Index:
Within 8" of Joint: **NO**
Remarks:

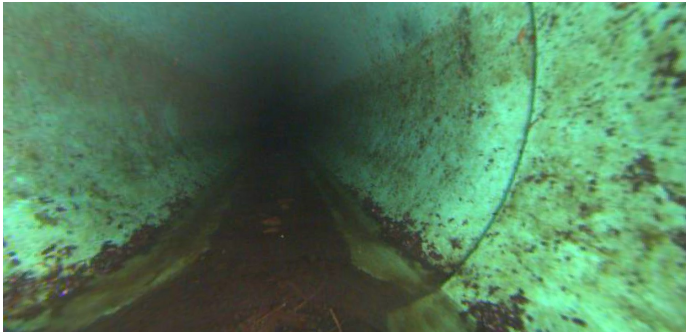
Code: **MWL**
Description: **Water Level**

Distance (ft): **173.0**
Structural Grade: **0**
O&M Grade: **0**
Clock Start/From:
Clock To:
1st Value:
2nd Value:
Value Percent: **5.000**
Continuous Index:
Within 8" of Joint: **NO**
Remarks:

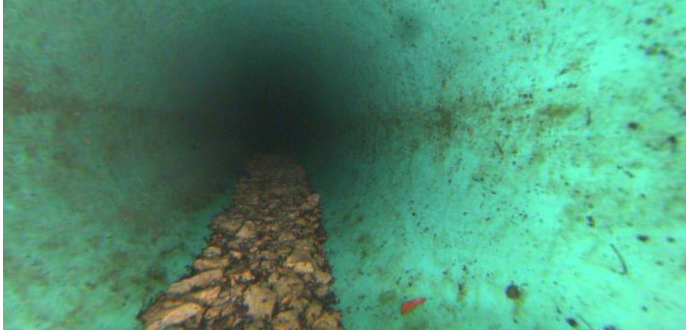
Code: **DSGV**
Description: **Deposits Settled Gravel**

Distance (ft): **187.0**
Structural Grade: **0**
O&M Grade: **2**
Clock Start/From: **6**
Clock To:
1st Value:
2nd Value:
Value Percent: **5.000**
Continuous Index:
Within 8" of Joint: **NO**
Remarks:

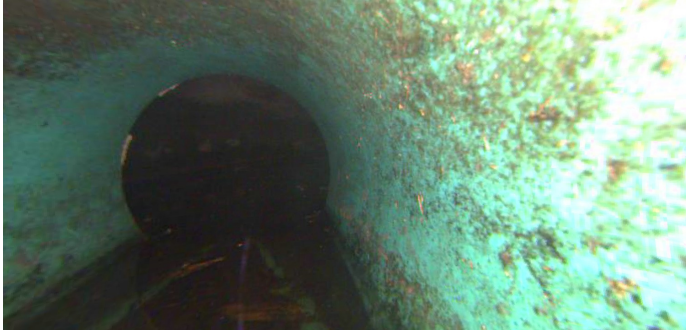
Code:	DSF
Description:	Deposits Settled Fine
Distance (ft):	213.3
Structural Grade:	0
O&M Grade:	2
Clock Start/From:	5
Clock To:	7
1st Value:	
2nd Value:	
Value Percent:	10.000
Continuous Index:	F03
Within 8" of Joint:	NO
Remarks:

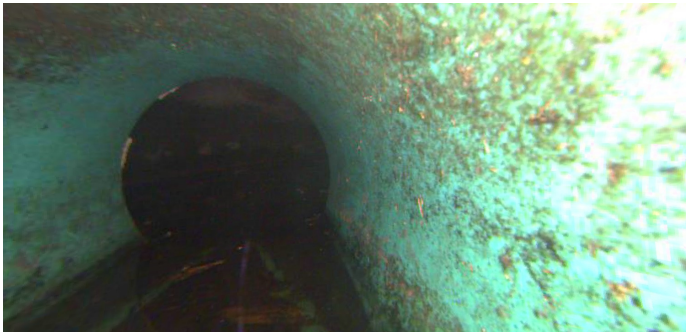
Code:	MWL
Description:	Water Level
Distance (ft):	213.3
Structural Grade:	0
O&M Grade:	0
Clock Start/From:	
Clock To:	
1st Value:	
2nd Value:	
Value Percent:	20.000
Continuous Index:	
Within 8" of Joint:	NO
Remarks:

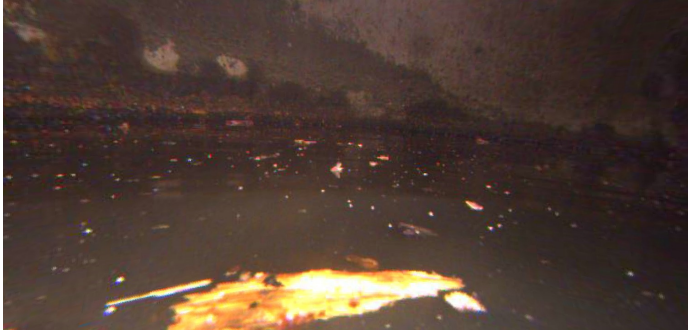
Code:	AMH
Description:	Manhole
Distance (ft):	215.4
Structural Grade:	0
O&M Grade:	0
Clock Start/From:	
Clock To:	
1st Value:	
2nd Value:	
Value Percent:	
Continuous Index:	
Within 8" of Joint:	NO
Remarks:	M-904-039
