Profile/Photo Observation Report

Street:	Brandt Pl.	Flow Control:	Not Controlled
City:	Hobart, IN	Year Renewed:	
Location:	Other	Tape/Media #:	
Purpose:	Not Known	Dia/Height:	10"
Use:	Sanitary	Material:	VCP
Drain Area:	NA	Lining:	
Category:	NA		
Comment:

Location Details:		Direction of Survey:	Downstream
US MH:	M-904-039	DS MH:	M-904-038
		Total Length Surveyed (ft):	2.5

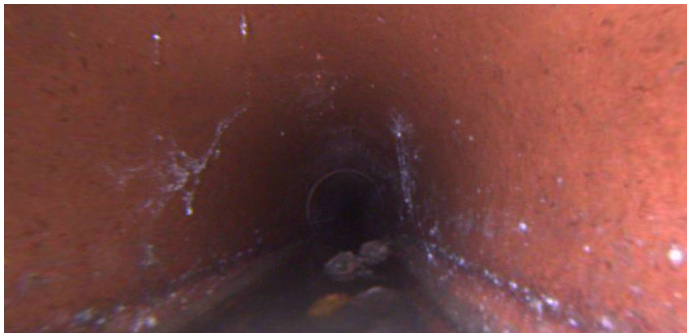
Code: **AMH**
Description: **Manhole**

Distance (ft): **.0**
Structural Grade: **0**
O&M Grade: **0**
Clock Start/From:
Clock To:
1st Value:
2nd Value:
Value Percent:
Continuous Index:
Within 8" of Joint: **NO**
Remarks: **M-904-039**

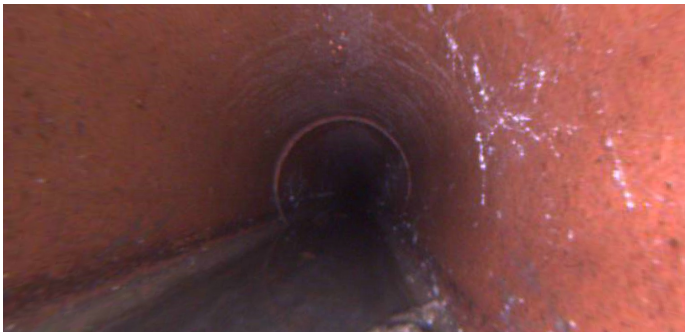
Code:	MSA
Description:	Abandoned Survey

Distance (ft):	2.5
Structural Grade:	0
O&M Grade:	0
Clock Start/From:	
Clock To:	
1st Value:	
2nd Value:	
Value Percent:	
Continuous Index:	
Within 8" of Joint:	NO
Remarks:	DEBRIS UNDER WATER
